INFORMATION RELEASE NO. 253

LANDSLIDES EVALUATION AND
STABILIZATION BETWEEN GILGIT AND
THAKOT ALONG THE KARAKORAM HIGHWAY

ARSHAD FAYAZ
MOHAMMAD LATIF
KANWAR SABIR ALI KHAN

Issued by the Director General, Geological Survey of Pakistan, Quetta.
1985

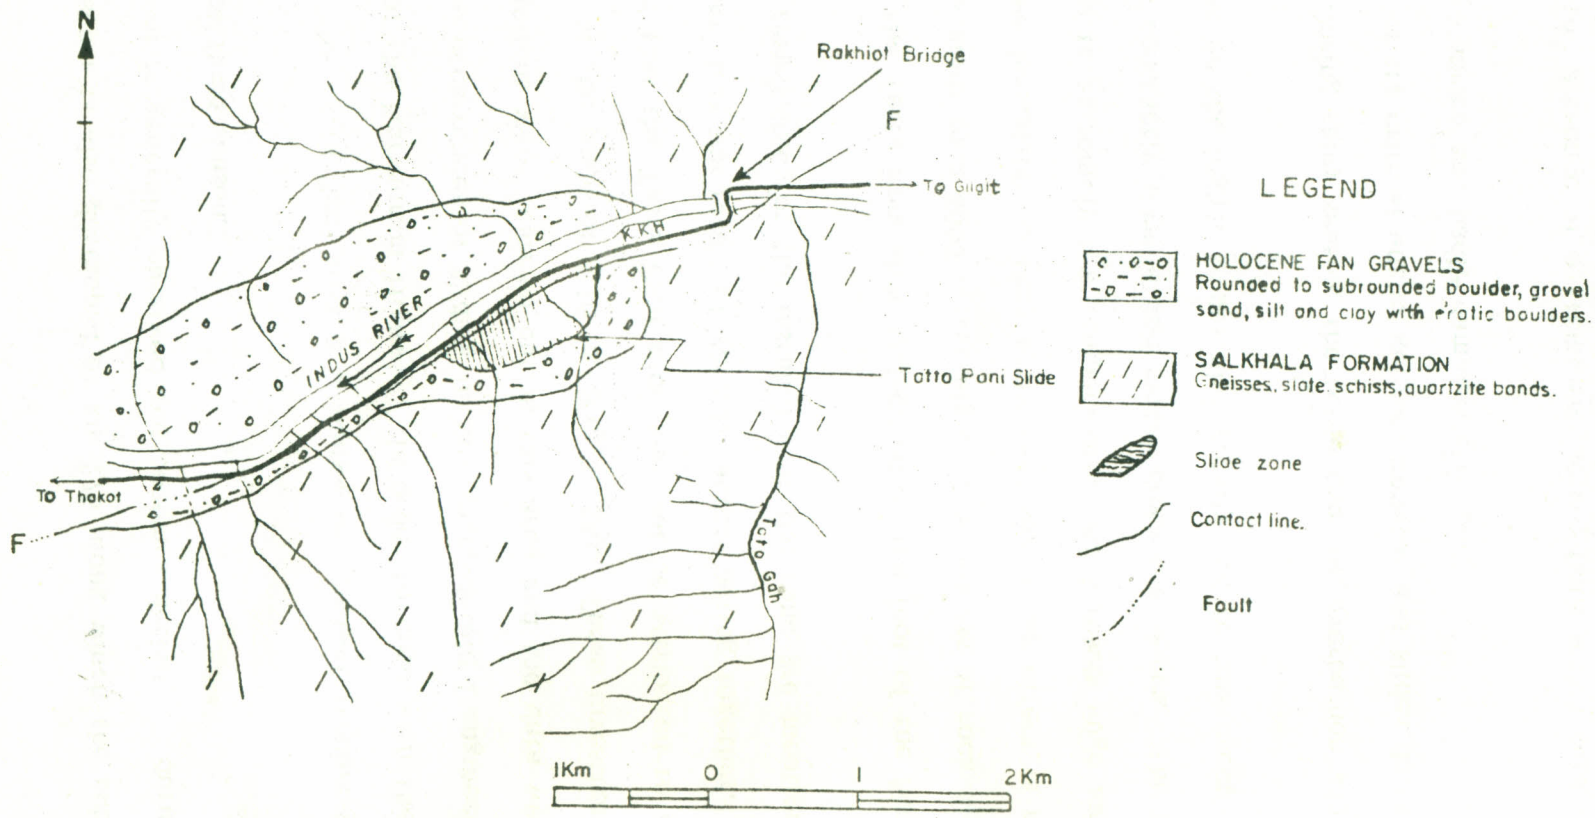
The rock types exposed in the slide consist of gneisses and quartzite. Holocene fan gravels are also developed at the foot of the Nanga Parbat massif. These Holocene gravels are affected by the recent tectonics and a zone of breccia 5 to 10 m thick is present along the KKH. Slickensides are developed in this breccia zone. Most of these slickensides appear to plunge along the dip of fault surfaces on which they are found. Locally a fault scarp is developed in these fan gravels in association with the breccia zone. It appears to reflect a steeply dipping fault downthrown to the north.

It has been observed that at Tatta Pani, the road subsides about 10 to 15 cm per day along the fault scarp and the down thrown block on the west has moved down more than 3 meters from the original road level.

Figure 2 - Generalised geological map showing location of Tatta Pani Slide at Km 275 on the KKH.

A big shear is also developed at km 275 along which the subsidence movement is generally observed and becomes active during the rain and high flood season.

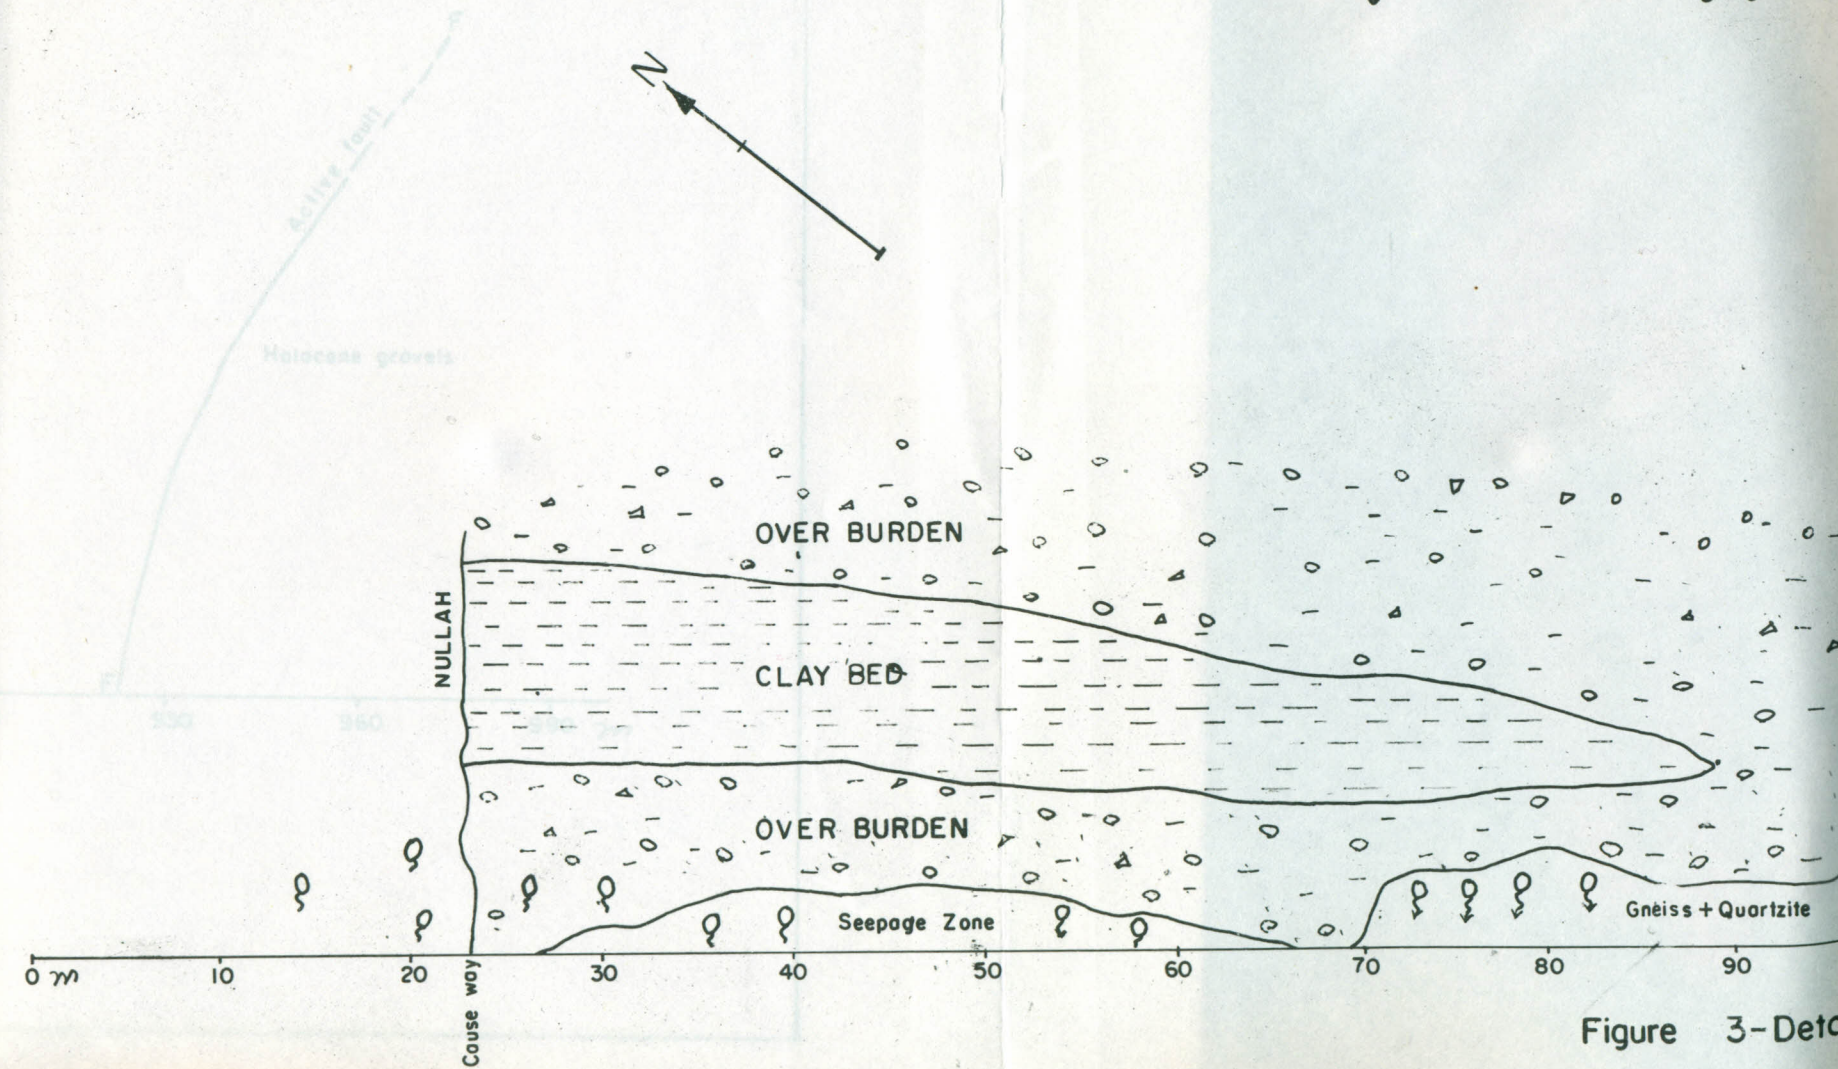
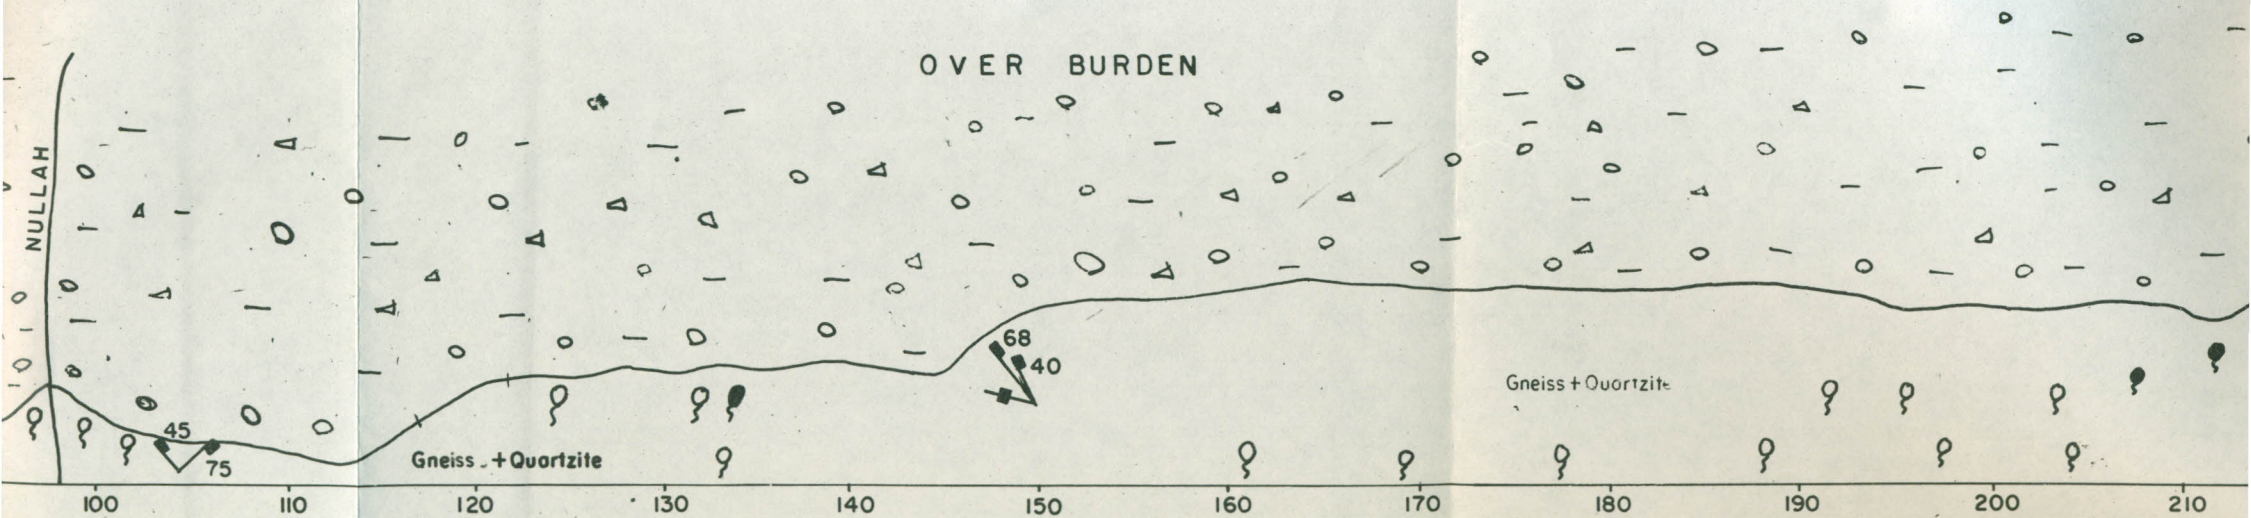
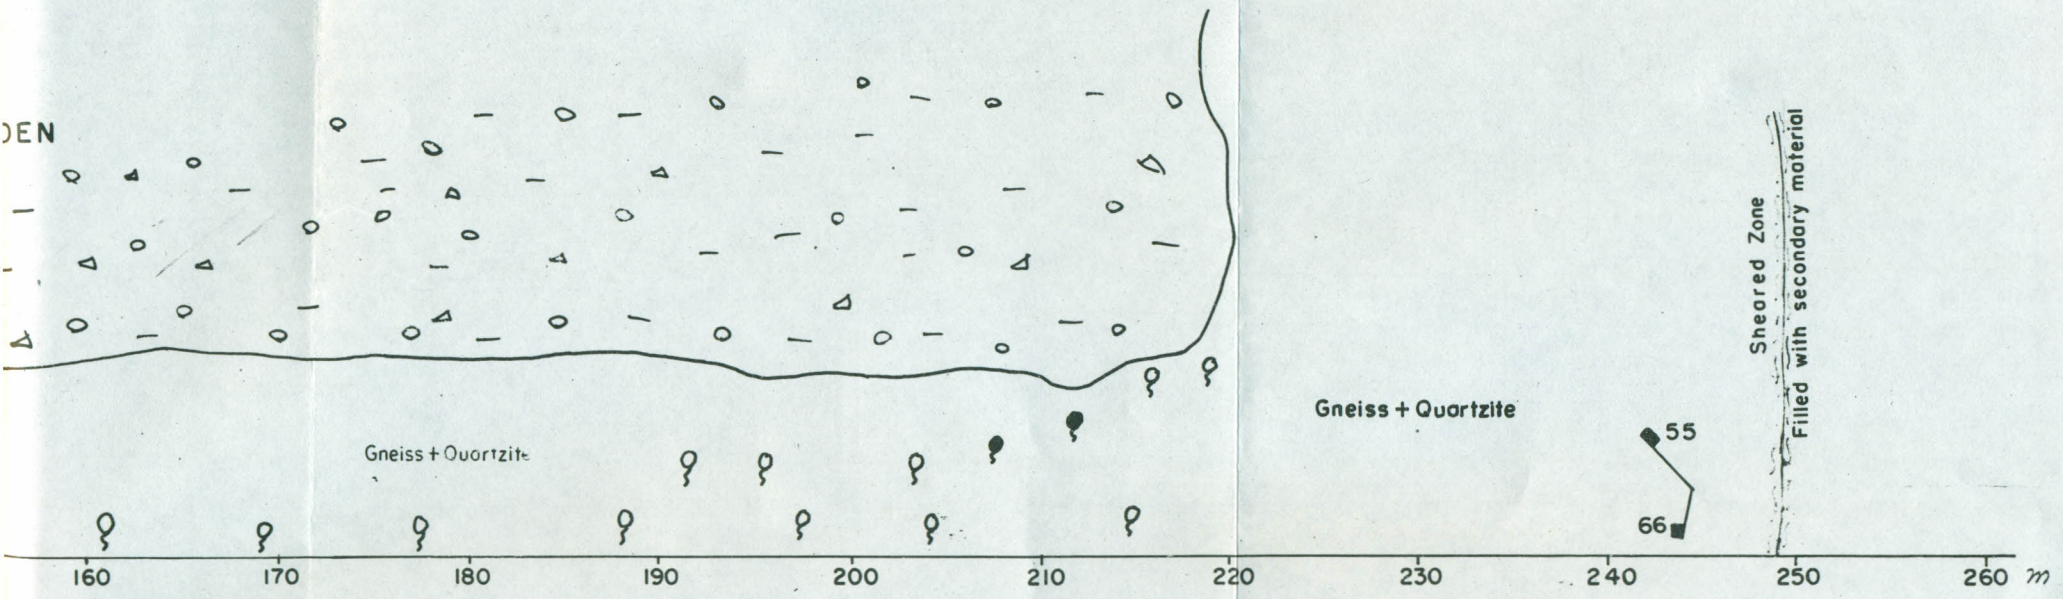
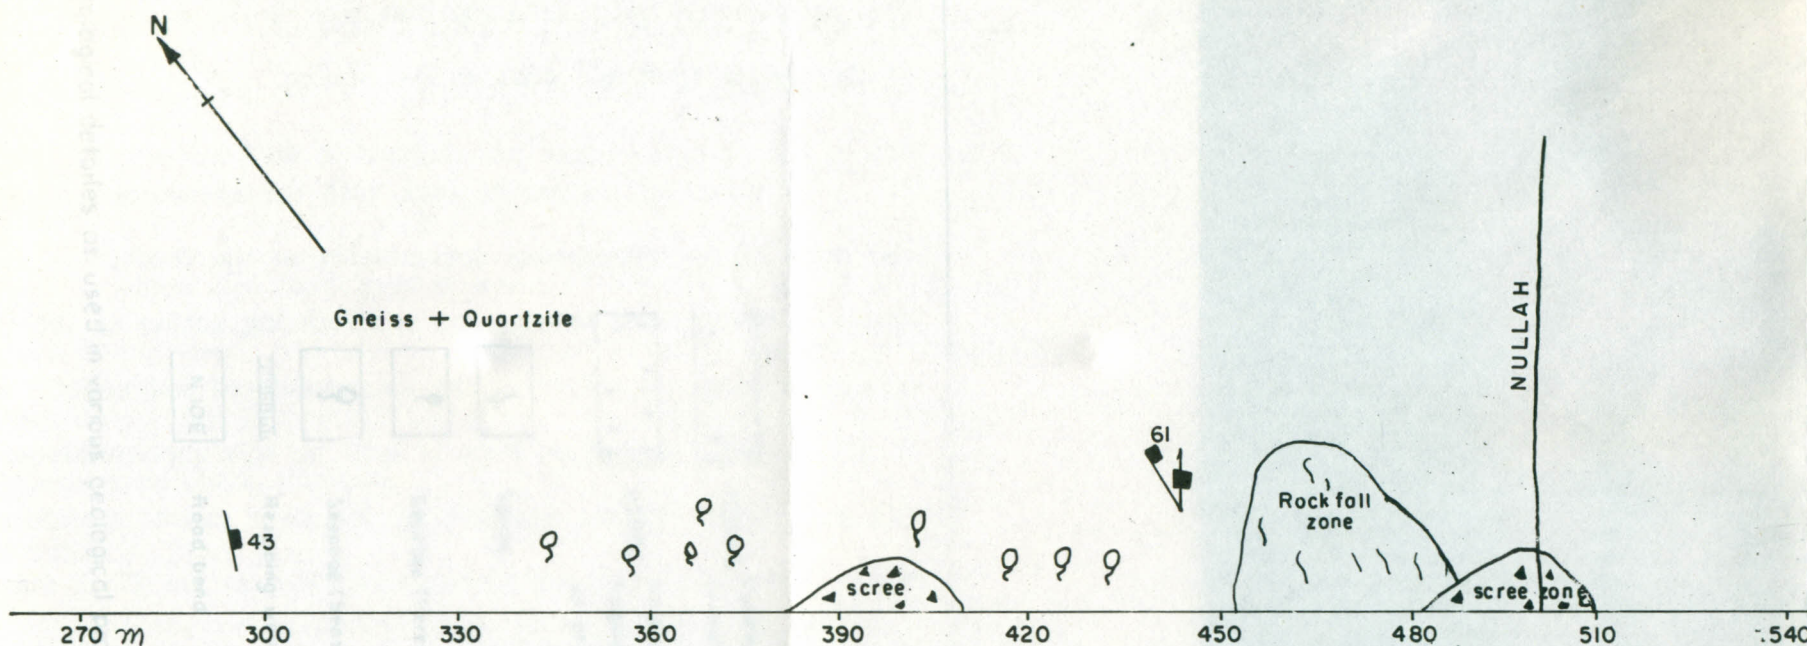
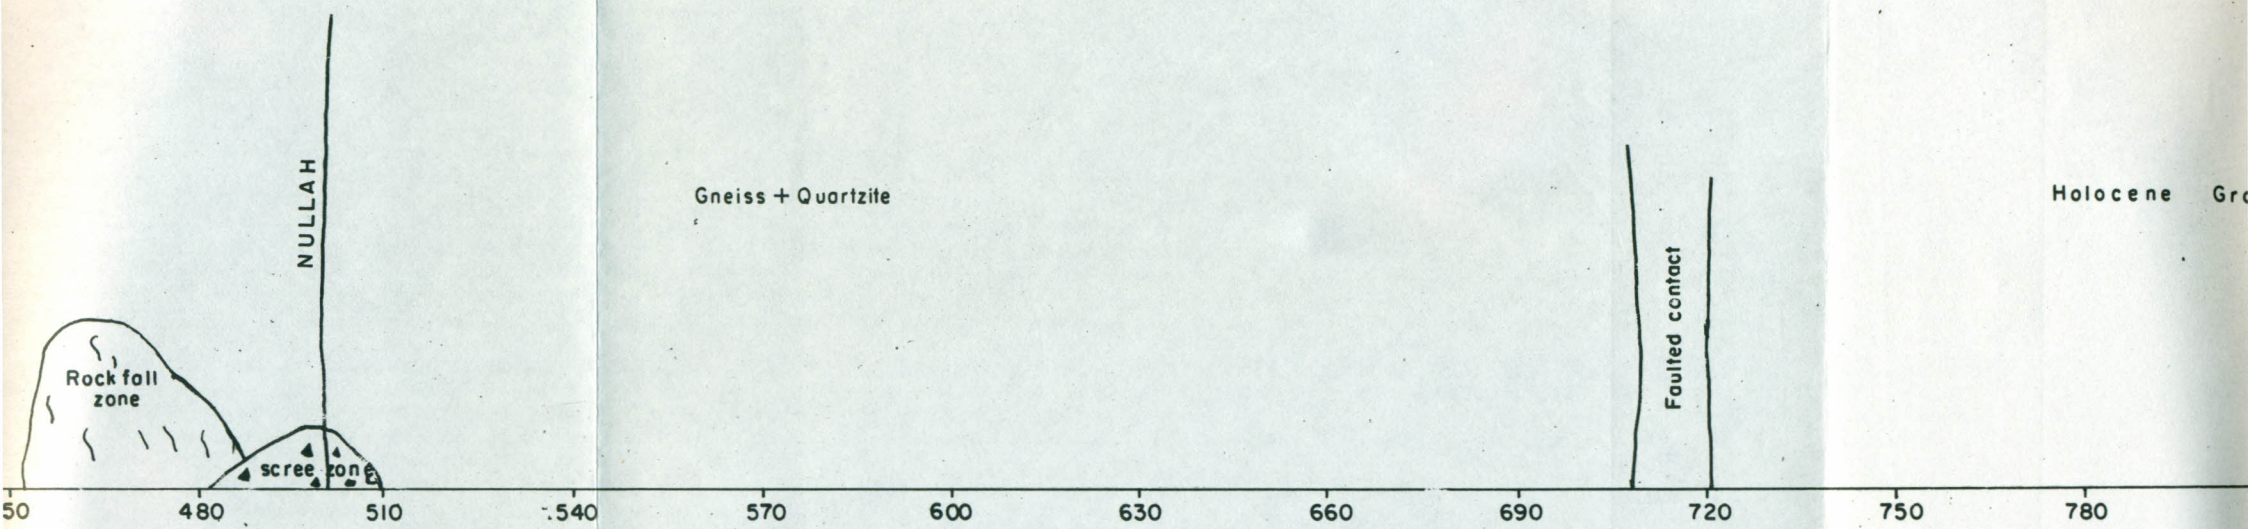
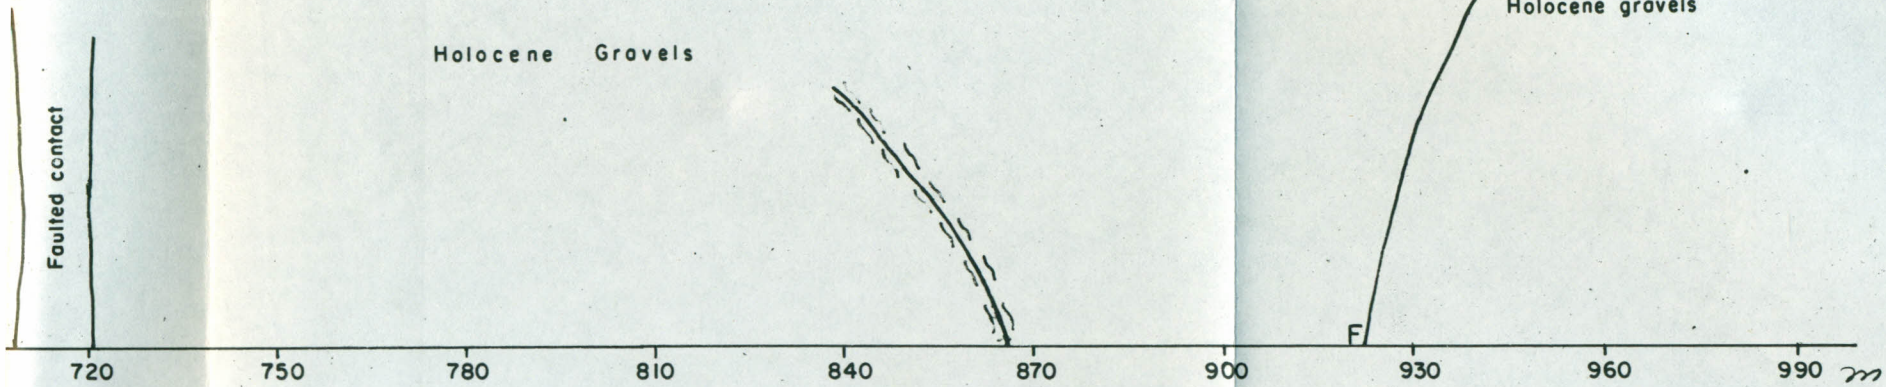
Geological profile of Tatta Pani Slide on the KKH. Symbols as shown in figure 3B

Figure 3A-Detailed geological profile of the Tatta Pani Slide on the KKH. Symbol as shown in fig 3B.
Scale. Horizontal 1: 30 m.
Vertical. Not to scale.

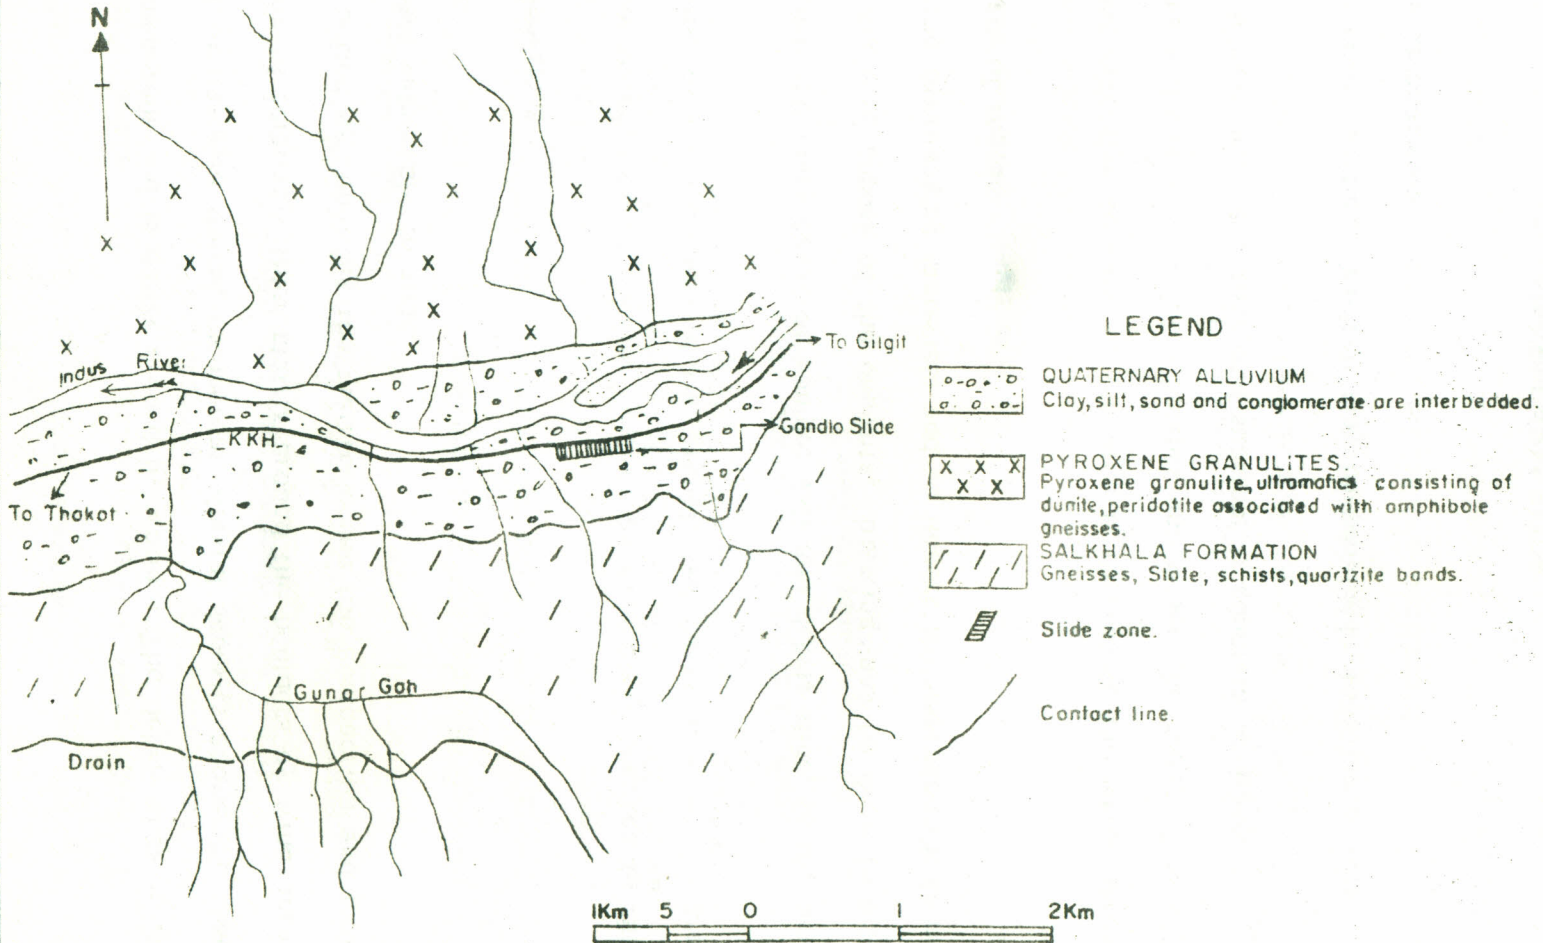
The material in the slide area consists of Quaternary deposits of boulders, gravels, and coarse sand of alluvial origin (Fig. 4). The percentage of sand is about 90% with boulders upto 2m. in diameter. The sand is loosely cemented and can be plucked with fingers very easily. The sand is coarse grained, partly stratified and semiconsolidated. The boulder gravels occur in partially cemented sand matrix and have become conglomeratic at the base. The area is unstable because the Quaternary deposits form almost vertical cliffs which are hanging at certain places along the slide affected zone.

Figure 4-Generalised geological map showing location of Gandilo Slide at Km 261 on the KKH.

quite incompetent and is easily eroded by water. The debris slide is thus the result of unstable slopes, incoherent alluvial deposits above the road and erosion of relatively finer matrix around the boulders by wind action. The wind action by removing the matrix loosens the compaction and makes the boulders vulnerable to slide.

- 1) The seepage of rain water cannot be efficiently checked in this area because of the looseness of the gravely sediments all over the area.
- 2) Since the main cause of boulder fall and debris slide, is the acute vertical angle of repose of the deposits, blasting may be done to bring down all the overhanging materials and to impart a comparatively more stable angle of repose.
- 3) One effective solution of the area is to reslope the whole stretch with berms and risers at suitable heights and widen the road. This will however, involve huge expenses and substantial quantum of work.
- 4) Effective surface drainage may be provided to serve as a temporary arrangement.

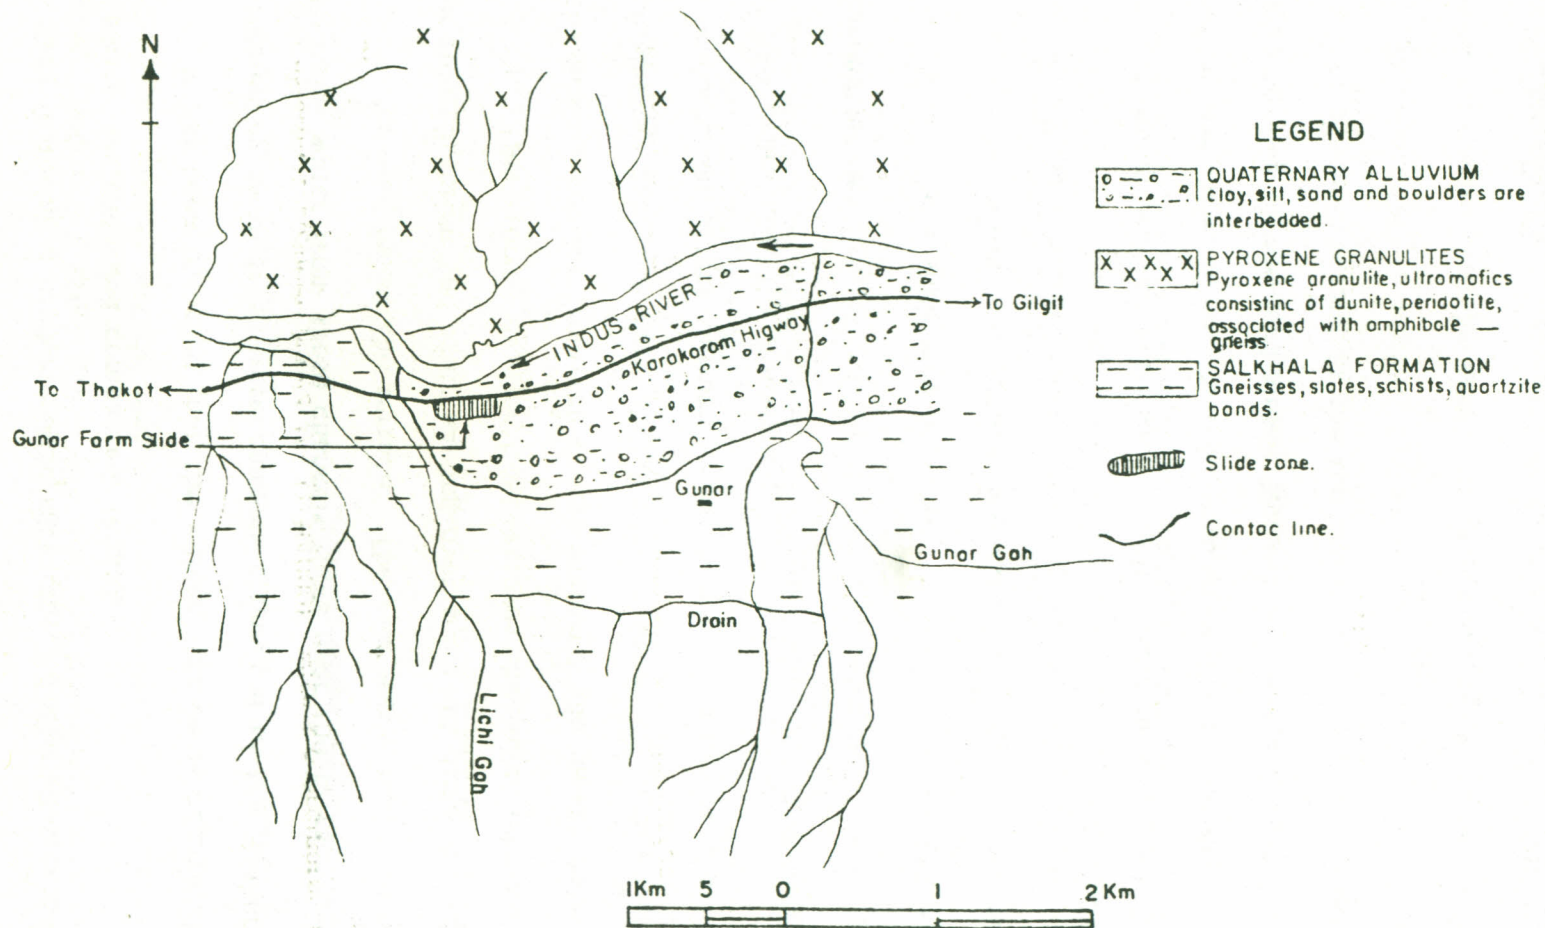
It has been observed that the village terrace is cultivated and is irrigated by small fresh water channel connected to the nullahs upstream. The surplus water from these channels flows over the terrace and falls down on the road below the terrace. The rain water also attains the same flow direction and after passing over the road, finds its way into the river. This process of over flow removes the finer sediments as well as the binding cement from the coarse material and makes them loose and vulnerable to sliding. A part of this run-off water infiltrates into the ground and produces subsurface channels which further loosen the alluvial cover; this flow thus aggravates the debris fall.

Figure 5—Generalised geological map showing location of Gunar Farm Slide on Km 257 on the KKH.

Guner Farm slide may be effectively controlled by channelising the flow of run off water and surface drainage. The surplus water may be diverted to proper culverts to check the ingress of water.

Although surface drainage itself is seldom sufficient for the stabilization of the slope, it can contribute substantially to the drying and thus, also controlling of the land slide. Nullah feeding the fields of Guner village should be channelized and at the top towards the roadside a concrete drainage should be provided to collect all excess water from other minor nullahs. This water can be easily diverted towards the west into the Lichi Gah to save the road. This distributary will also help in rainy season when almost all the water coming on top will pass through it and only direct hit of rain on the deposits will remain the problem. As the rains are not very common in this area, rest of the problems can be solved by providing road side drains to safely pass the water.

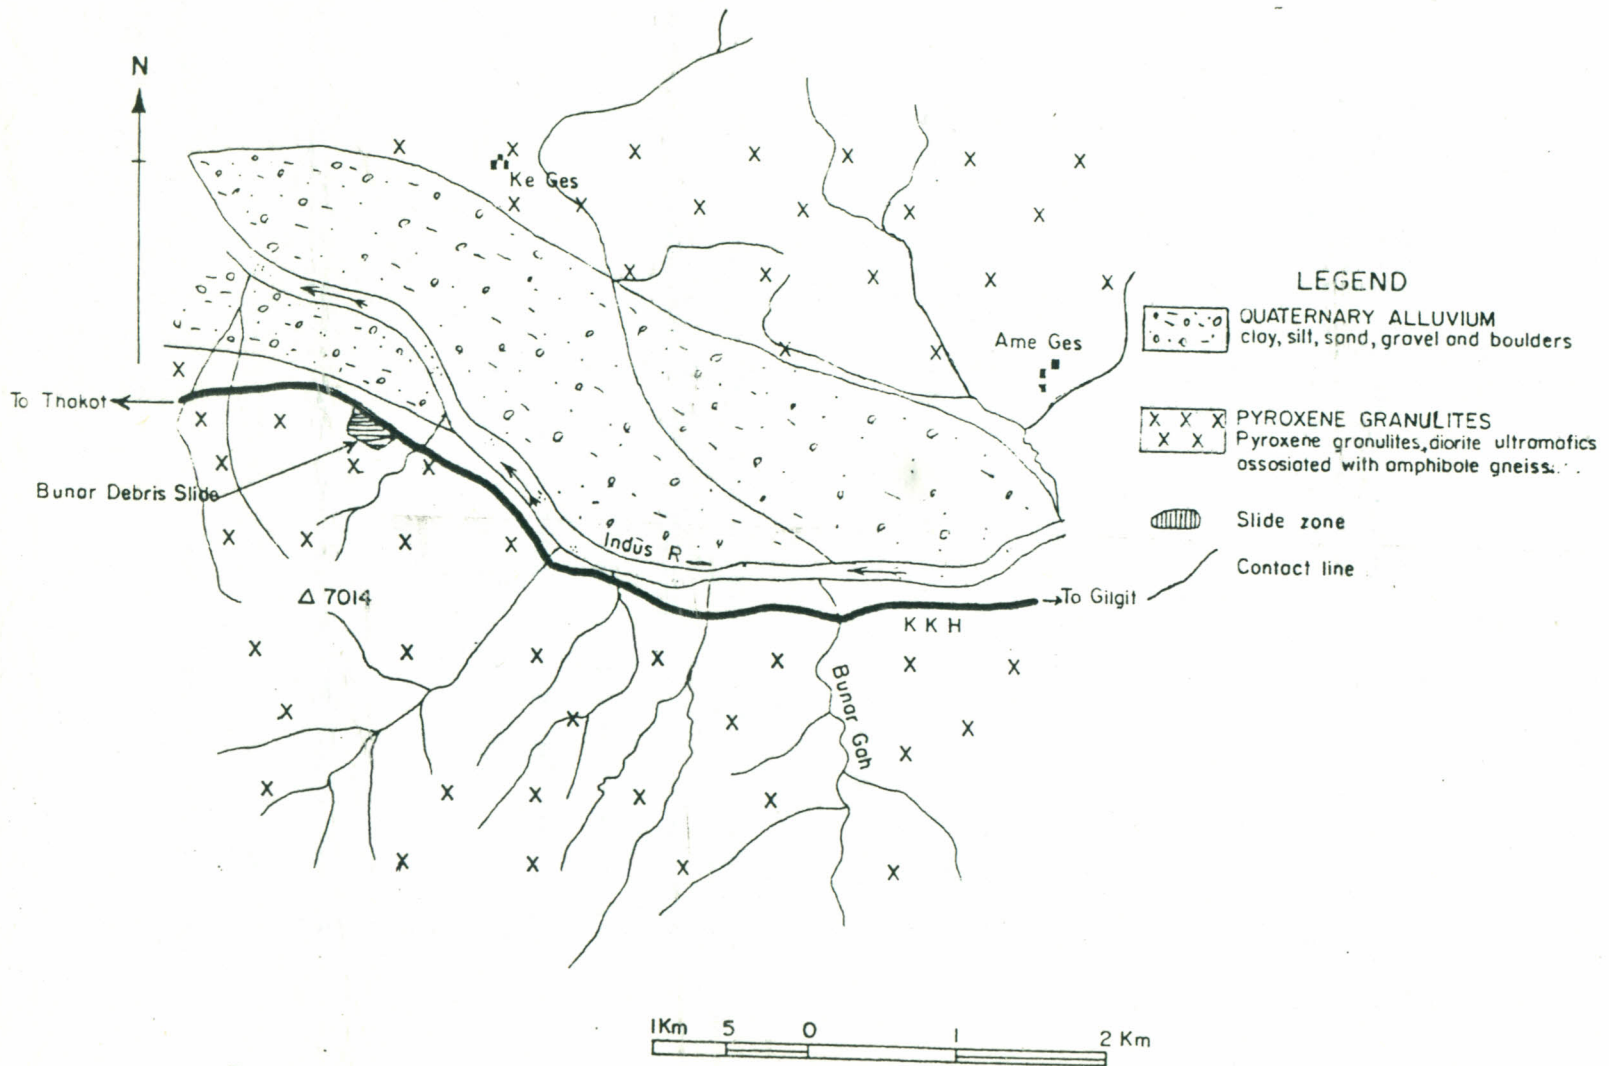
Rock type exposed at the site is diorite. Jointing is very regular and three sets of joints were noted (1) N 55 W, 37 SW (2) N 80 W, 80 NE. (3) N 45 W, vertical. At the height of 65 m from the road level a shear plane is developed and slip surface is formed. Relatively finer material is lying in between the crown of shear plane and road, scree is piling up at the lower level near the road. Almost half of the road is covered by scree, which is lying at 40° i.e. the critical angle. The rain, facilitates the material to slide down. In situ debris are partly cemented and roughly stratified. With the variation of temperature, scree material on loosening, fall under gravitational action.

Figure 6- Generalised geological map showing location of Bunar Debris Slide at Km 255 on the KKH.

- 1) Retaining wall of about 3 m. high may be constructed at the base of the slide to retain material.
- 2) Ditch may be provided at the toe of the retaining wall to drain water.

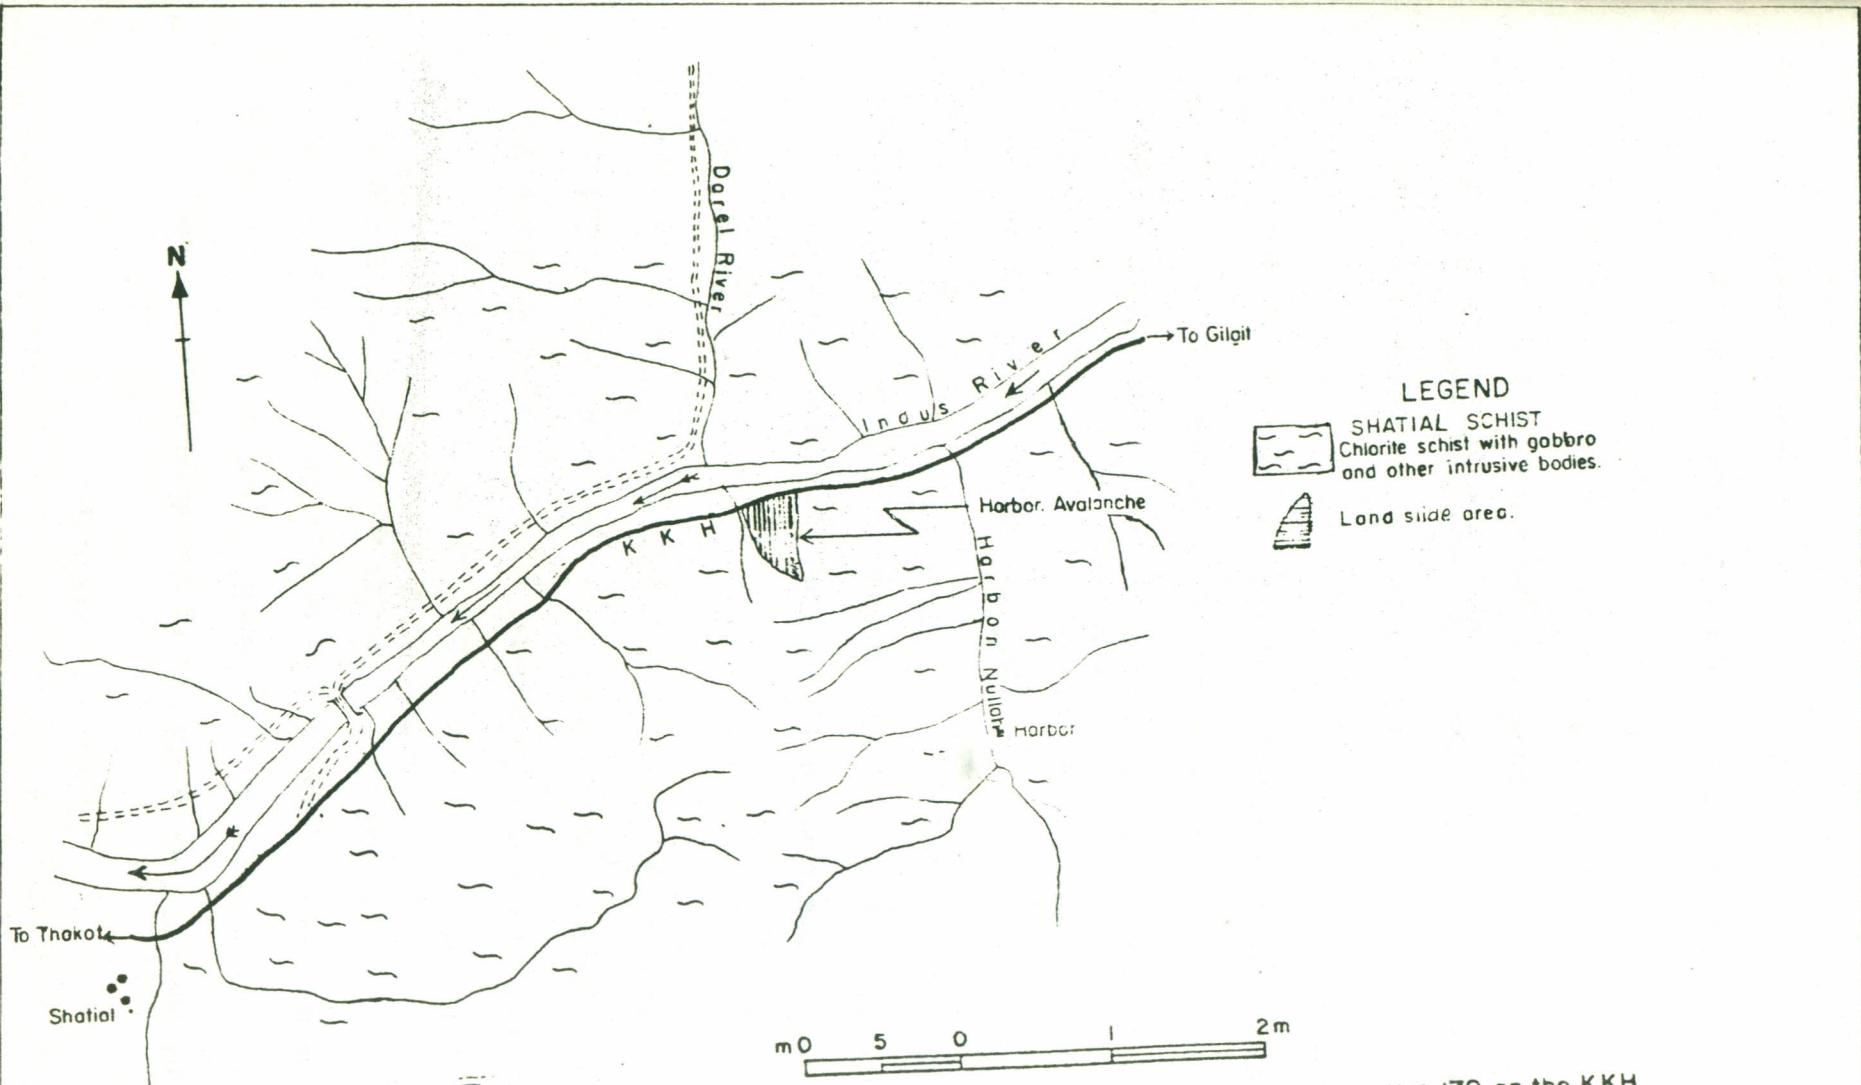
A traverse was made upto the top of the Harbon hill to know the exact nature of the slide. At a height of approximately 900 m there is almost a flat terrace consisting of boulders pebbles, gravels and clayey silt with thin blanket of soil developed on this unstratified deposits. Near the top of the slide the terrace is subjected to vertical sinking and breaking of the landmass into blocks. Six major east-west trending cracks, almost parallel to each other, with a parting distance of 6 to 9 m. were noted (Fig. 8). From the crown of already developed shear plane first crack is 30 m. inside which is 15 to 30 cm. wide and fairly deep. Cuts or cracks made on the top of the terrace created depressions in which water accumulates. This water subsequently penetrates into the residual material, thereby loosening the soil mass and allowing it to slide down in the form of an avalanche. Other factors which support slide are:

1. Vertical movements of terrace material along these cracks in the form of slumps and sinks.

Figure 7- Generalised geological map showing location of Harbon Avalanche Area at Km 170 on the KKH.

1. Side drains should be made to reduce and prevent the ingress of water into the cracks.
2. Filling and tamping of all open cracks are required to make them safe from such water flow and from the percolation of snow melt water which are conducive to widening of cracks. These cracks may even be filled with material available in the vicinity. After filling, a layer of impervious soils may be plastered.
3. Deep rooted trees may be planted at the terrace. Some bushes are already grown. The trees would give anchoring support to the mass and will greatly help in stabilizing the ground.

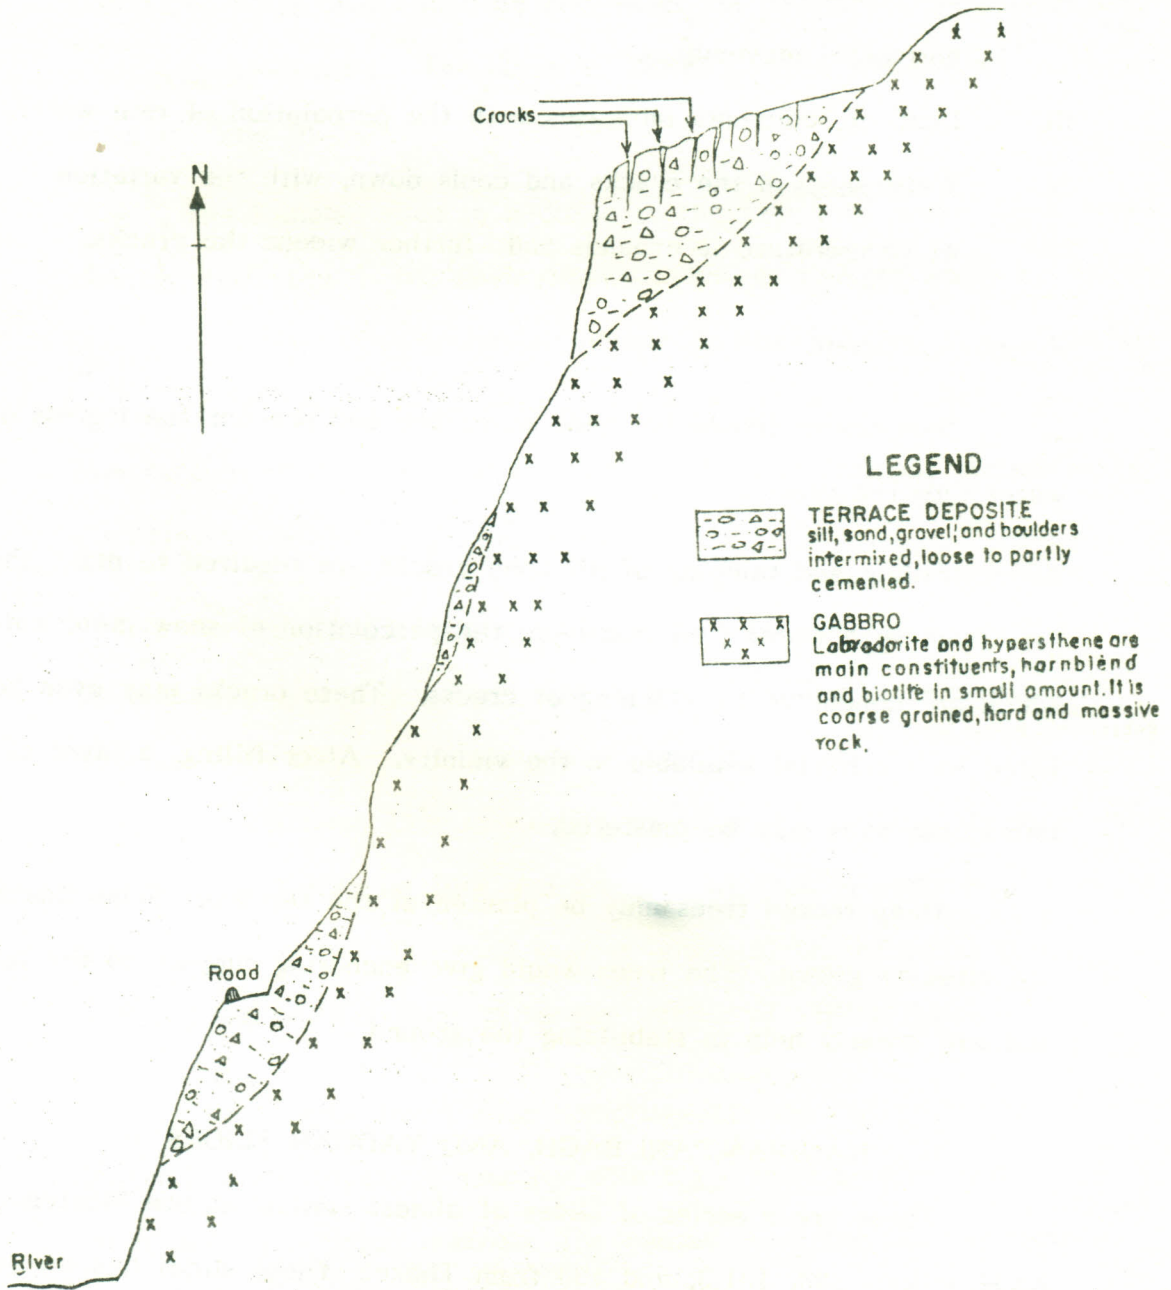
Figure 3 - Geological cross section of Harbon Avalanche showing vertical scar above the road level and pattern of cracks on a flat terrace.

- II. Water sinking through continuous water action prompted horizontal movements.
- III. Load of sediments increases with the percolation of rain water.
- IV. Water seeps in the cracks and cools down, with the variation of temperature it expands and further widens the cracks.

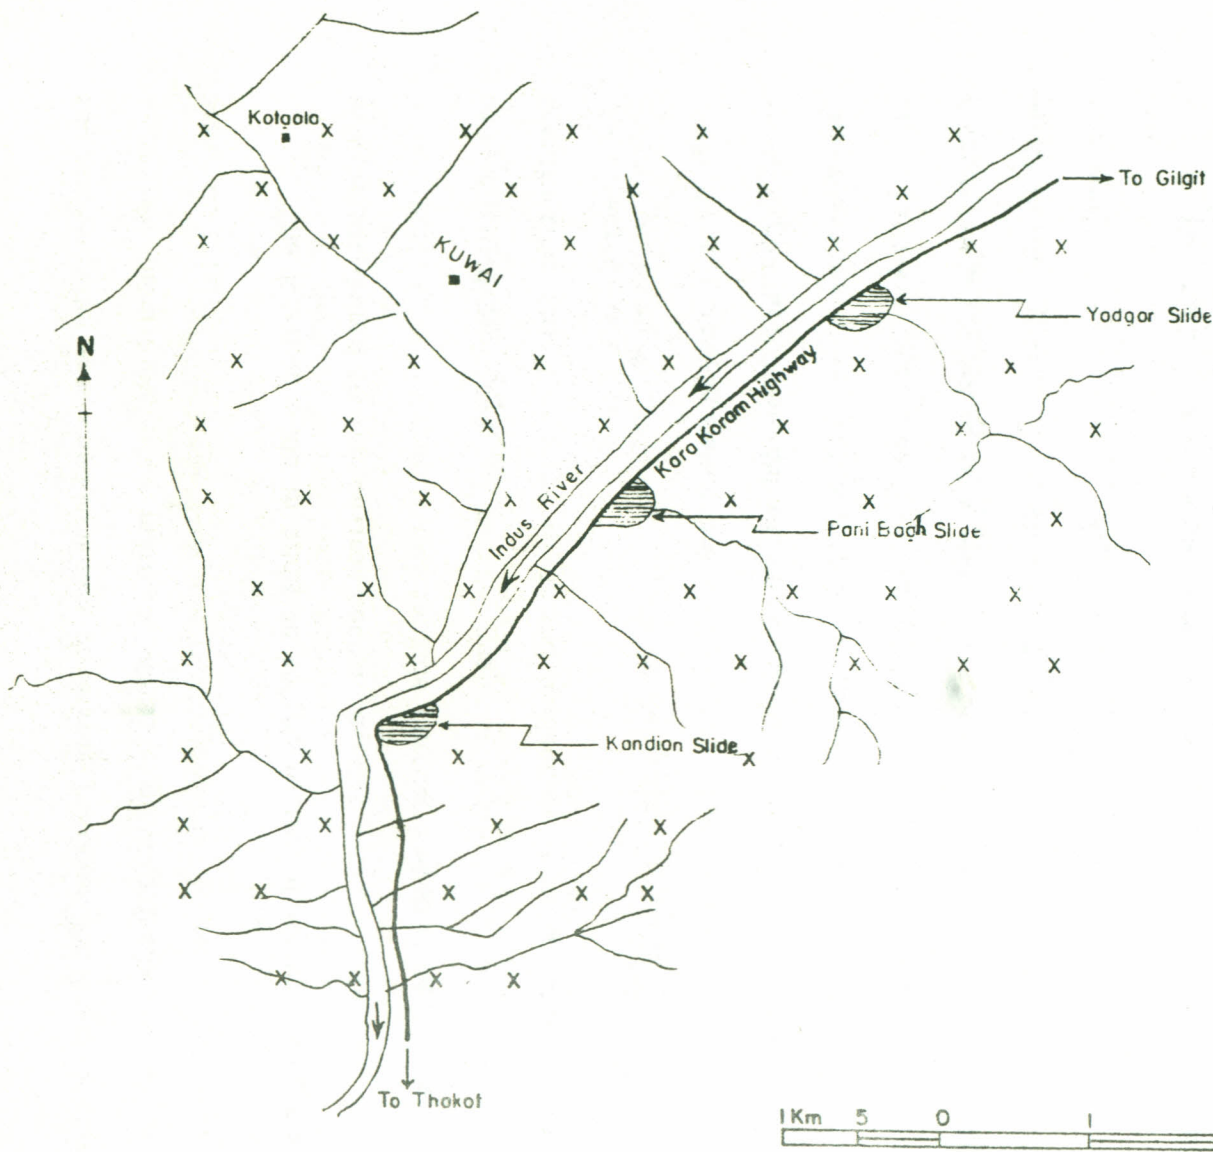
and sticky under wet condition and on drying becomes loose and attains a greyish colouration. The material moves enmass and sweeps the road along it. (Fig. 9).

The Kandian slide in addition to the factor of heavy rains, may also be attributed to the environmental changes brought about by the human activities. The activities include cutting and grazing of trees and vegetation, disturbance of natural angle of repose as a result of construction activity on the road, and inadequate drainage system along the affected section.

The Pani Bagh slide has similar type of material exposed at steep angles upto a height of about 100m. The slide zone derives its material from higher catchment areas through a couple of streams which are 2 to 3 km long. Due to steep gradient of the nullahs, the rain water comes like a torrential flow and brings down load of sediments in large quantity and force. The road section opposite the torrential streams is damaged and washed away under the impact of falling debris.

The Yadgar debris slide comprises mixture of coarse and fine material in almost equal quantity with big erratic boulders embedded within the silty-clayey matrix. The causes of sliding are the same as described above i.e. over saturated debris material wash downhill due to the flash floods in the hill torrents. The debris on drying attain a very steep slope angle. The finer material is removed by strong wind action and makes the coarser sediments and big boulders susceptible to sliding in dry season as well. Three tributaries join the main nullah which aggravate the problem of debris flow.

1. At Kandian, the run-off water falls from height and causes slope failure and damages the road. This water may be channelized and made to fall over a suitably designed stone - pitched water fall at an angle of 10° - 15° less than the original slope angle. A drain may also be provided at the base of the slope at road level to divert the water properly into the river on the other side of the road.
2. At Pani Bagh, the flow of nullah could also be controlled with similar type of structure as described in the case of Kandian slide.
3. The mudflow at Yadgar Slide may be checked to some extent by diverting the potential flow of three nullahs. It would involve considerable quantum of work. A strong retaining wall may impart additional support to the slope.
