INFORMATION RELEASE NO. 253

LANDSLIDES EVALUATION AND
STABILIZATION BETWEEN GILGIT AND
THAKOT ALONG THE KARAKORAM HIGHWAY

ARSHAD FAYAZ
MOHAMMAD LATIF
KANWAR SABIR ALI KHAN

Issued by the Director General, Geological Survey of Pakistan, Quetta.
1985

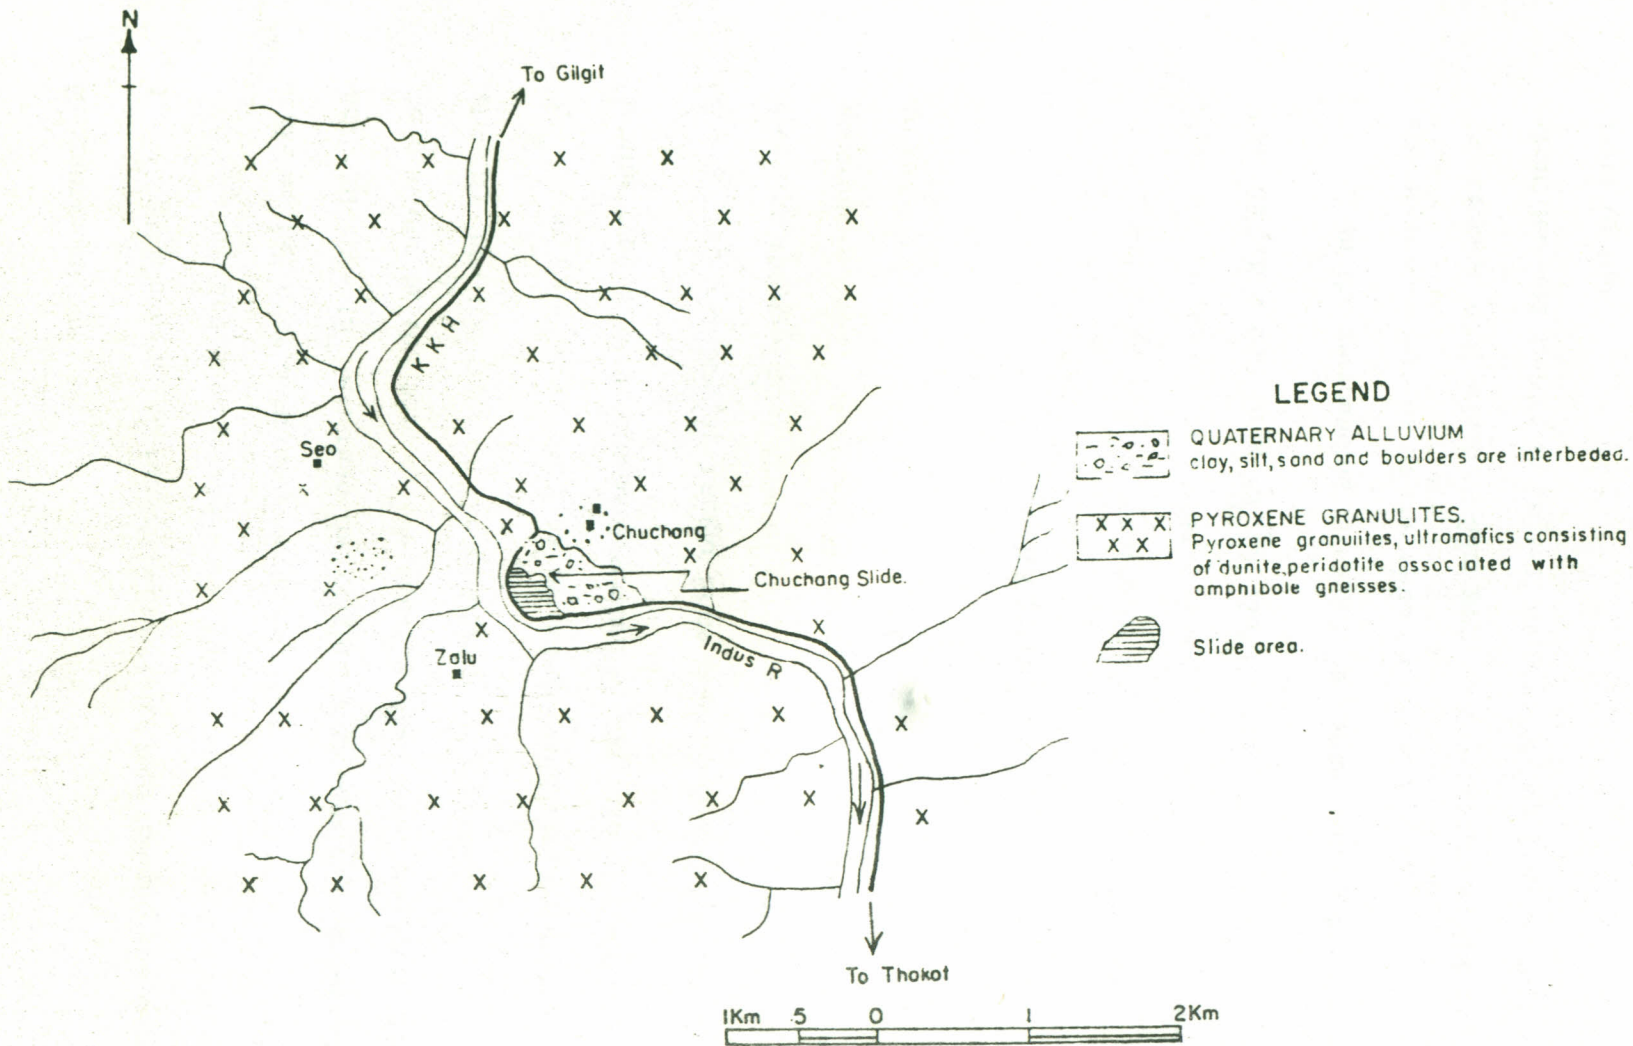
In the surrounding of Chuchang slide area pyroxene granulites are exposed where as at the slide Quaternary alluvium is present making the vertical cliff which is 30m high to its maximum. The deposition is stratified and consist in general of the following sequence from road level to top :

- (a) Coarse loosely cemented sand about 3 m thick.
- (b) Rounded boulders and gravel with sand 13 m thick.
- (c) Sand loosely cemented 13 m thick.
- (d) Clay with angular boulders and gravel 3 m thick.

Figure 10 - Generalised geological map showing location of Chuchang Slide Area at Km 110 on the KKH.

The above strata normally stable at 50° to 60° . The sand is standing vertically but keeps on falling with the slightest vibrations from wind and vehicular movement. At one place overbreak of 2 m depth has taken place.

The affected area is drained by a seasonal nullah which causes considerable undercutting and erosion of the side walls and causes large scale sliding.

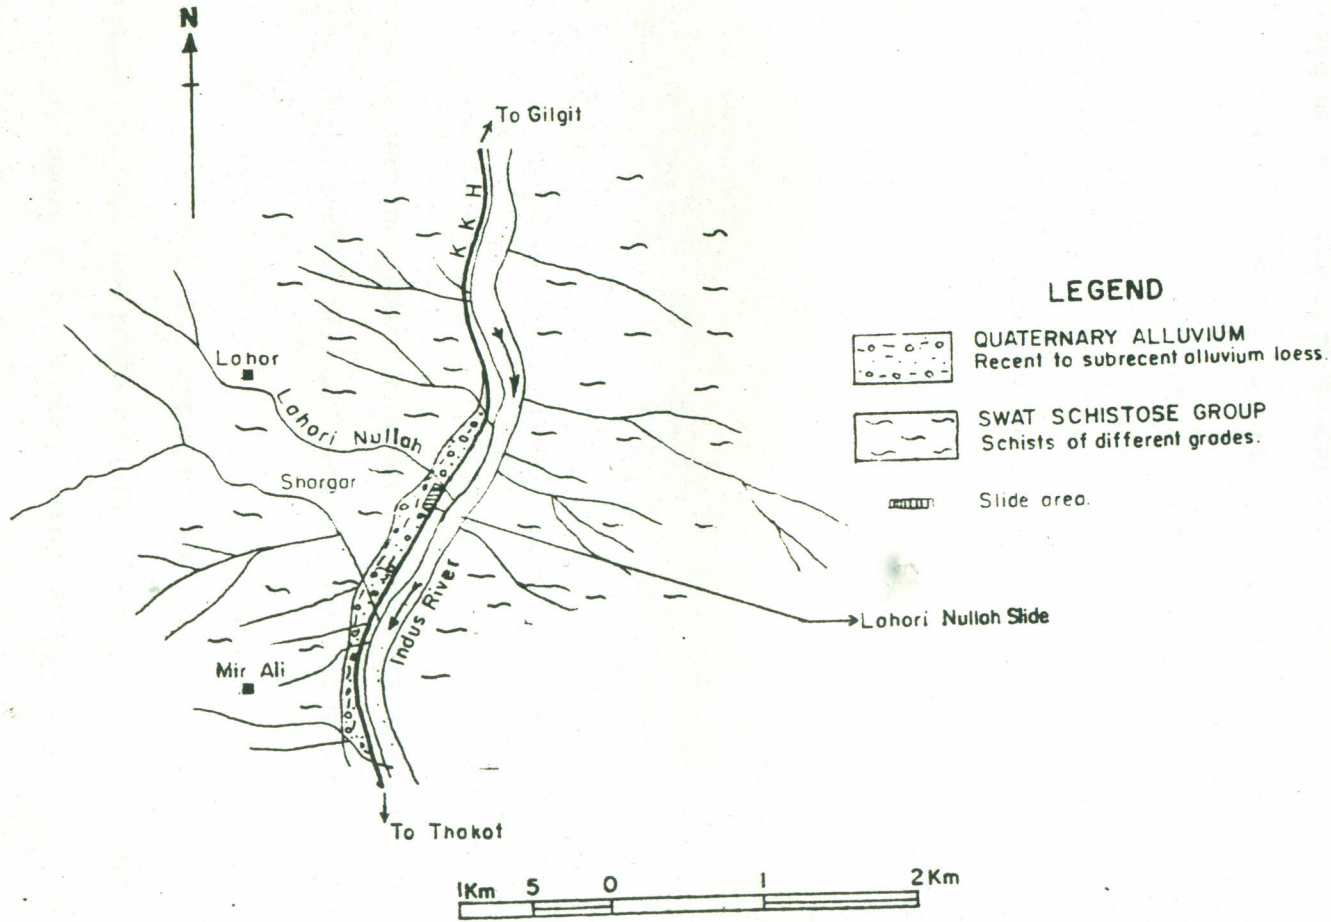
Lahori nullah slide is located at 32 km from Thakot. The rocks exposed in the area comprise schists and gneisses which are soft to medium hard. (Fig. 11).

The material involved in the slide is derived from decomposed and highly weathered schist rocks and is in the form of fine clayey soil with big slabs of broken parent rock. The process of soil formation is quick due to the soft and incompetent nature of the parent rock and considerably thick weathered soil cover is formed on the bedrock surface. This thick soil is used for crop cultivation where narrow long strips of terraced fields are developed on the hill slopes.

Figure 11- Generalised geological map showing location of Lahori Nullah Slide at Km 32 on the K.K.H.

The Lahori nullah slide occurs in the form of a debris slide which is 110 m wide and the scar of the slide is distinctly visible at the height of about 100 m above the road. This slide most probably initiated due to the disturbance of its angle of repose during widening and construction of the road. The toe support was removed leaving the overhead material unsupported, making it vulnerable to sliding.

As these hill slopes are highly cultivated the infiltration rate is comparatively more which enhances the process of rock decay. The clayey contents get lubricated and start sliding down under the impact of gravity. Contact of terrace deposits with the rocks after receiving continuous moisture from the cultivated fields gets lubricated and start falling down.

- 1) The slide may be effectively checked by the construction of a breast wall at the road level and a retaining wall below the road.
- 2) Stone-pitched drain may be constructed at the road side to divert the rain water and pass it down the road through a culvert.
- 3) Excessive infiltration of water may be checked in the terraced fields above the slide zone by limiting the supply of crop water.

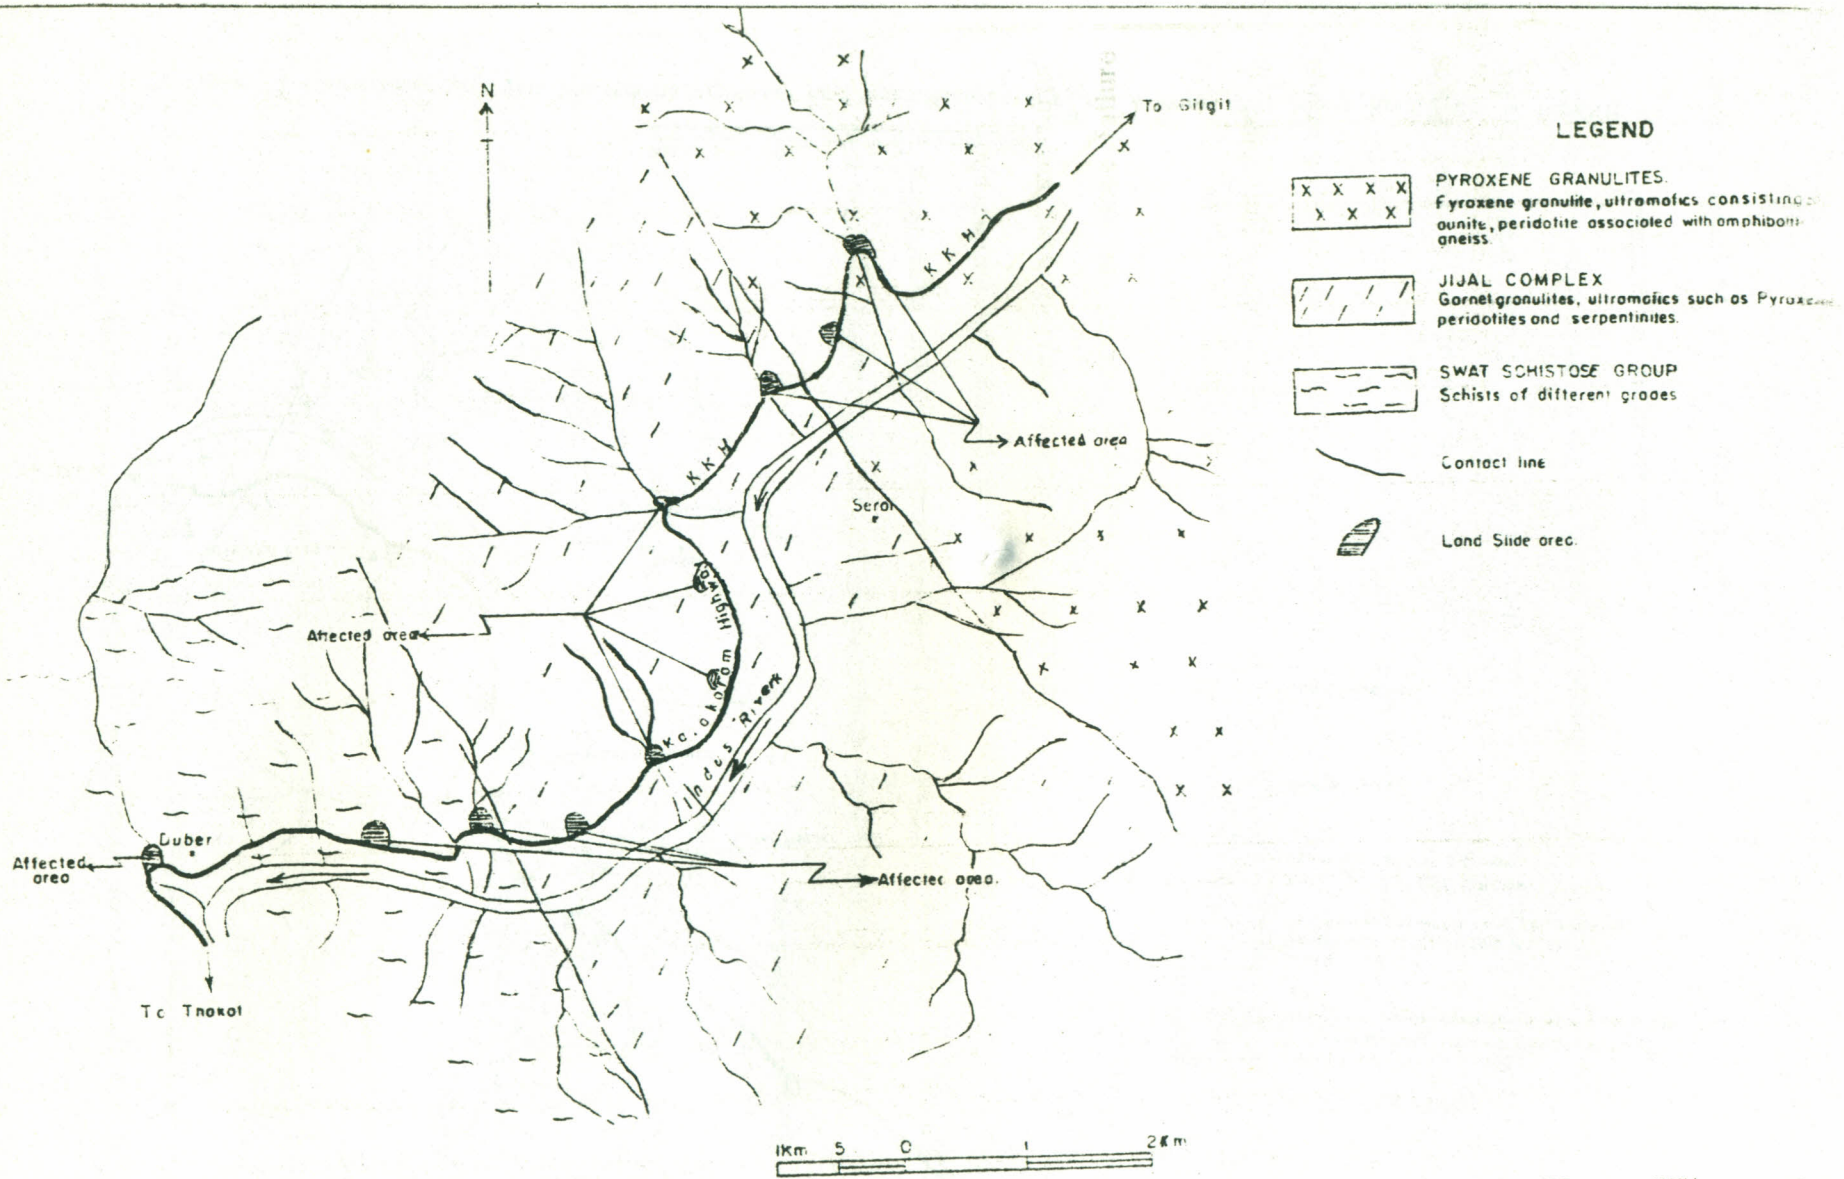
Appendix-1,2 gives a detailed inventory of the mass movements occurred in various stretches of the Karakoram Highway on different dates particularly after the torrential rains which has been collected with the courtesy of Frontier Works Organisation. It was observed that on 26th October, 1982, at least 12 slides occurred in 13 kilometer between 47 to 60 km from Thakot (Fig.12). The nature of the mass movement phenomenon comprised rock falls, mudflows and debris slides and involved about 36,900 cubic meter of rock and talus debris (Appendix 1).

Figure 12 - Generalised geological map showing locations of land Slide effected areas on 26 October 1982 at Km 47 to 60 on the KKH.

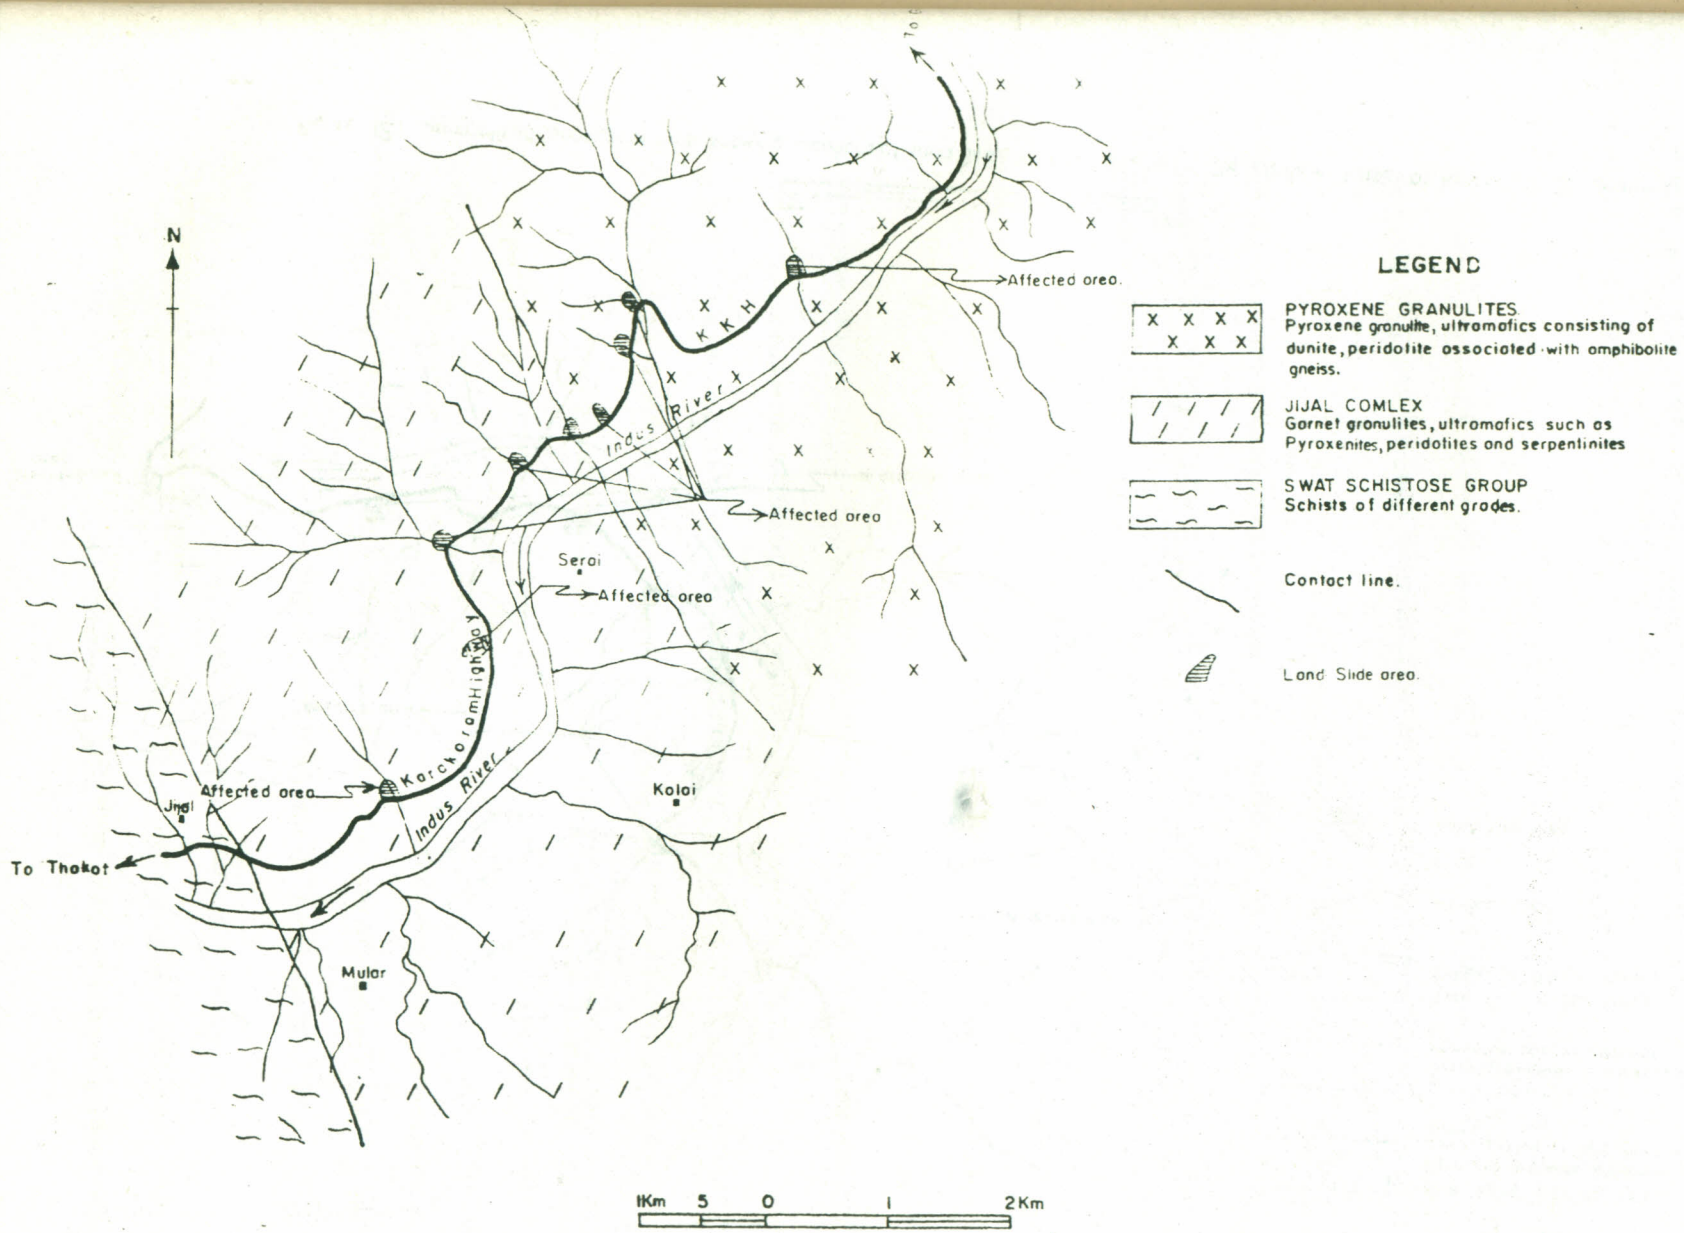
On 11th March, 1983, the phenomenon reactivated in the same road stretch from km 53.6 to 62.5 where at least 10 slides were recorded after the rains and involved 4,700 cubic meter of rock and debris. (Fig. 13, Appendix 1).

Figure 13 Generalised geological map showing locations of land slide affected areas on the 11, March 1983 between Km 53-63 on the KKH.

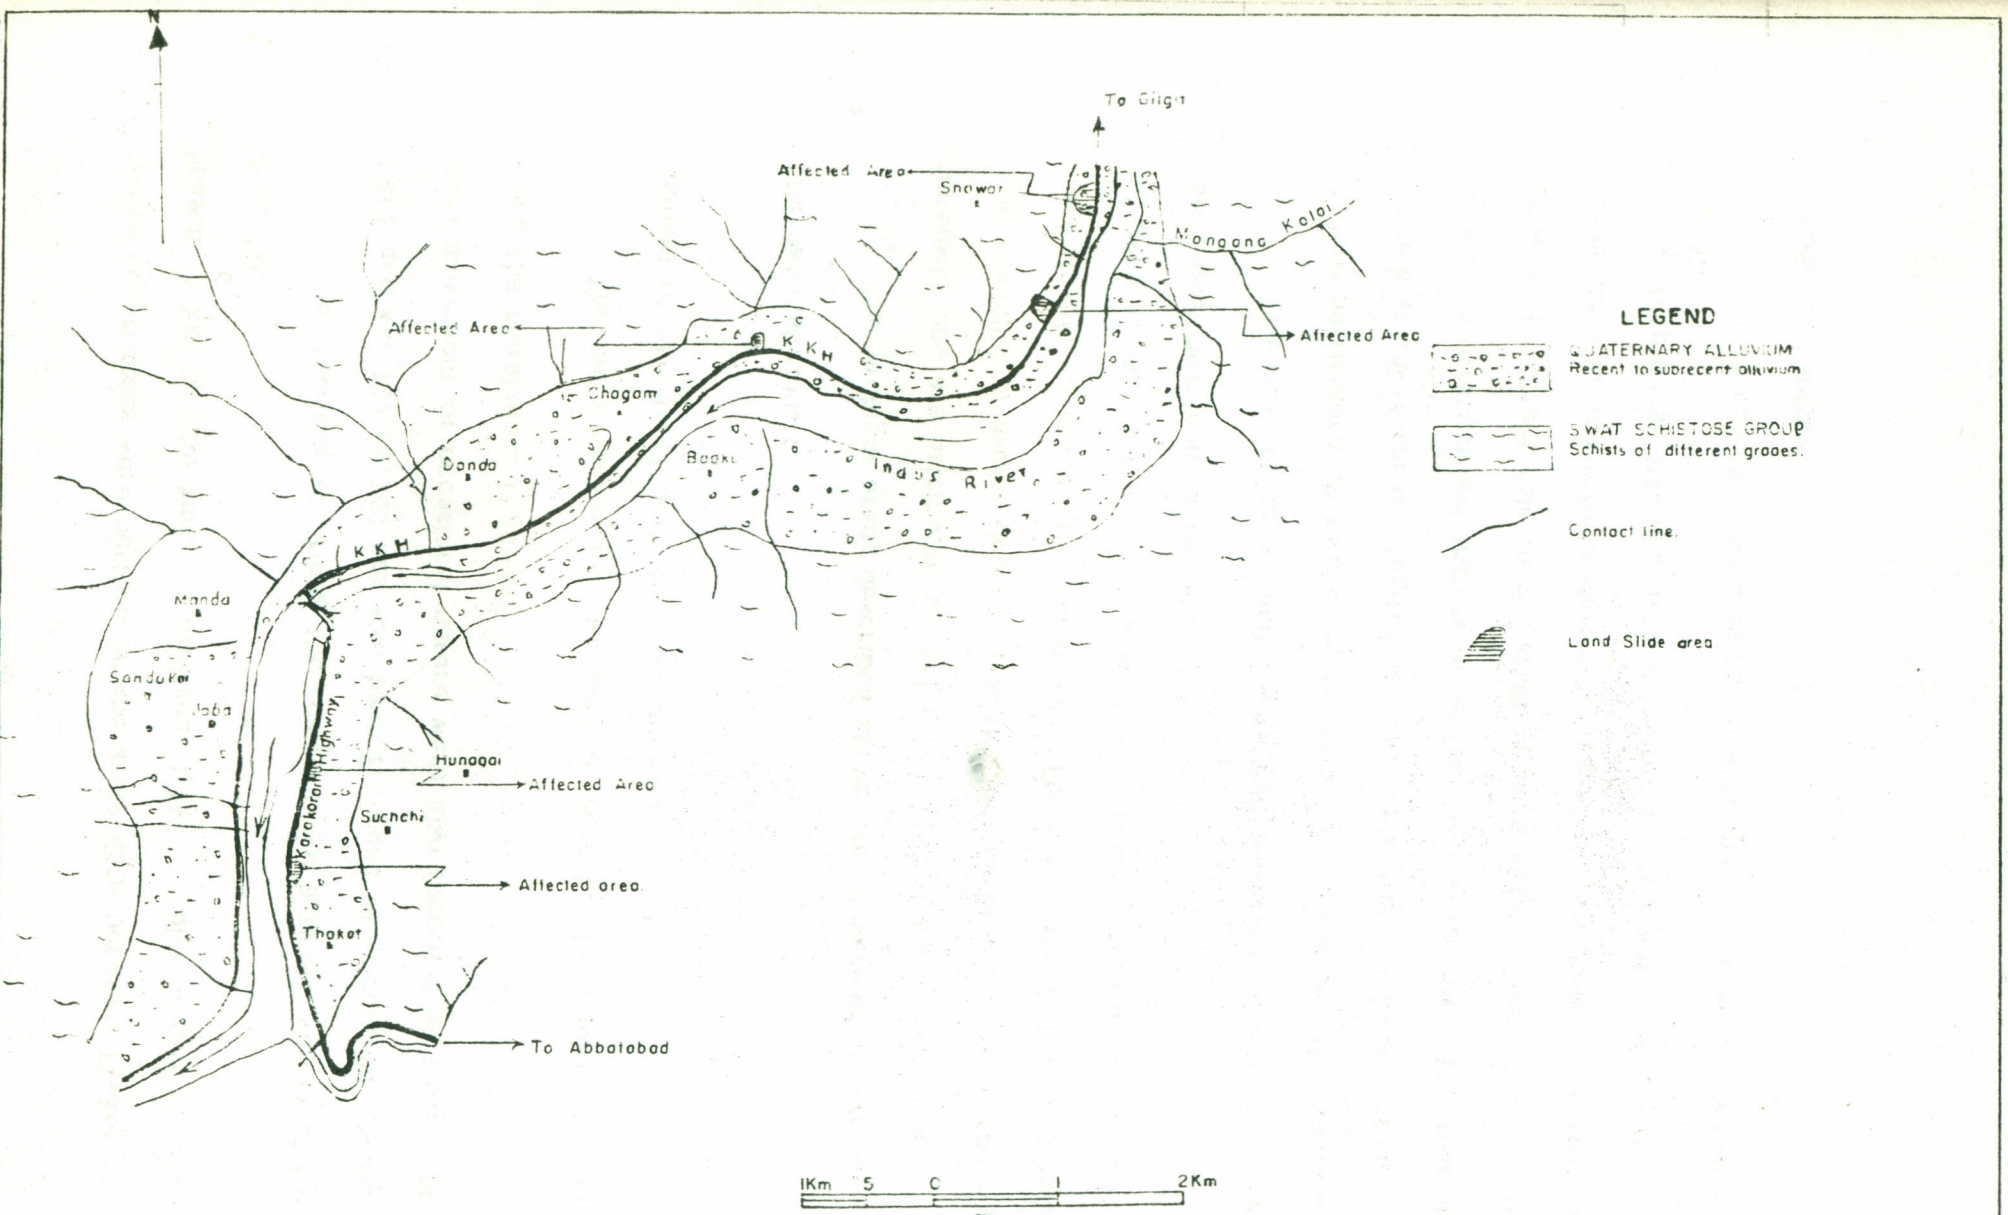
Similar occurrences were noticed on the same date between Thakot and Shawar (0 km to 12.6 km). It involved 1,115 cubic meter of material (Fig. 14).

Figure 14—Generalised geological map showing locations of land Slide Affected areas on 26 March 1983, Thakot and Shawar at Km, 0 to 13, on the KKH.
