Information Release No: 893

**POST DISASTER THREATS IN ATTA ABAD AND
ADJACENT AREAS, HUNZA VALLEY,
GILGIT-BALTISTAN**

**S. Hamid Hussain
Simon Sadiq
Mohammad Latif
Environmental & Engineering Geology Division**

**Issued by Dr. Imran Khan, Director General, Geological Survey of Pakistan
April, 2010**

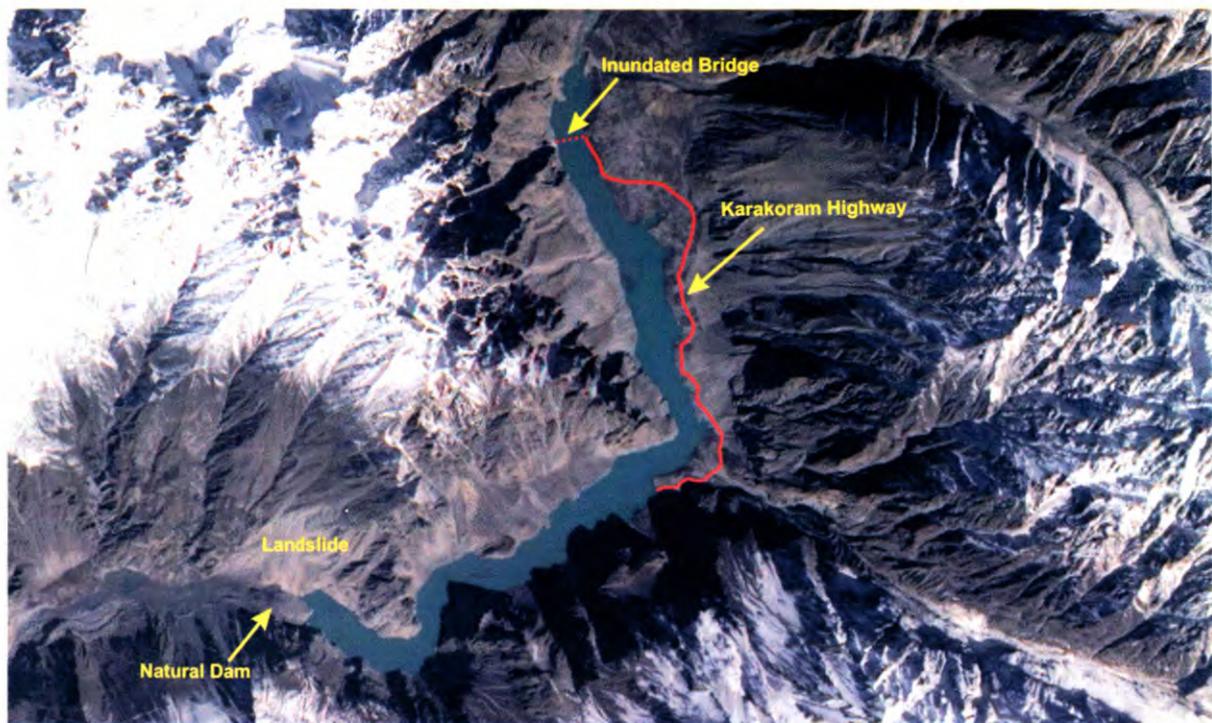
On 4th January 2010, the much anticipated landslide occurred; it has been estimated as 1900 m long and 690 m wide. It is basically a right bank slope failure of Hunza River which flows there nearly in the east-west direction, and the locality is known as Atta Abad after which the landslide has been named as Atta Abad Landslide. The landslide debris from the right bank after blocking the river moved up towards the left bank where it attained a height of about 200 m. The resultant lake has attained a length of 11.7 km on March 26, 2010 with a maximum height of about 70m; figure 3 shows the landslide, natural dam and resultant lake.

Figure 3. View of Atta Abad landslide and the resultant lake.

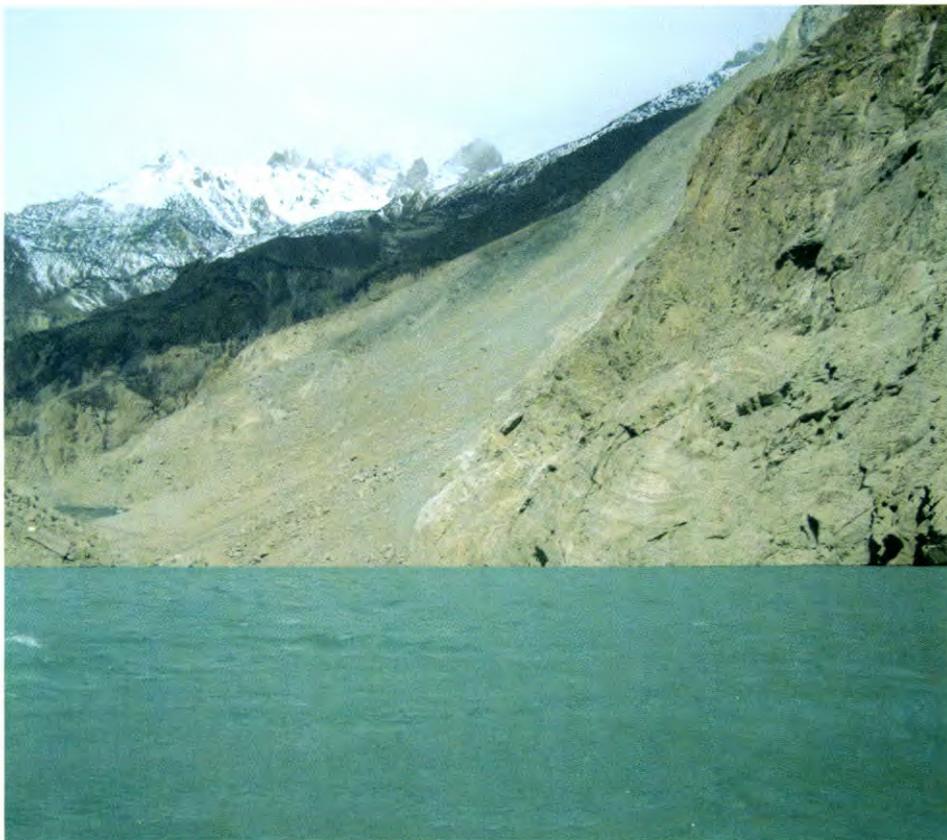
Figure 5. View of Atta Abad landslide and resultant lake.

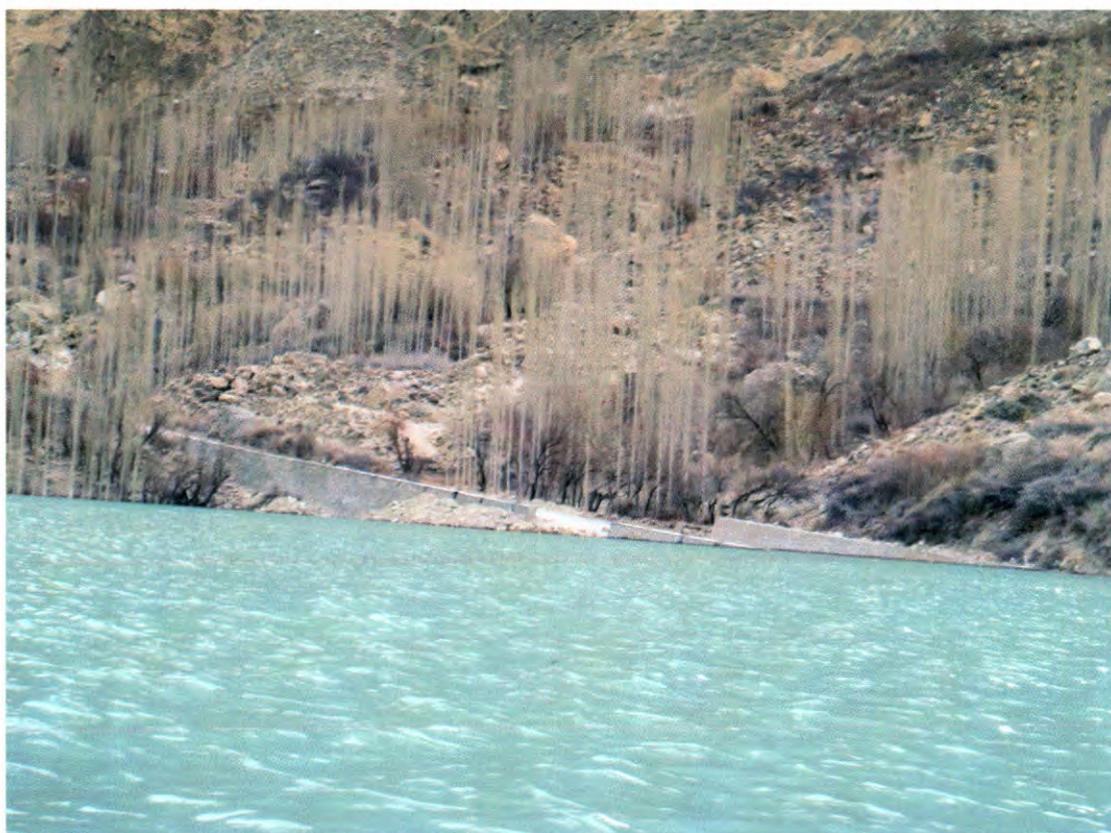
On the other hand, the disaster has adversely affected the Karakoram Highway which is still blocked due to landslide debris; parts of KKH in the upstream area are submerged under lake water formed by the river damming (Figure 6). This has adversely affected trade with China as the goods have to be transported in the boats in order to cross the lake area. This has increased the cost to a much higher level due to increased time and wages involved in unloading and loading of the goods. The government is bearing extra money in transportation of utilities to the upstream areas through boats as well as helicopters. People moving to and from upstream areas to the rest of the country, specially female and children are suffering a lot as they have to cross a long and uneven area by foot in order to board on the boats to cross the lake.

Figure 6. View of submerged KKH under lake water.

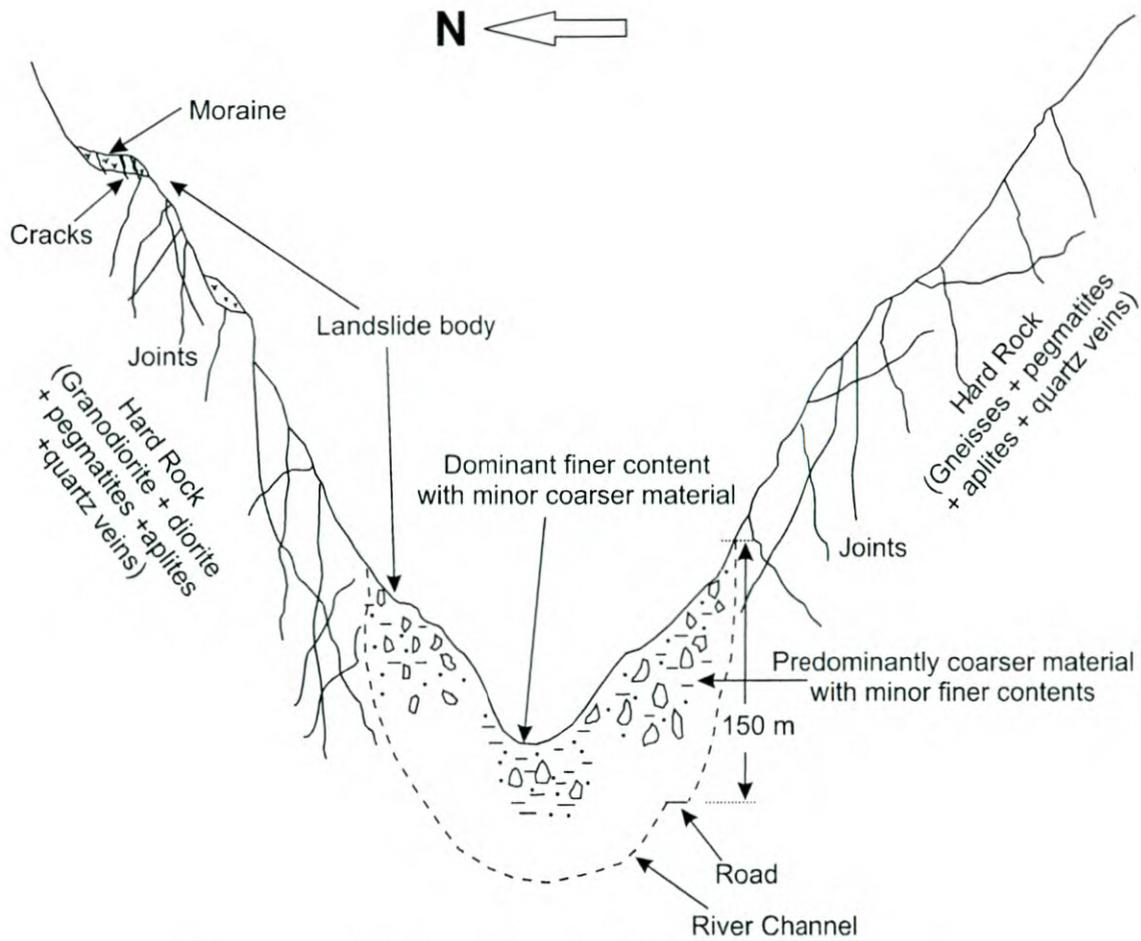
Figure 7. Schematic cross section of Atta Abad landslide area.

The material which slid comprised fluvio-glacial deposits, mainly moraines, lying over bed rock. The moraines are predominantly sandy and silty matrix with rock fragments of pebble, cobble and boulder size; the rock body is predominantly diorite and granodiorite. The analysis of the general joint set data of the area suggests the wedge failure to be the more probable mode of failure with less chances of plane failure, and almost no chances of toppling. Other than general joint sets, there are many other discontinuities in the form of local faults which have been observed at many places. Probably, these local discontinuities in collaboration with general joint sets provided a plane of failure which was reinforced with wedge failure. It is important to note that local people observed large rock pieces falling from the landslide area two days before the actual event happened; it is quite possible that wedge

failure may be the source of that rock fall. So, it can be inferred that Atta Abad landslide is a complex landslide involving more than one sort of failures.

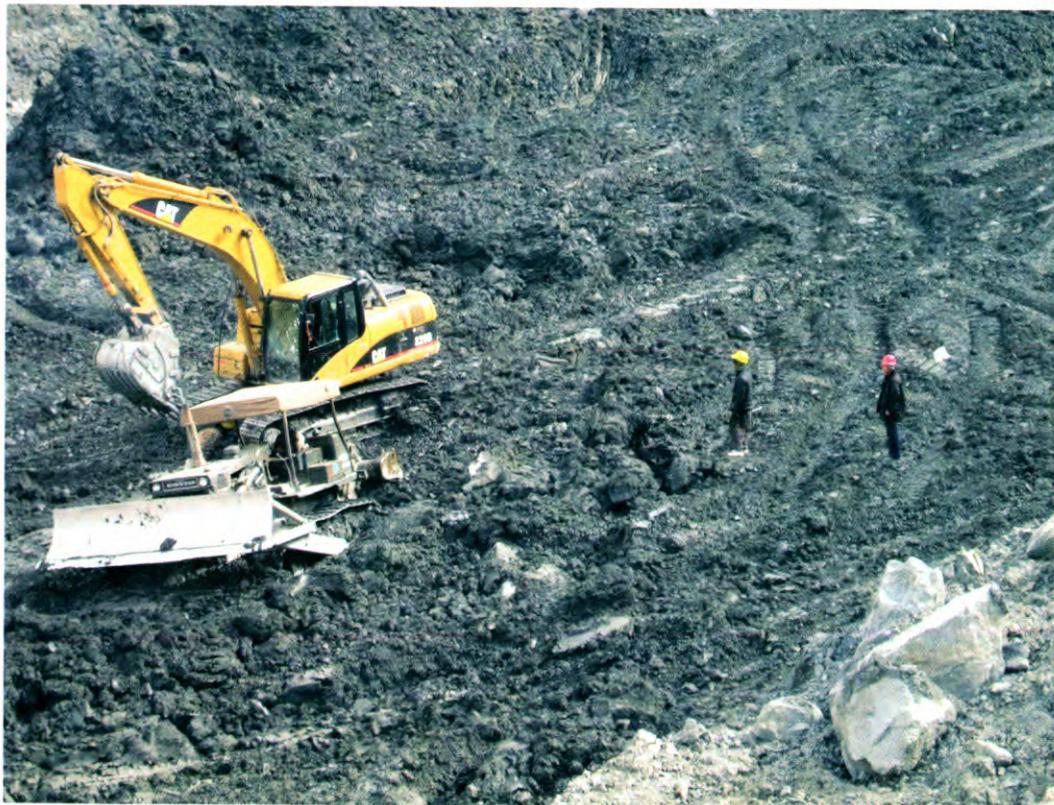
The size of the embankment is about 250 m wide and the length is more than 1 km. The main landslide material has accumulated on the opposite side (left bank) of the river where it attains its maximum elevation of about 200 m above the river bed. The resultant saddle has the lowest elevation which was about 125 m above the river bed, and this is the area where FWO is excavating for a spillway (Figure 8).

Figure 8. Spillway construction by FWO is in progress.

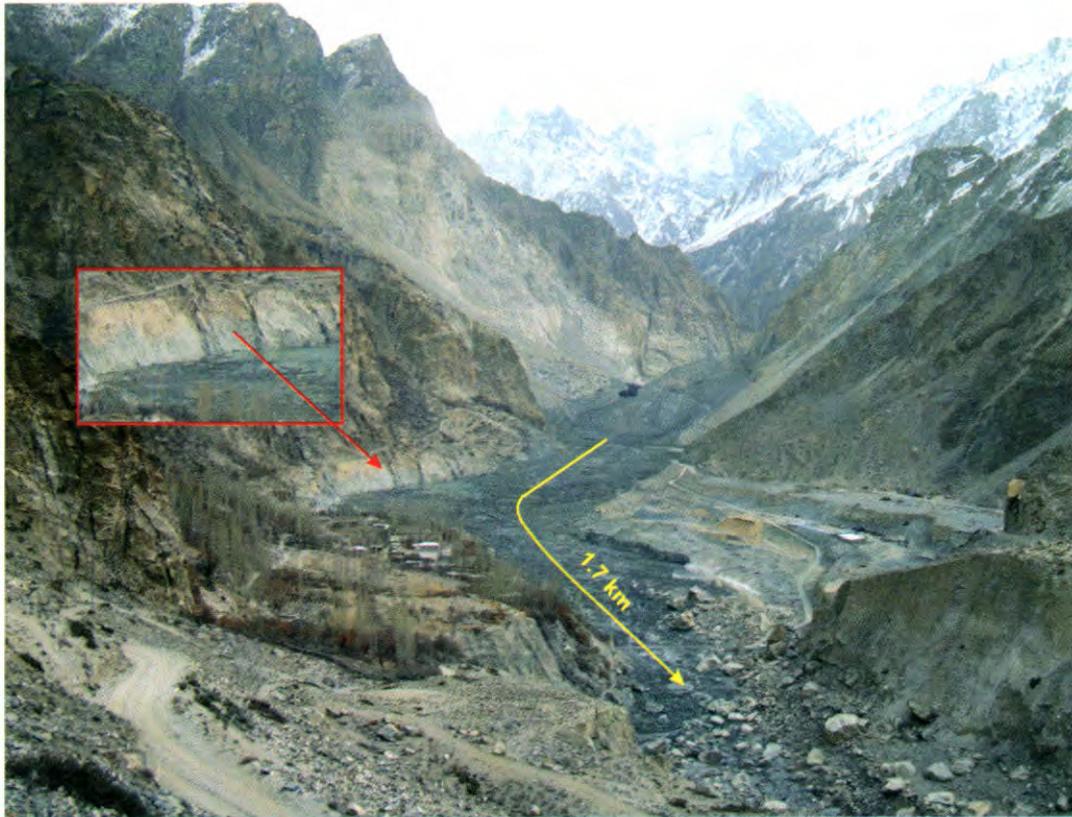
Figure 9. Mudflow in the downstream area.

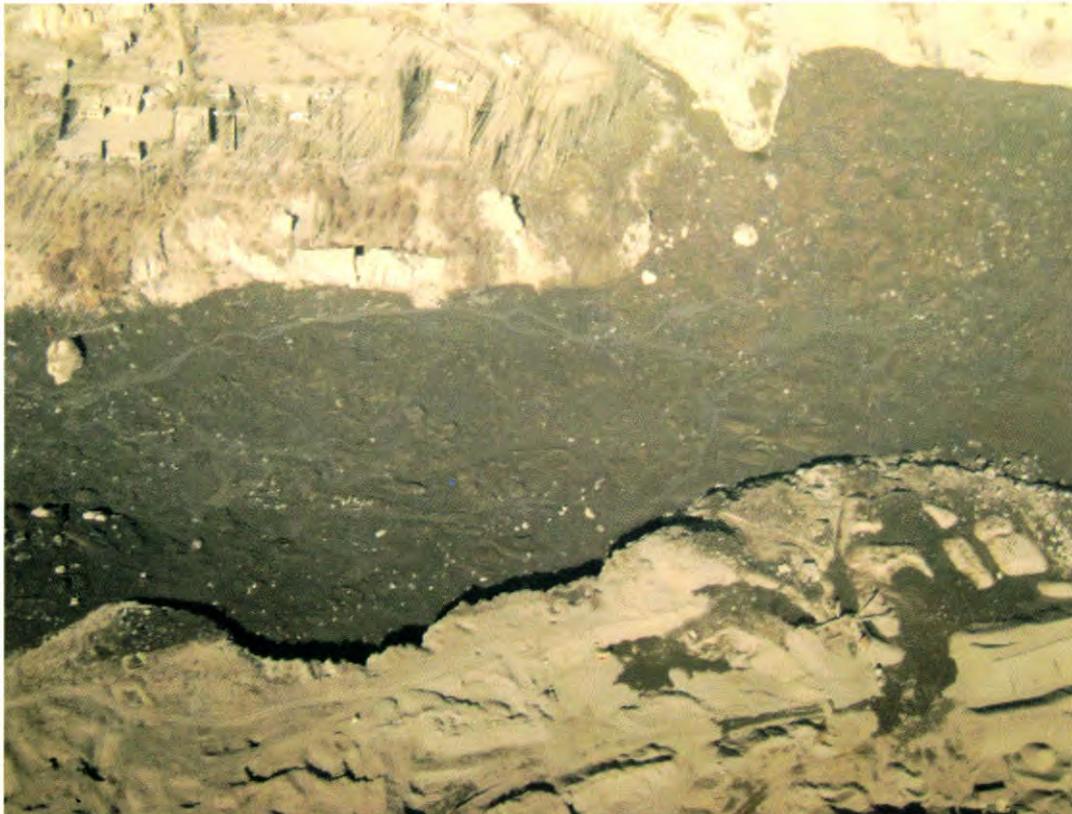
Figure 10. Mudflow in its full swing (with courtesy from Mr. Abdullah, Geologist Bounji Dam Consultants)

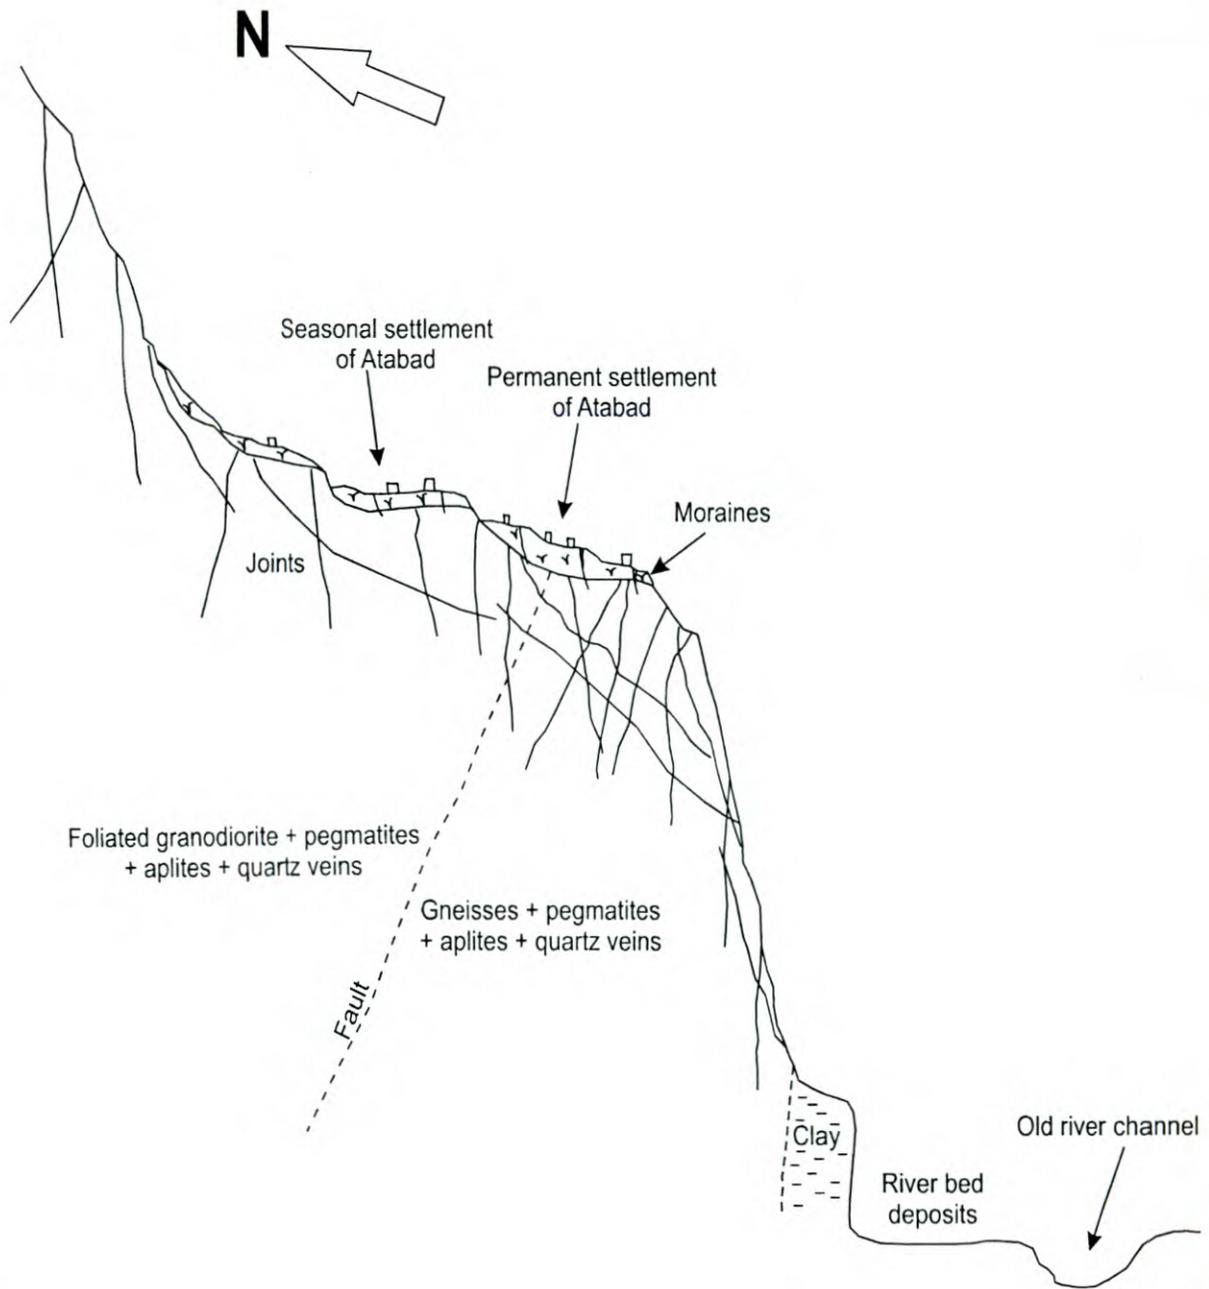
The eastern part of the village has already slid while cracks of different sizes have been developed in the remaining western part; these cracks have an increasing concentration towards the landslide area. If water enters into the cracks, it will further widen them triggering the mass movement as the slopes are already steep enough to facilitate the movement. Moreover, the rocks beneath the Quaternary deposits are highly fractured and jointed; when water infiltrates the joints, their openings will increase in response to frost and thawing effects, and it will further worsen the situation.

Figure 12. Schematic cross section of Atta Abad area.

The Atta Abad village should be abandoned for habitation as the human activities will cause more water infiltration into the cracks. One thing is important that if the Atta Abad village is evacuated then it can delay the mass movement for some time as no human activities will be involved to accelerate the landsliding process. A map showing high hazard areas has been shown in figure 14; red colour shows high hazard areas which should be abandoned for inhabitation.

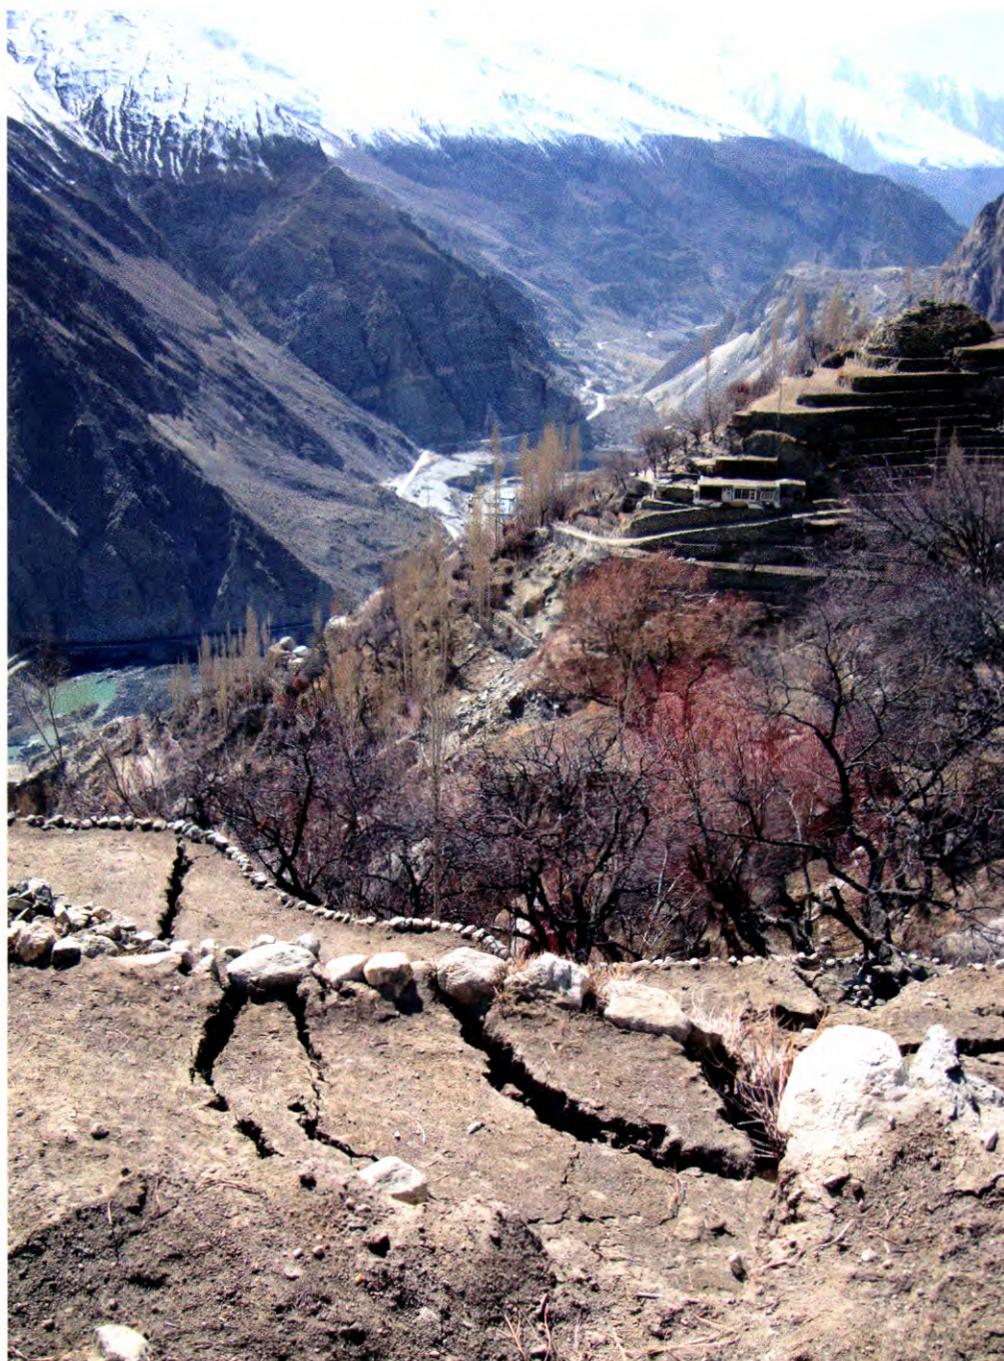
Figure 13. Network of cracks in the Atta Abad village.

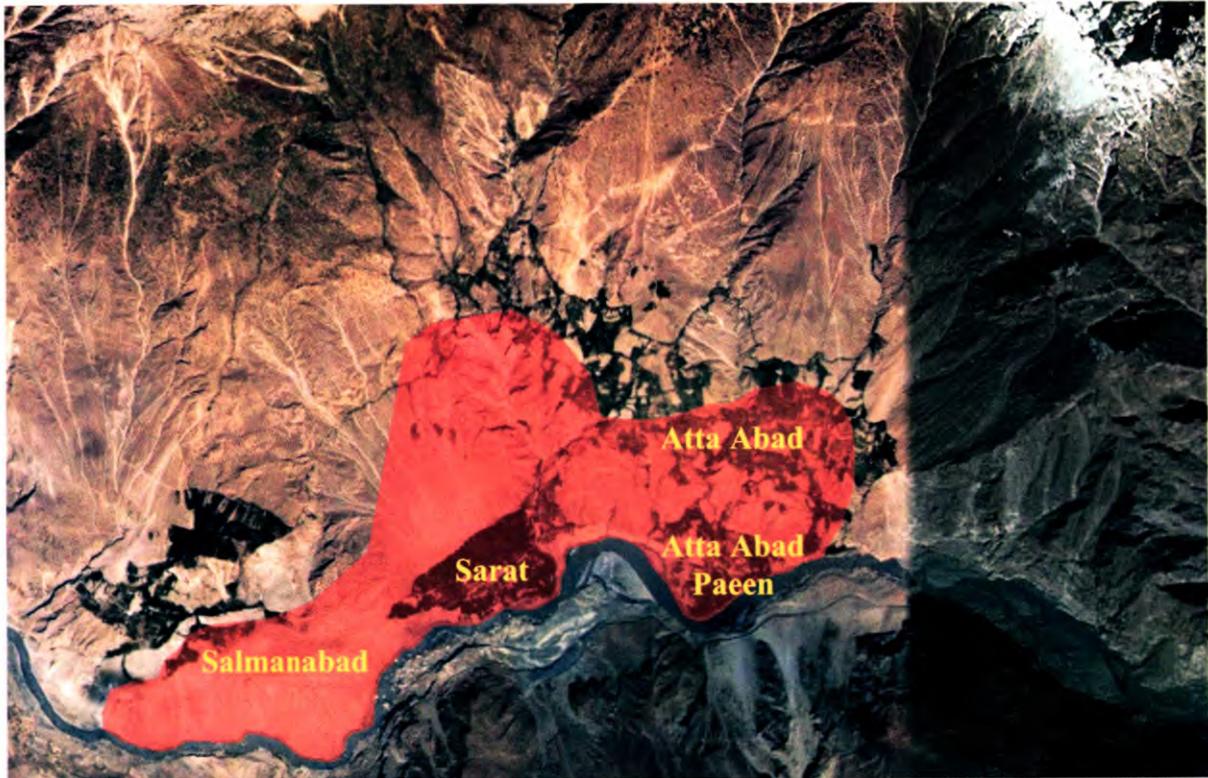
Figure 14. Map showing high hazard areas.

- There are two types of settlements in Atta Abad area, one is permanent and the other is seasonal. The eastern part of permanent settlement has already slid down while the remaining western part has cracks of different sizes; the intensity and size of cracks vary from place to place: so this area falls in high hazard zone and it should be evacuated on top priority.

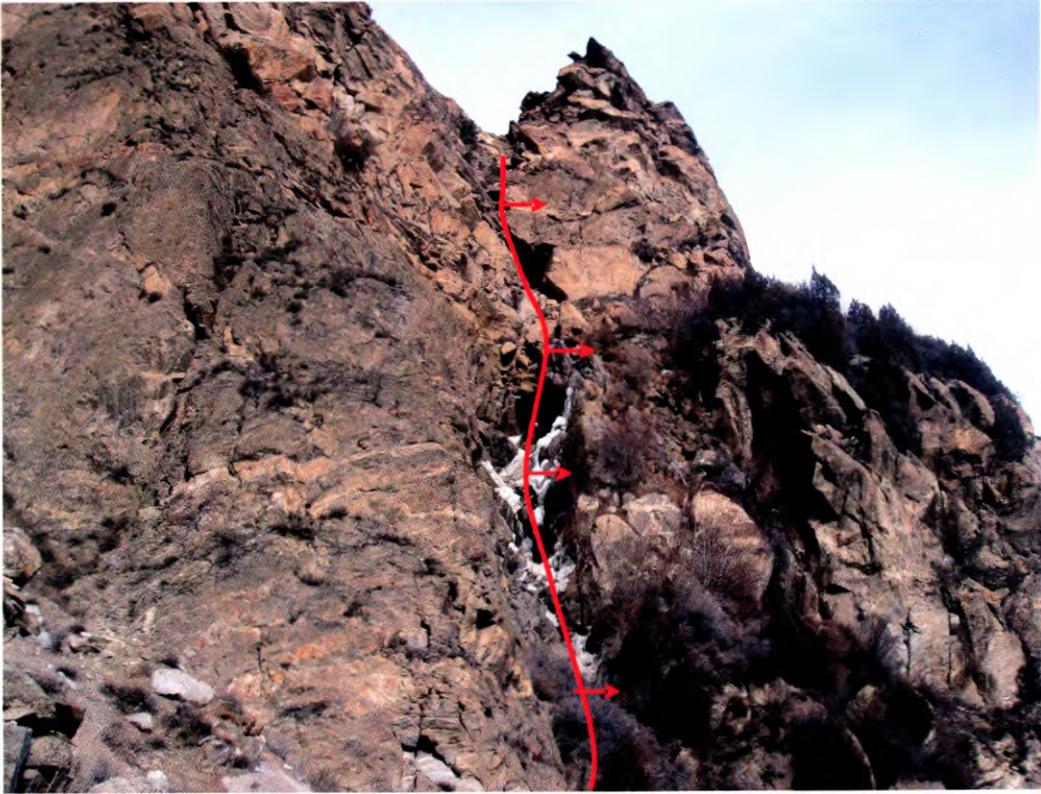
Sarat village is located about 1.5 km downstream of the Atta Abad natural dam, at an elevation of about 20 m from the river bed. In case of dam breach, the Sarat village will be under a direct threat of river undercutting as well as inundation flooding. Other than the dam breach issue, the ridge at the back slope has posed a direct threat to the village. Generally, the rock body of the ridge is highly jointed but a particular rock block of the approximate dimensions of 90 m x 50 m x 45 m is a permanent threat to the inhabitants. The full extension of the crack is not visible in the downslope area due to scree accumulation along the slope. The visible detachment is 50 centimeters to 1 meter from the main body, and its tendency to

fall is towards the main valley where the Sarat village lies as the general slope is towards the river valley.

Figure 15. Side view of the detached block.

- Sarat village is facing two types of threats; first one of flash flooding due to lake burst while the other one of rockfall as a big block of 90 m x 50 m x 45 m dimensions has detached up to one meter from the main body. Its failure from the main body will cause huge damage to the population of Sarat; to avoid such destruction evacuation is must.

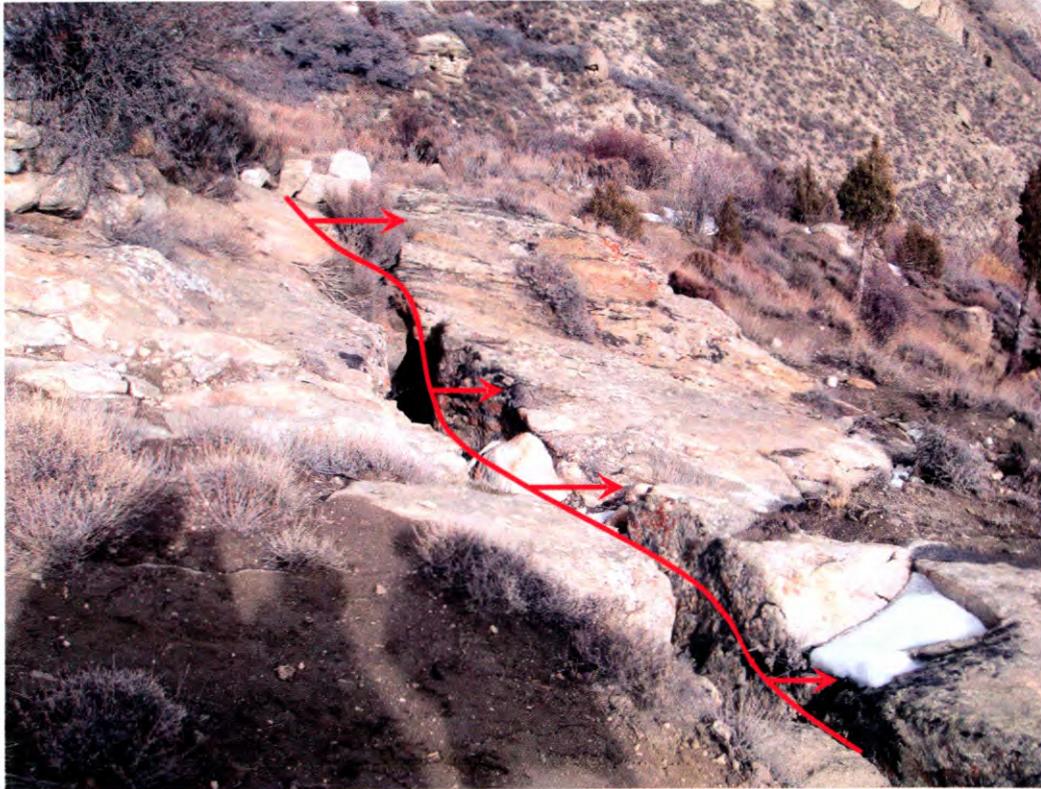
Figure 16. Top view of the detached block.

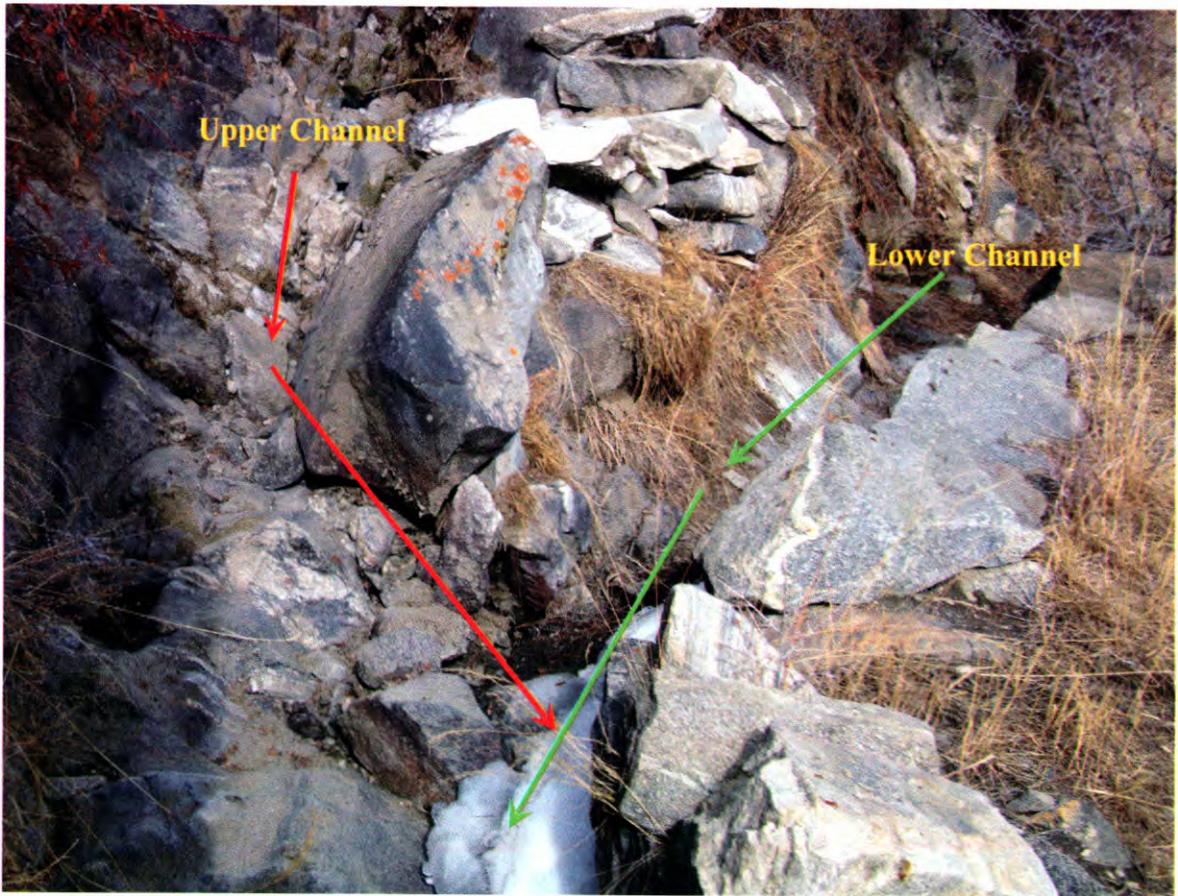
Unfortunately, the locals have been, and are still using the lower part of this huge detachment crack as a water channel. Actually, there are two water channels i.e. the upper water channel and the lower water channel, the part of the former falls down through the detachment crack then join the lower one. According to locals, the crack first appeared about 10 years ago but the opening became much wider 3-4 years ago.

Figure 17. Upper and lower water channels above Sarat area.

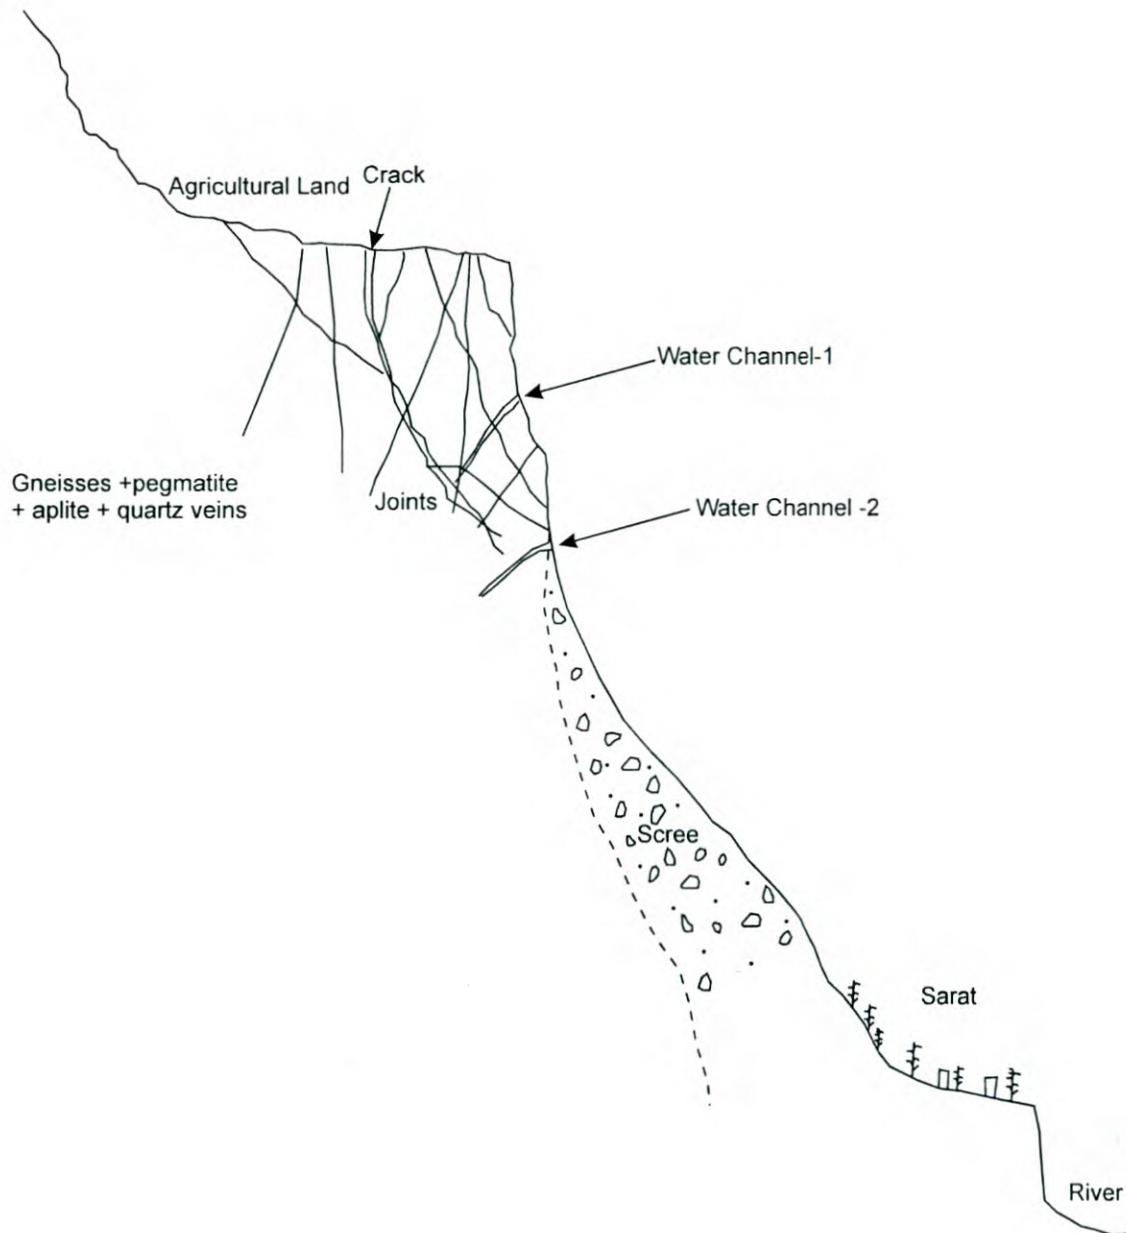
Figure 18. Schematic cross section of Sarat area.

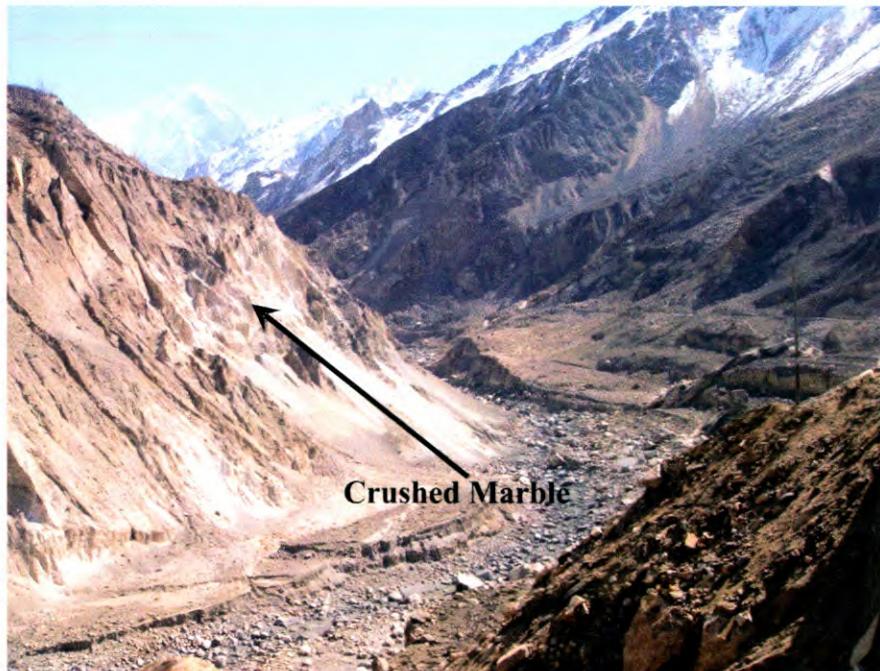
The remnants of the old landslide material can be viewed from the slopes of the Salmanabad terraces, the white crushed material, probably, belongs to the marble bands on the opposite side of the river. The absence of marble on the right bank of Hunza River, and marble outcrop on its left bank further strengthens the idea.

Figure 20. Crushed marble along slopes of Salmanabad village, right bank of Hunza River.

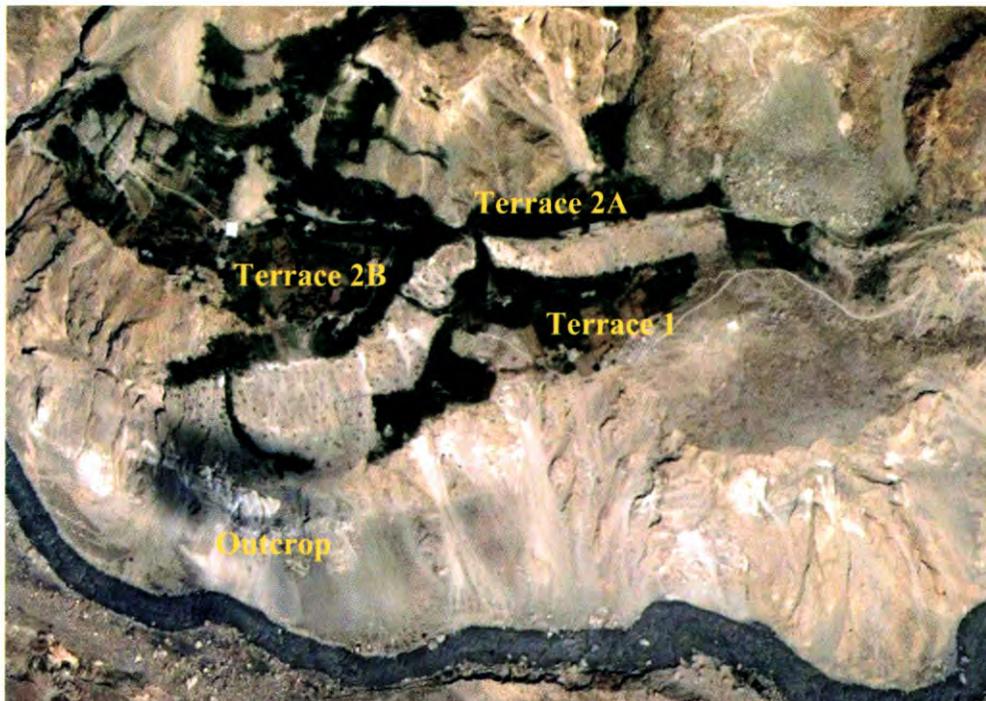
Figure 22. Aerial view of Salmanabad village showing different terraces.

The village can be divided into two distinct terraces, say, terrace 1, and terrace 2; terrace 2 can be further subdivided into terraces 2A and 2B (Figure 22). The back slopes of

the Salmanabad seem to be relatively stable but a possible flood resulting from the dam breach may erode the toe of the terrace 1 as no hard rock / outcrop have been observed at its base. However, terrace 2 is apparently quite safe as it will not be directly hit by the flood waves; moreover, outcrop is also visible at places at its toe.

- The Salmanabad village is located on two terraces; the lower terrace is developed on the material of old landslide. In case of high flood in Hunza River, this terrace will be directly hit by flood water. As the material is composed of crushed marble and gneisses so it is more likely to slide down due to rapid undercutting by flood waves. The population on this terrace should be shifted to a safe place.

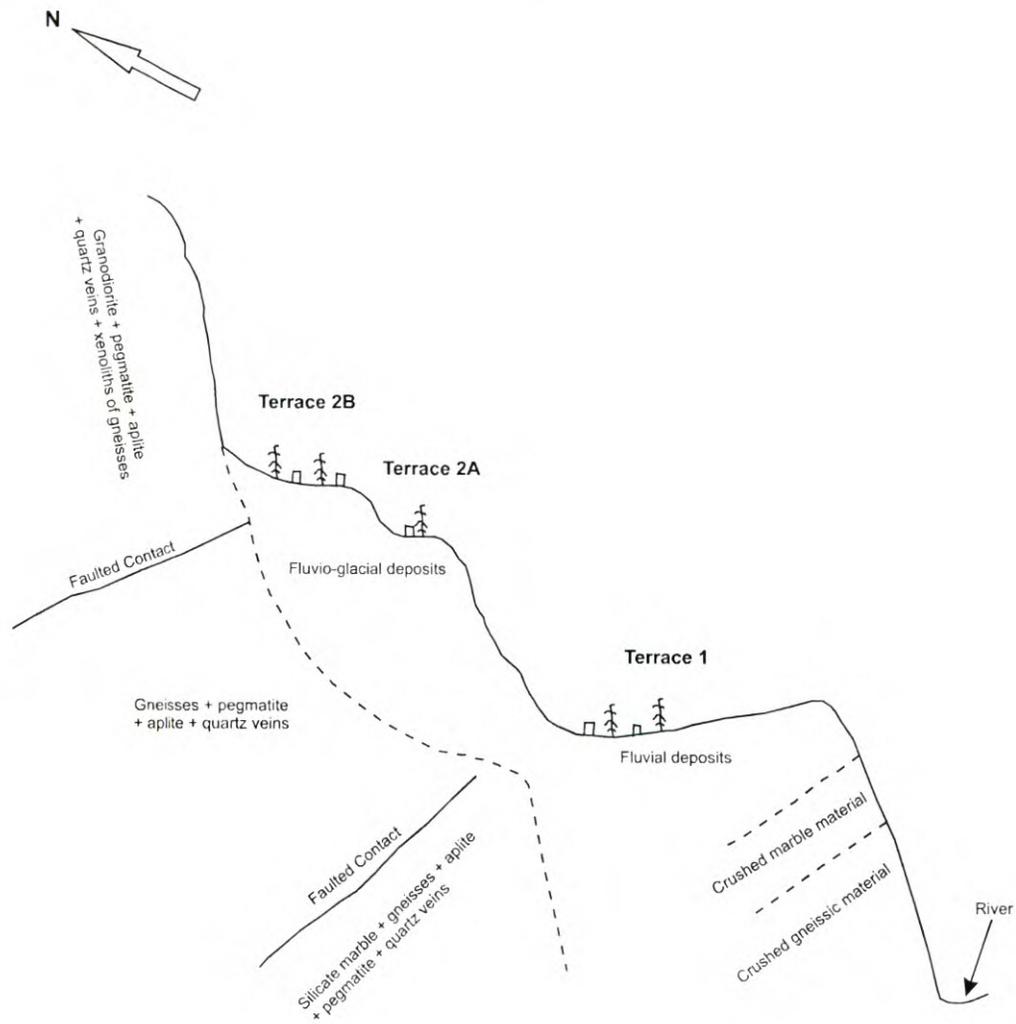
Figure 23. Schematic cross section of Salmanabad area.
