ROCK AND DEBRIS SLIDES
BETWEEN KHUNJERAB PASS AND GILGIT
ALONG THE KARAKORAM HIGHWAY

By
KANWAR SABIR ALI KHAN
ARSHAD FAYAZ
MOHAMMAD LATIF &
AMIR KHAN WAZIR

INFORMATION RELEASE NO.272

Engineering Geology Branch, Northern Areas Directorate,
ISLAMABAD.

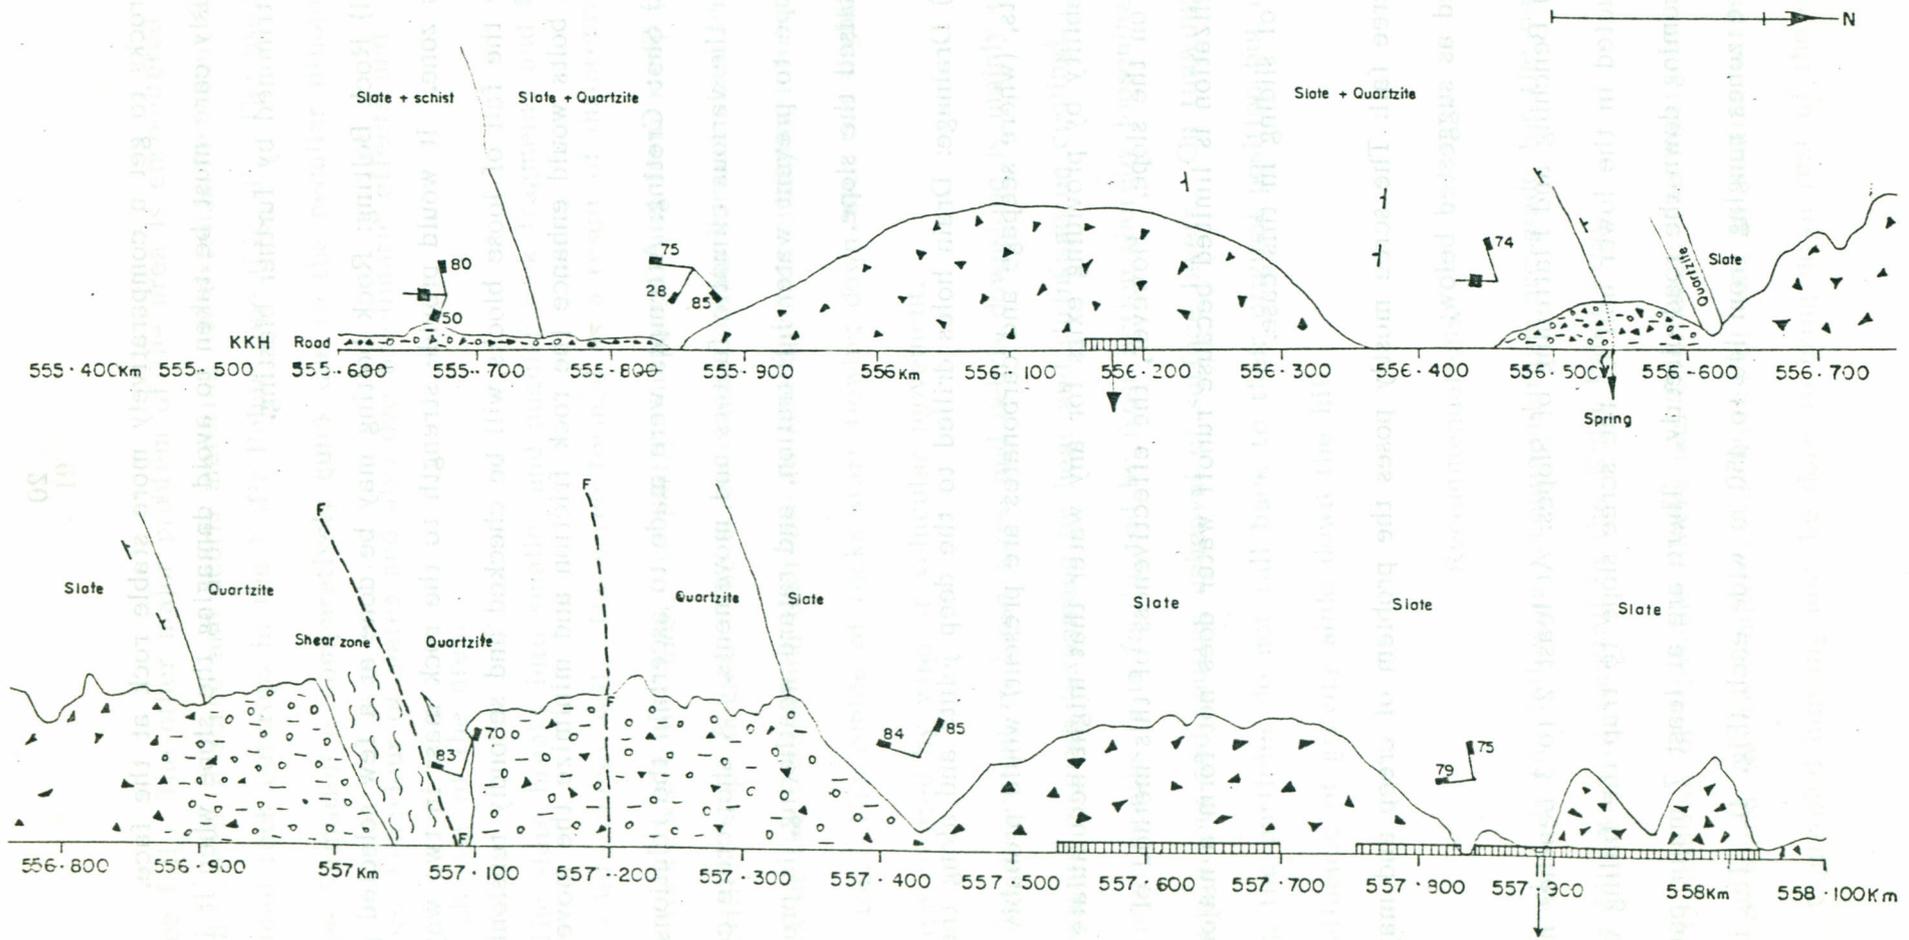
Figure 4 - Detail geological profile of the Kafir Pahar Slide between 555.6 Km to 58 Km on the KKH. Symbols as shown in figure I. A.

i) Benching and Flattening of Slopes: At least 2 to 3 benches may be constructed in the lower half of the scree slope to trap the falling debris from coming down the road directly. There are at least 7 major patches of scree zones ranging from 140 to 450 m wide each (Fig. 4). The individual

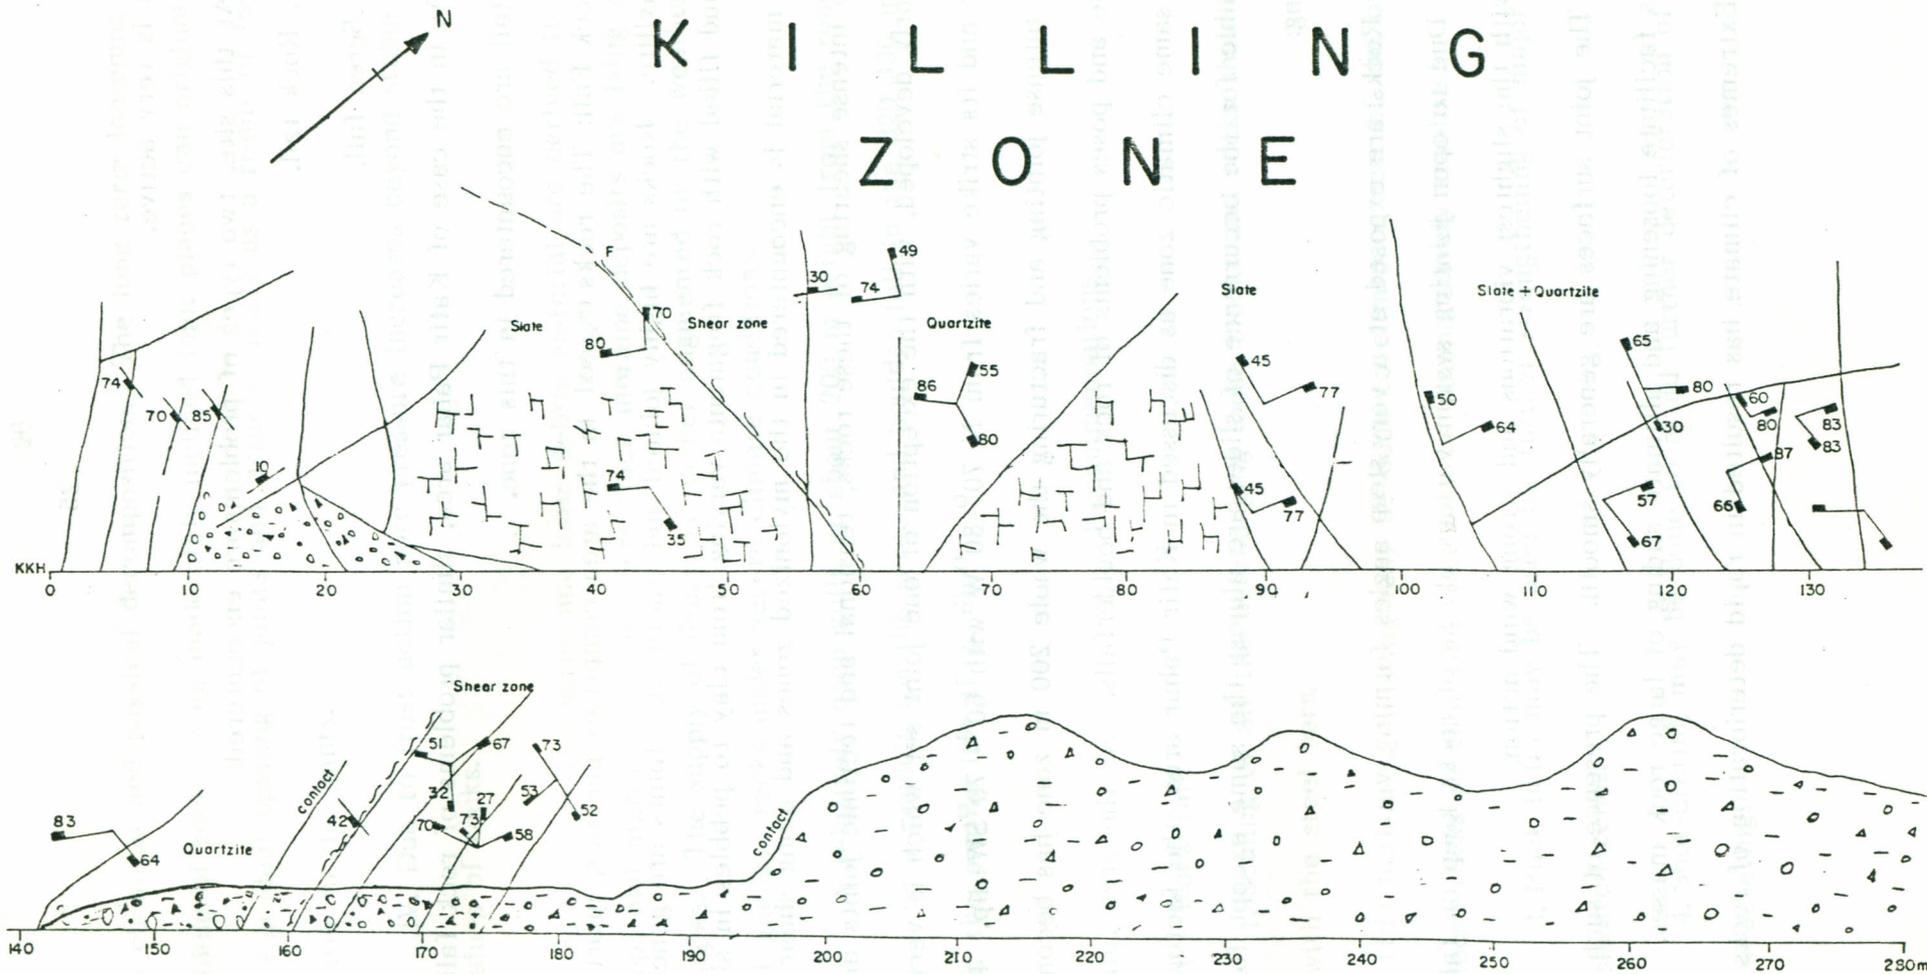
Figure 6-Detailed geological profile of Notoriou Killing Zone between 549-280 Km on the KKH. Symbols as shown in figure I.A.
Scale. Horizontal 1:10m
Vertical not to scale.

This slide zone stretches for about 450 m and the name given to this slide indicates the seriousness of the situation. The Notorious Killing Zone was mapped on large scale by making longitudinal profiles on a scale of 1"=10m. The first 200 m from the starting point is rocky and problem of rock and boulder fall is encountered (Fig. 6). Proceeding north of the zone between 200 m to 450 m, the area comprises loose scree lying at critical angle of which particularly the scree patch between 320 to

330 m is very active.

In addition to the above proposed recommendations, for the worst affected area between 320 m to 330 m stretch, the following corrective measures should immediately be undertaken:

- i. diversion of scree towards the south of slide by providing diversion spurs.
- ii. benching at 2-3 sites at various intervals.
- iii. **re-con**struction of already damaged retaining walls.

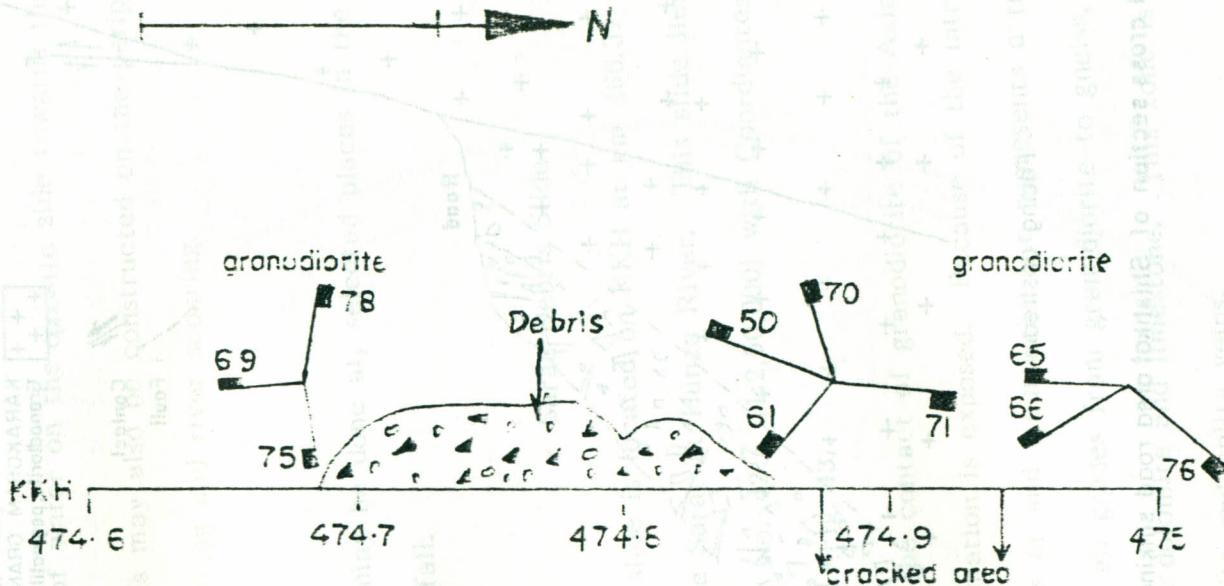
Figure 10-Geological Profile of the Shishkat Bridge Slide between 474.6 Km to 475 Km on the KKH. The details of the debris on the Road side. Joint pattern of the bed rock are shown, vertical scale is approximate where as horizontal scale is

The road section opposite the confluence of Shishkat nullah with Hunza River is faced with road damage due to sinking. This problem is taking place due to the undercutting action of water below the road at the bed level. The river forms a bend at this place and the water under the action of centrifugal force is diverted to the right bank and starts scouring and removal of rock and fill material. The situation is further aggravated during flood season and as a result road starts sinking and sliding.

About 200 meter down stream, the granodiorite rock poses problem of rock sliding above the road level. This is due to intense jointing at the place and vertical face cut above the road. A big NE dipping fault also runs roughly along the road and has formed a big fault scarp which dips valley side (Fig. 10-11). The fault coupled with jointing causes problems of rock sliding.

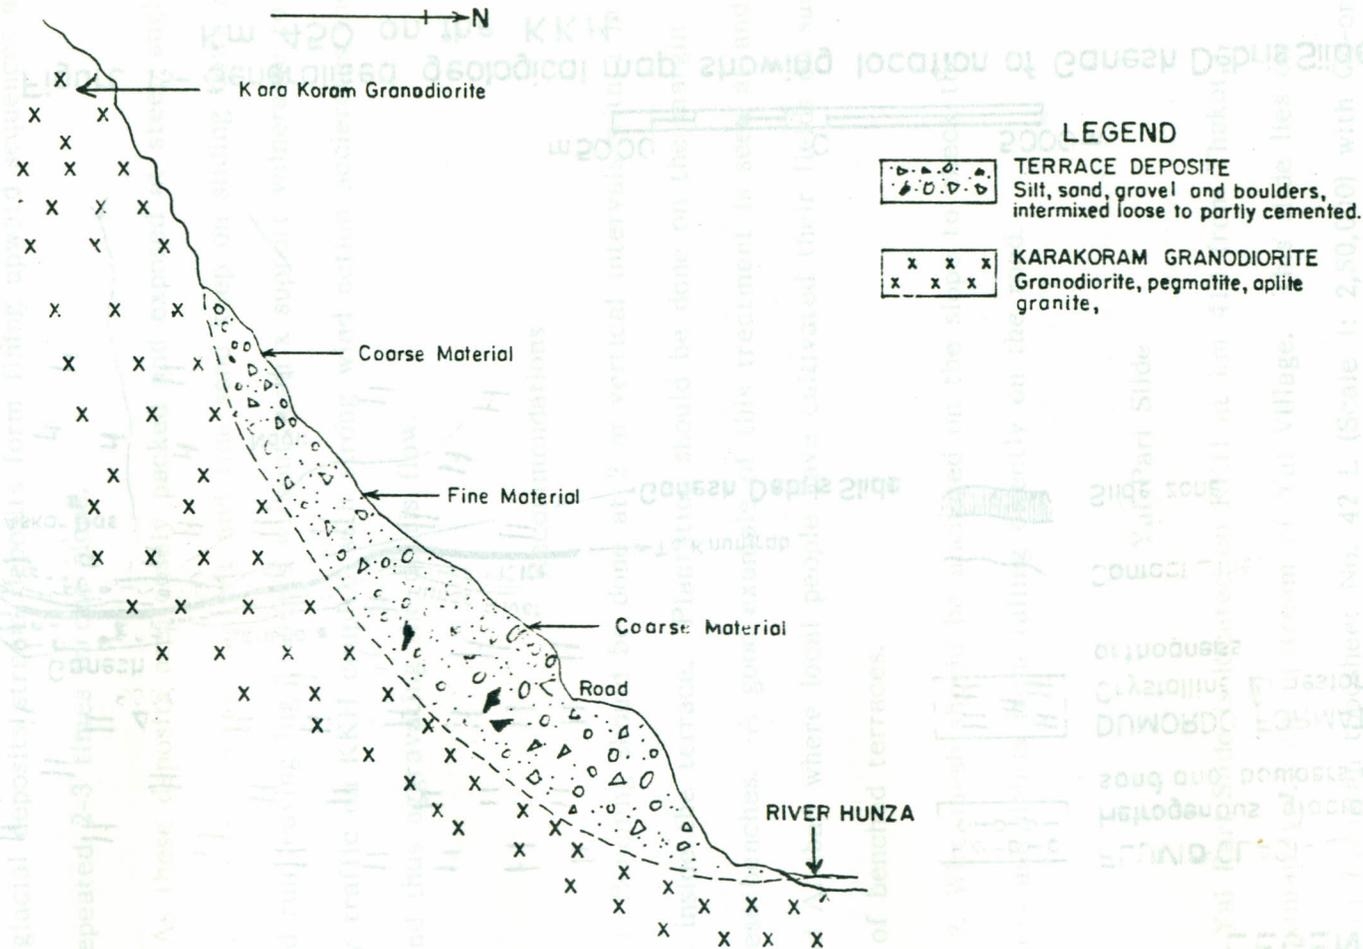
Figure 14—Generalised cross section of Sarat Dabris Slide showing the position of various type of material.

a result thick accumulation of weathered material in the form of scree to place on the exposed surface of rocks and along the valley slopes. Scree is loose to partly consolidated and exposed at the maximum angle of repose. This material keeps on sliding under the action of gravity and blocks the road frequently. The cross profile of this material shows greater percentage of coarse material including boulders of all sizes at the road level followed upward by finer material (Fig. 14).

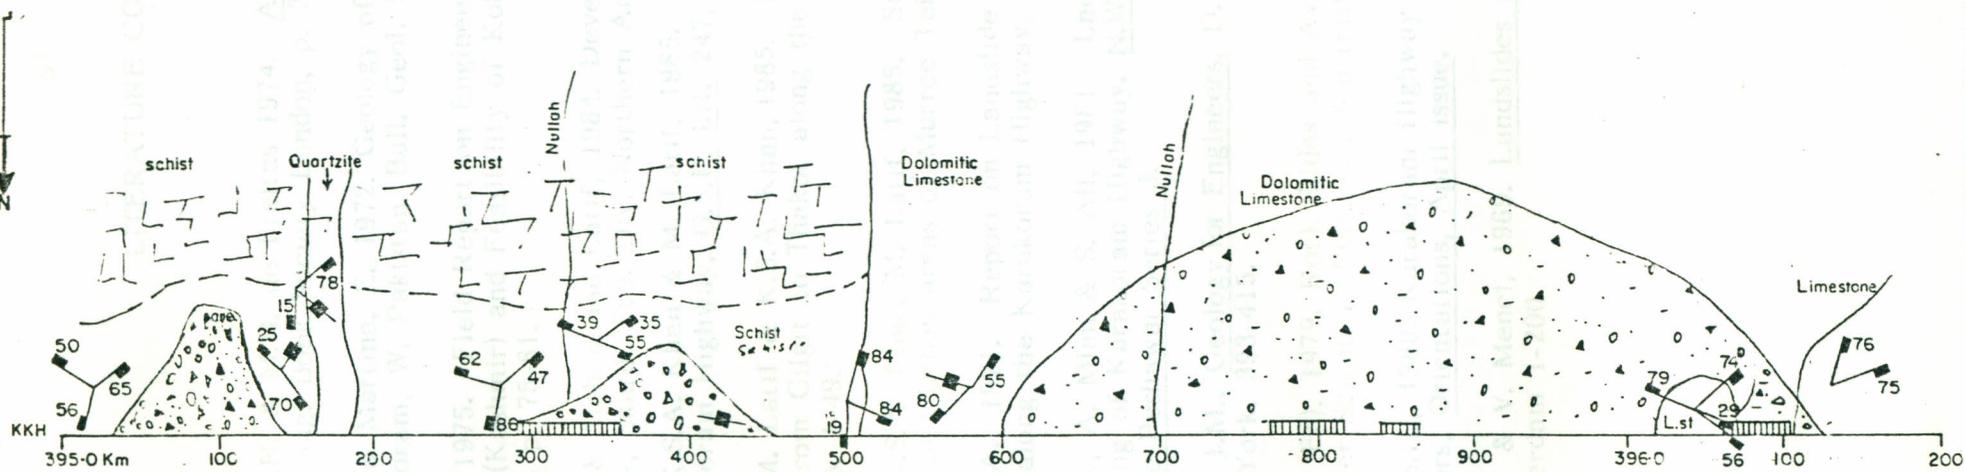
Figure 19-Detailed geological profile of the Shitan Pari Slide between Km 395 to 396.2 on the KKH.

Schists are of platy structure, thinly bedded and loosely jointed. At places schists are well foliated with steep vertical faces when followed upward give rise to highly fractured schist blocks. Away from the road these blocks vary from 30x15x10 cm to 100x60x10 cm. Schists are so

closely jointed that at places it appears like scree. The general primary dip of the schists, jointing, shearing and fracturing are mainly due to Chalt fault which is an active fault and is an extension of the main Karakoram Thrust (Fig. 20).

The schists rubble lying at critical angles fall down as small pieces by the slightest vibration of strong winds accentuated by steep slopes. The authors on 6th October 1983 during their course of investigation encountered similar problems of rock and scree fall due to strong wind storm that hit the place at about 3 p.m. The party was totally trapped between one km long stretch of Shitan Pari and witnessed the fall of material at site. It was also noticed that due to abrupt fall of stones from the top the wind screens of at least 3 vehicles were broken, and the passengers had a narrow escape.

1. At fractured zone, where the cliff is higher, wire mesh No.9 may be used to stop the fall of rocks. Wire mesh preferably should be anchored.
2. Wire mesh, however, can also be suspended from the top of the face which will provide another method for controlling the individual boulders from falling on the road. This method will trap the debris inside the mesh on the inner edge of road.
3. Retaining walls are already constructed at critical sites to control the scree. Their regular and proper maintenance however is urgently required.
