Information Release No: 893

**POST DISASTER THREATS IN ATTA ABAD AND
ADJACENT AREAS, HUNZA VALLEY,
GILGIT-BALTISTAN**

**S. Hamid Hussain
Simon Sadiq
Mohammad Latif
Environmental & Engineering Geology Division**

**Issued by Dr. Imran Khan, Director General, Geological Survey of Pakistan
April, 2010**

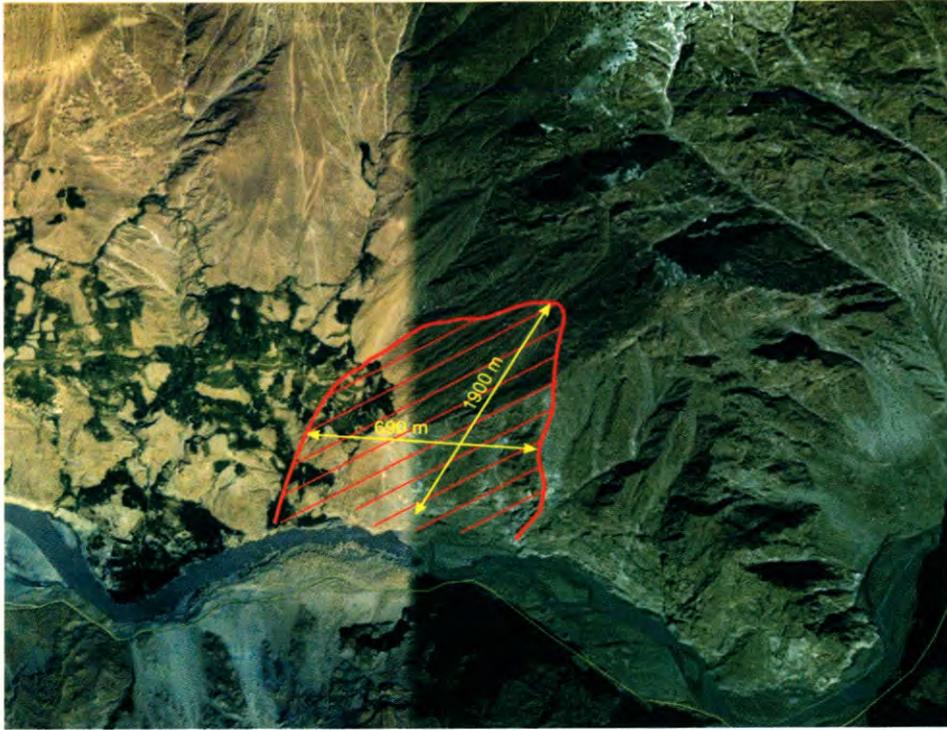
Figure 4. Location of Atta Abad Landslide.

On 4th January 2010, the much anticipated landslide occurred; it has been estimated as 1900 m long and 690 m wide. It is basically a right bank slope failure of Hunza River which flows there nearly in the east-west direction, and the locality is known as Atta Abad after which the landslide has been named as Atta Abad Landslide. The landslide debris from the right bank after blocking the river moved up towards the left bank where it attained a height of about 200 m. The resultant lake has attained a length of 11.7 km on March 26, 2010 with a maximum height of about 70m; figure 3 shows the landslide, natural dam and resultant lake.

The landslide debris hit the houses in Atta Abad Paen about half a kilometer downstream, and it was the area where 19 casualties have been reported. Luckily, there was no life loss in the actual landslide location as the area had already been evacuated in response to the report submitted by Geological Survey of Pakistan. The upstream areas are slowly but steadily submerging under water e.g. more than 12 houses of the village of Aeenabad have already submerged, and the lake level is still rising.

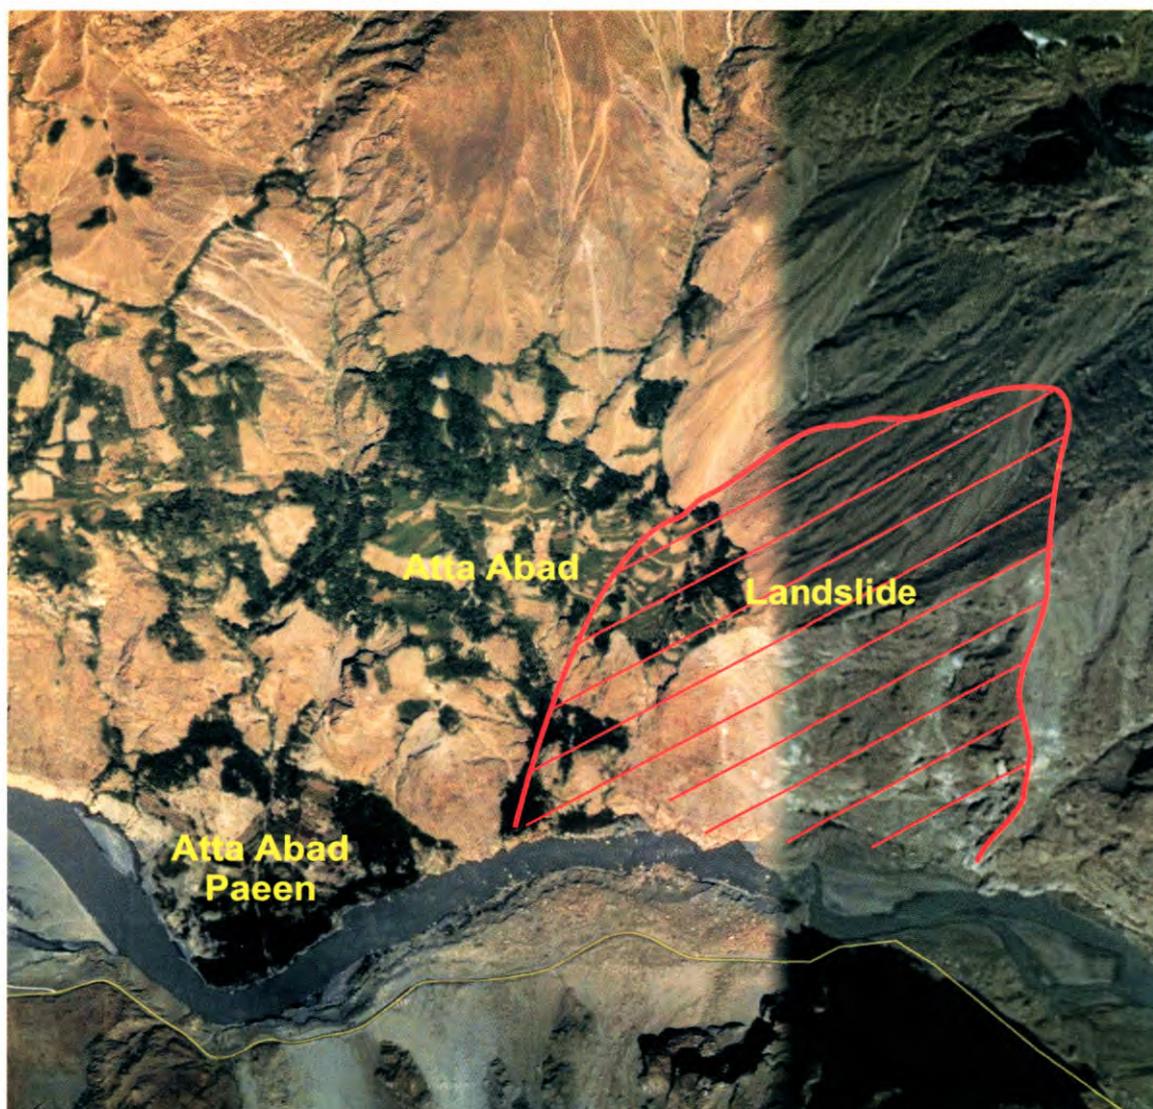
Figure 11. Atta Abad landslide, Atta Abad village and Atta Abad Paeen demarcated on Satellite image.

The eastern part of the village has already slid while cracks of different sizes have been developed in the remaining western part; these cracks have an increasing concentration towards the landslide area. If water enters into the cracks, it will further widen them triggering the mass movement as the slopes are already steep enough to facilitate the movement. Moreover, the rocks beneath the Quaternary deposits are highly fractured and jointed; when water infiltrates the joints, their openings will increase in response to frost and thawing effects, and it will further worsen the situation.

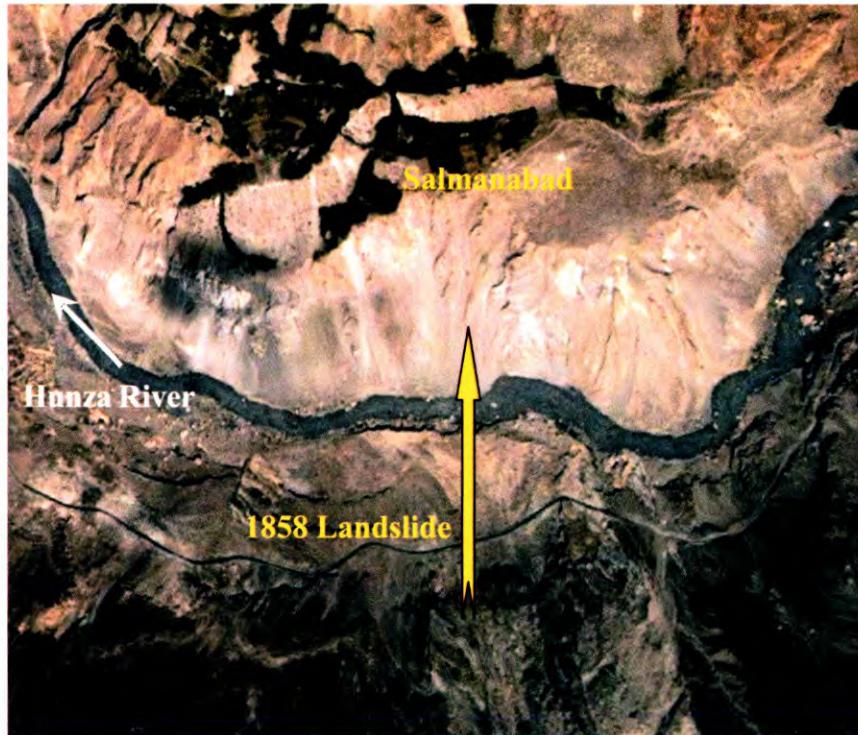
The village of Salmanabad lies at about 1.7 km downstream of the Atta Abad landslide body at an elevation of about 300 m above the river bed. It is the site where historic landslide of the year 1858 occurred creating a natural dam for about 6 months (Drew, 1873); since the building of the Karakoram Highway, this area has deposited the greatest concentration of debris found anywhere on the Highway (Jones et al., 1983; Derbyshire et al., 2001).

Figure 19. Location of 1858 landslide.

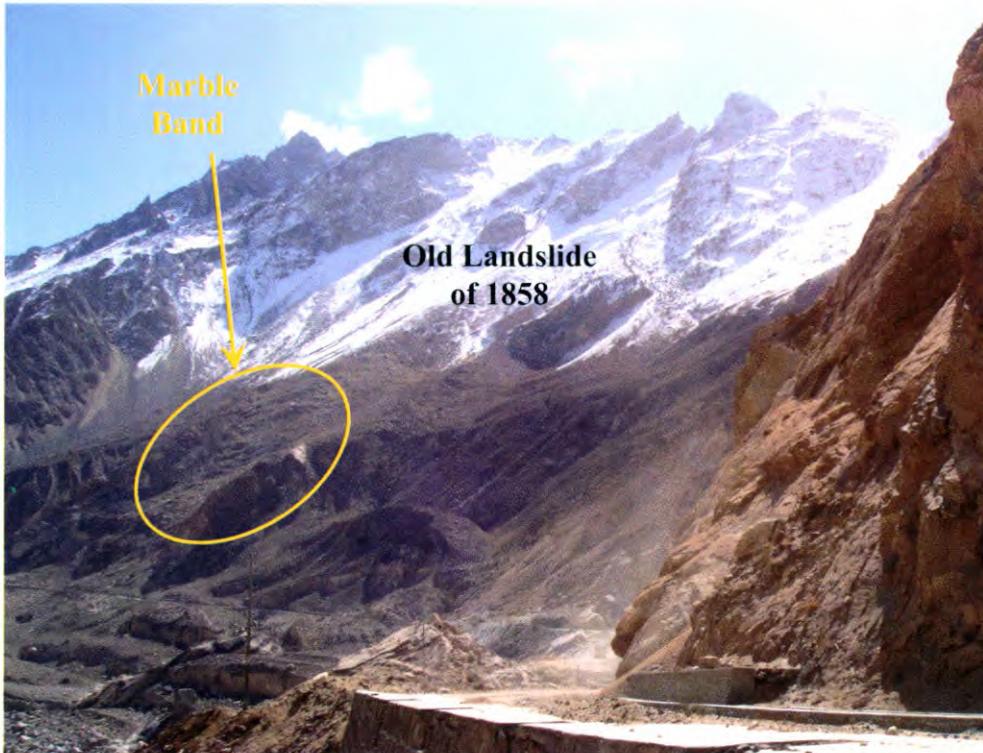
The remnants of the old landslide material can be viewed from the slopes of the Salmanabad terraces, the white crushed material, probably, belongs to the marble bands on the opposite side of the river. The absence of marble on the right bank of Hunza River, and marble outcrop on its left bank further strengthens the idea.

Figure 21. Marble bands on the left bank of Hunza River.
