ROCK AND DEBRIS SLIDES
BETWEEN KHUNJERAB PASS AND GILGIT
ALONG THE KARAKORAM HIGHWAY

By
KANWAR SABIR ALI KHAN
ARSHAD FAYAZ
MOHAMMAD LATIF &
AMIR KHAN WAZIR

INFORMATION RELEASE NO.272

Engineering Geology Branch, Northern Areas Directorate,
ISLAMABAD.

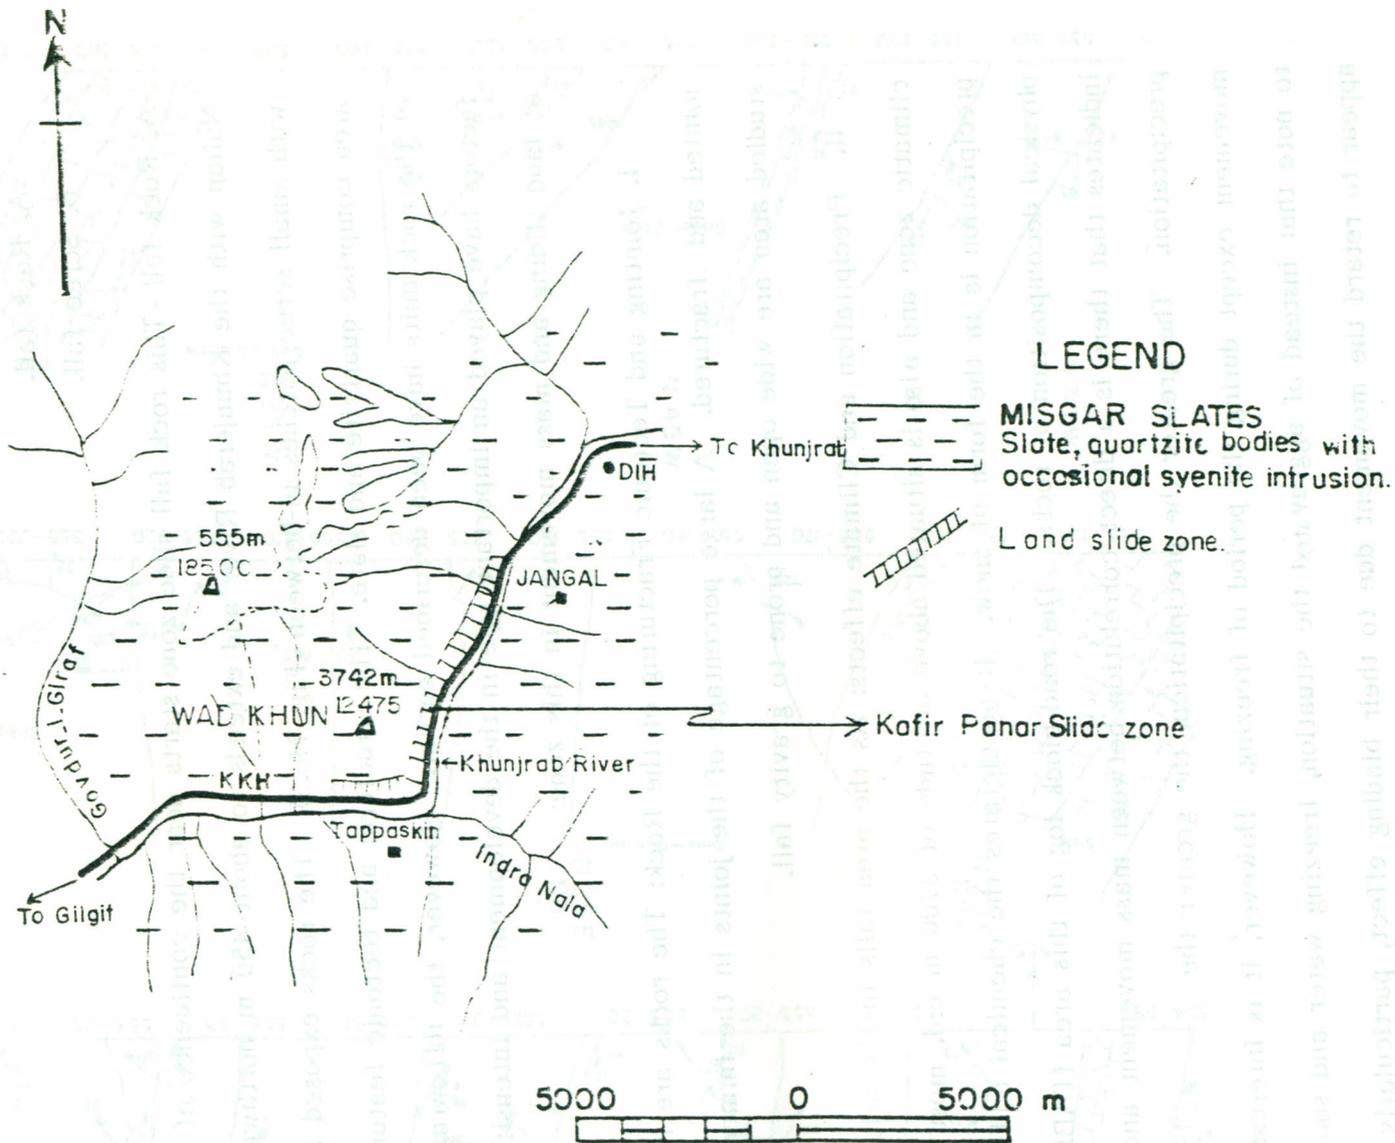
Figure 2. Generalised geological map showing location of Kafir Pahar Slide zone at Km 555 to 550 on the KKH.

in this zone are slates and quartzite (Fig. 2). The dominant rock type is slate whereas quartzite occurs as lenticular bodies; and noted five such quartzite bodies in this zone. The slate is highly jointed and fissile. The quartzite is hard and competent and may stand at steep angles except the parts where it is highly jointed and fractured. The contact of slate and quartzite are highly sheared. In a zone of 450 m there are 2 faults and 6 shear zones. At the faulted contact of slate and quartzite, secondary carbonates have been deposited along the seepage lines. The rocks are tightly folded and faulted. Quartzite breaks into big blocks whereas the individual blocks in slate vary in size depending upon the joint system in the area. At least two to four sets of joints have developed among which the set No.1 with attitude $N 60^{\circ}W$ and southward dip is the master joint and extends continuously in the slate body. Due to this intense jointing and structural disturbances, the whole 450 m zone has become unstable and poses problem of rock and boulder fall.

The slate due to its fissility and close jointing system coupled with intense shearing has been badly crumbled and weathers into fine scree material. Wide scree zones have developed all along the Kafir Pahar zone and problem of scree fall is frequently encountered. These scree zones range in width upto 600 m and form scree cones, with their apex located approximately 150 m high from the road level. The process of scree formation is further intensified by extremes of diurnal and seasonal variations in temperature. The scree slopes are formed at critical angle of repose and creep en masse due to the undercutting river action and vibration caused by the movement of heavy traffic.

I. Jointing and Tectonic Fracturing of the Rock: The rocks are highly jointed and fractured. A large percentage of the joints in the immediate studied area are wide open and prone to gravity fall.

The slate breaks into smaller and angular rock fragments and finally changes into clayey soil. The scree formed as a result of disintegration of the rocks which are loose to partly compacted and form steep cones with critical slope angles. The scree cones contain various sized blocks of rock at the base which decrease in size upwards changing into finer material at the top. This rubble of rocks start flowing down with the slightest vibration created by wind or vehicular movement.

The movement of loose scree and debris downslope is mainly due to temperature changes (expansion by heat and shrinkage on cooling). During the winter months it is facilitated by frost action thereby loosening the rock fragments and causing upheaval of surface layers. On thawing during spring, the particles do not fall back to their original position but under the influence of gravity slide down the hill.

A - Rock fall: The following recommendations are made for the control and stabilization of rockfall in the Kafir Pahar area:

i) Removal of Unstable Blocks and Overhangs: The most obvious measure would be to remove loose blocks of rock by scaling with steel bars. Controlled blasting may be done to bring down rest of the overhanging

loose rocks to get a comparatively more stable rock at the face. Obviously care must be taken to avoid damaging the slope when it is being trimmed by further blasting.

ii) Rock Bolting: Rock bolting may be done at a few selected places in this zone. It would provide strength to the rock mass in two ways. Firstly the fall of loose blocks will be checked and secondly tensioning of the bolts would enhance the rock friction and minimize the movement.

iii) Shot Creting: Attempts were made to ascertain the relationship between the various climatic factors and movements. A shot-crete cover on the slope to prevent water infiltration, and retard weathering, is proposed to stabilise the slope.

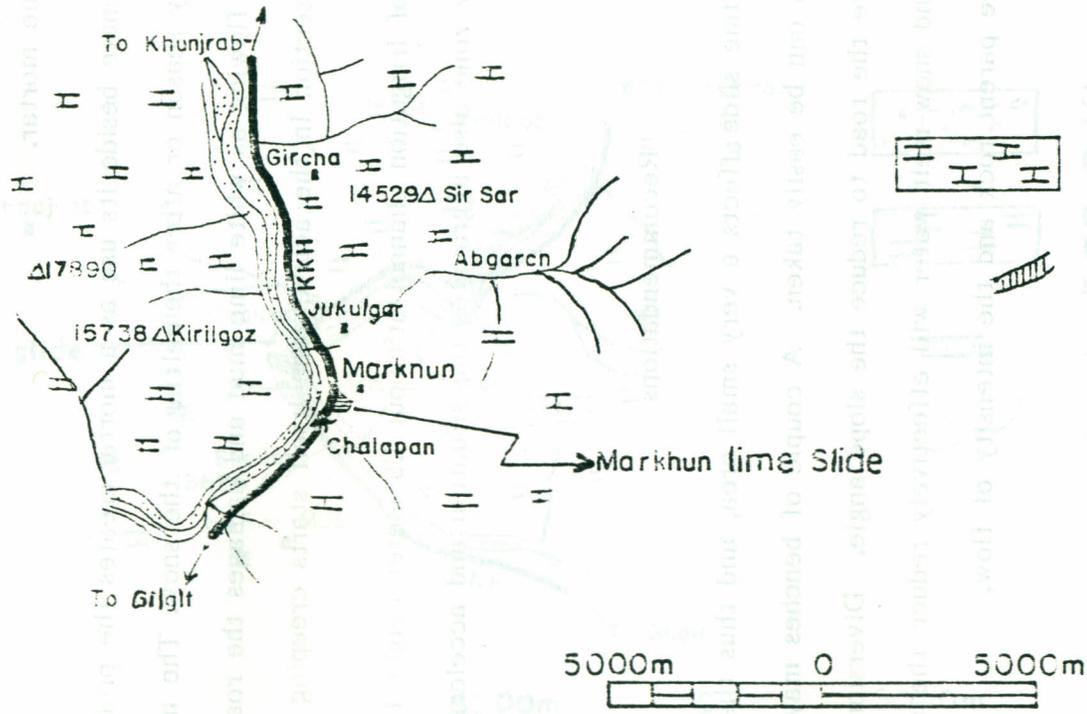
Figure 7 - Generalised geological map showing location of Markhun lime Slide area at Km 521 on the KKH.

Morkhun lime slide is located on KKH at km 521 from Thakot at about 1.6 km downstream of Morkhun Camp. This slide lies on Survey of Pakistan toposheet No. 42 L (1:2,50,000) with co-ordinates Lat. $36^{\circ} 36' 20''$ N and Long. $74^{\circ} 52' E$.(Fig. 7).

At this site thick monotonous sequence of Gujral dolomite is exposed with minor dolomitic limestone interbeds. The dolomitic limestone at certain places is badly decomposed in the form of powdery lime with some unaltered boulders of the parent rock. The process of decomposition is very rapid and the weathered product of dolomitic limestone occupies the

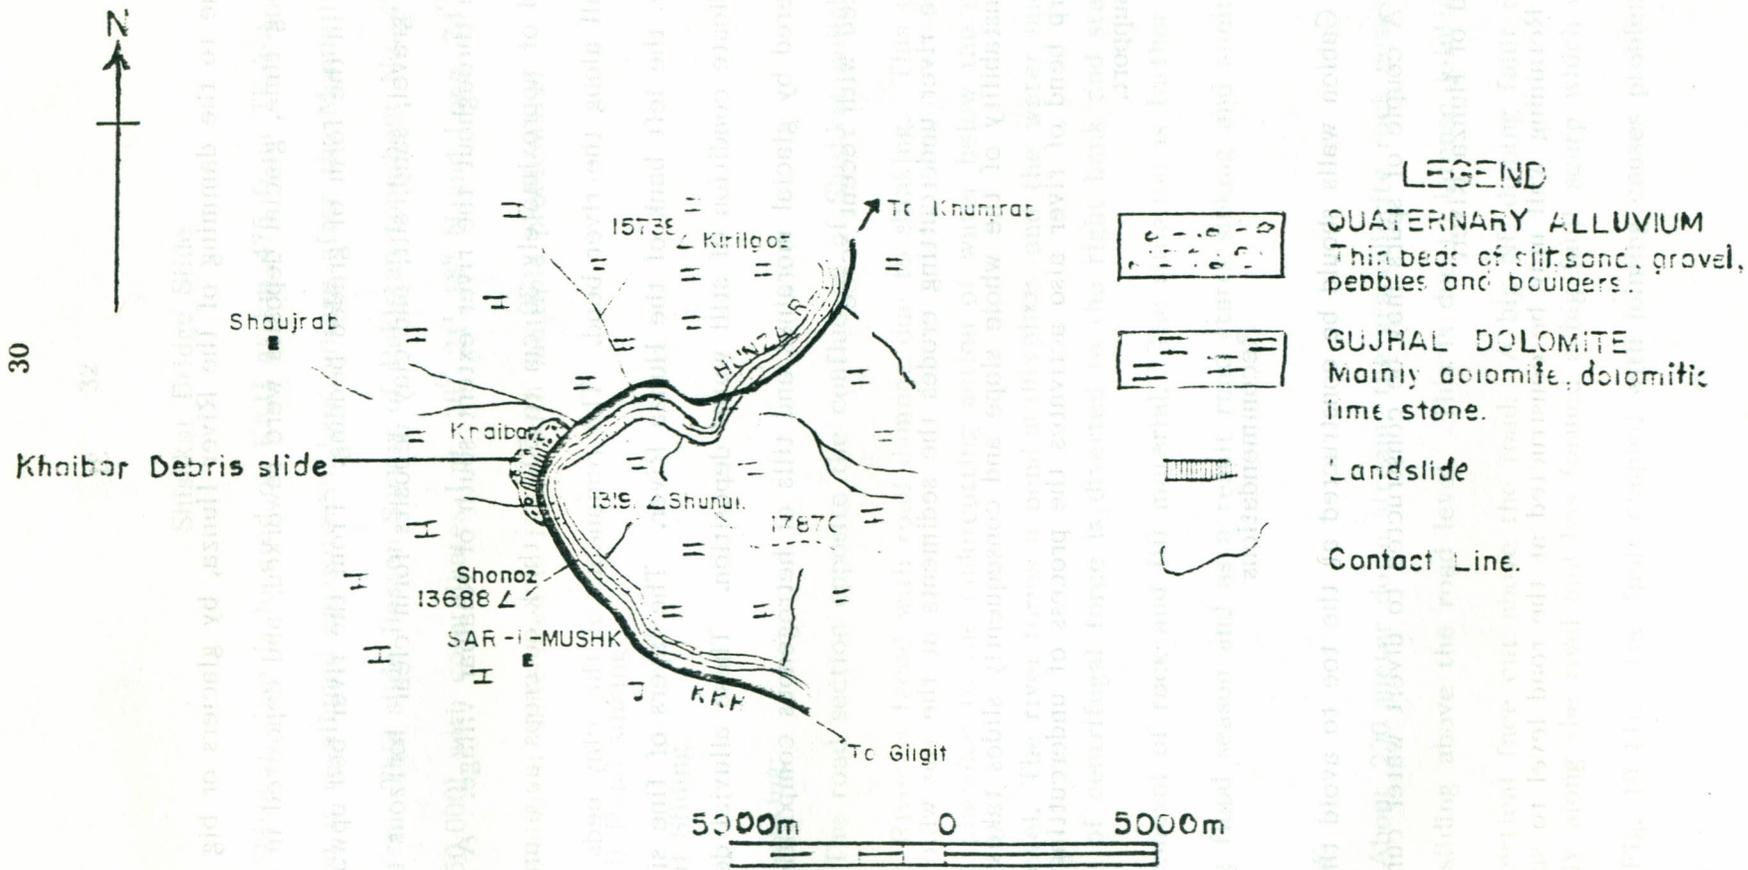
Figure 8— Generalised geological map showing location of Khaibar Debris Slide at Km 510 on the KKH.

Khaibar Debris Slide is located on KKH at km 510 from Thakot, approximately 1.6 km down stream of Khaibar village at the bend of Hunza River. This slide lies on Survey of Pakistan toposheet No.42 L (scale 1:2,50,000) with coordinates Lat. $36^{\circ} 34' 12''$ N Long. $74^{\circ} 47' 30''$ E. (Fig. 8).

Due to the damming of the River Hunza, by glaciers or big avalanches, for a long time, glacial deposits were reworked, and deposited in clear layering in the form of graded bedding. From the river bed upward alluvial gravel, sand, silt, and clay deposits form clear horizons and continue throughout the river extent south of Khaibar village. A buff coloured clay bed of approximately 30 cm to 50 cm thick outcrops at a uniform height all along the river bend. The remnants of this clay beds are also found on the left bank of the Hunza River. The layers of fine silt and clay indicate condition of still water deposition. These alluvial deposits are covered by glacial moraines and tills of heterogeneous composition which is intermixed with recent scree.

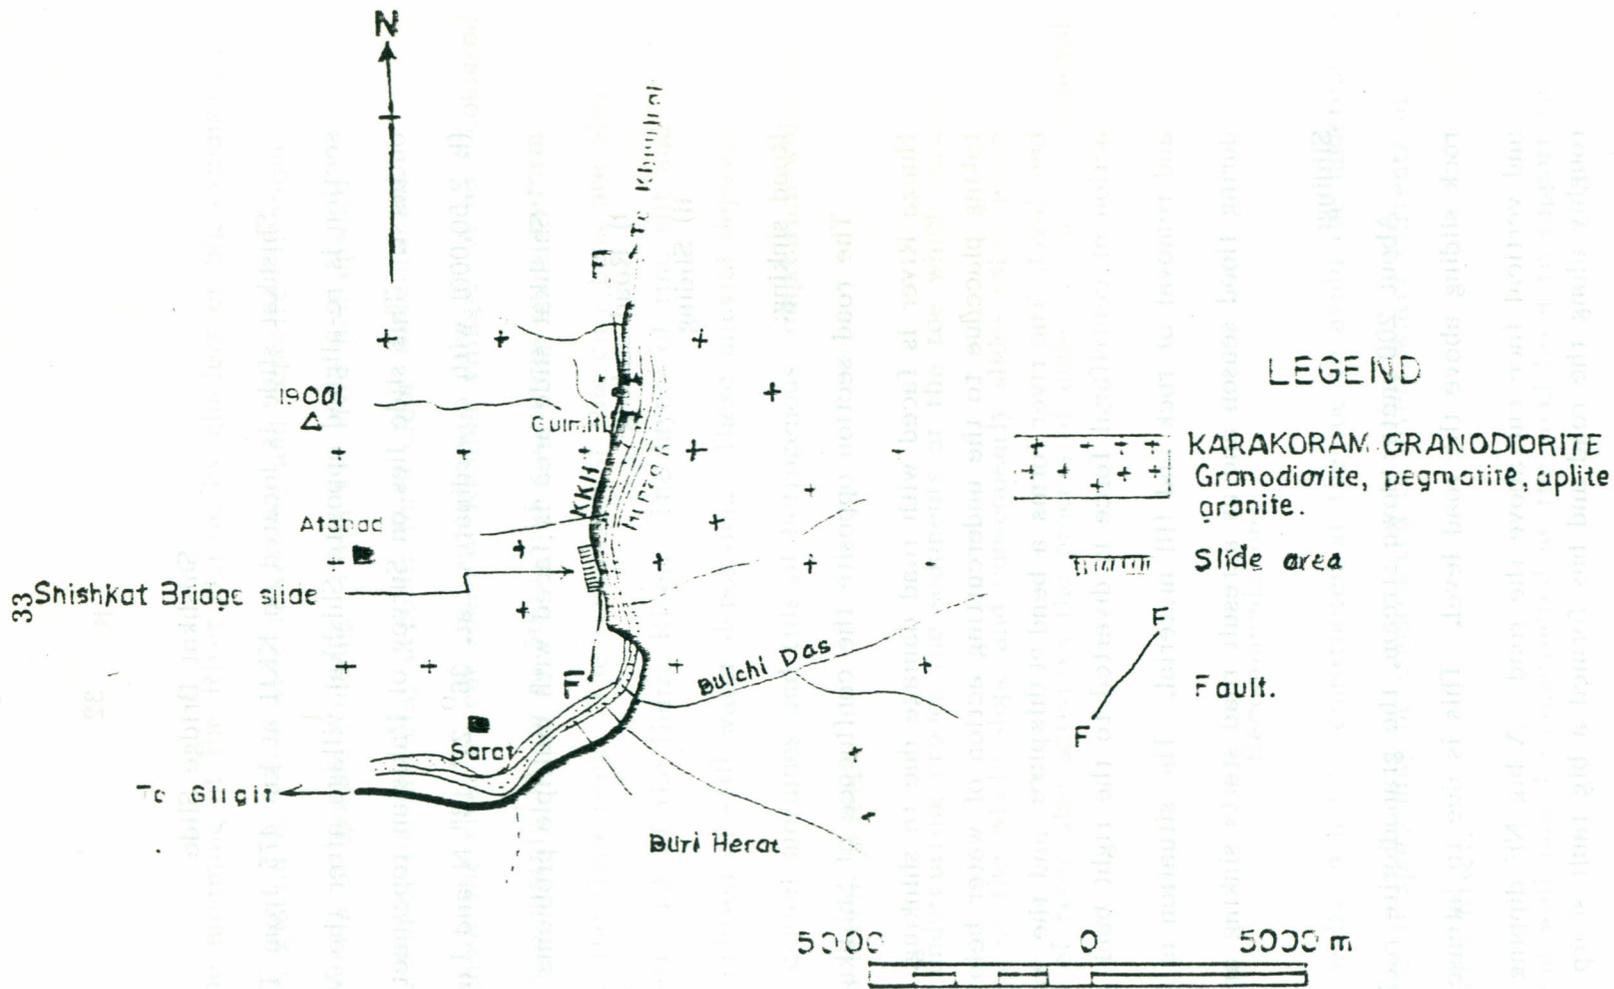
Figure 9 - Generalised geological map showing location of Shishkat Bridge Slide and road sinking area at Km 475 on the KKH.

Shishkat slide is located on KKH at km 475 from Thakot. This road section is re-aligned opposite Shishkat village after the Momhill glacial outburst. This slide lies on Survey of Pakistan toposheet No. 42 L. (1: 2,50,000) with co-ordinates Lat. $36^{\circ} 21' 18''$ N and Long. $74^{\circ} 52' E$. (Fig.9).

About 200 meter down stream, the granodiorite rock poses problem of rock sliding above the road level. This is due to intense jointing at the place and vertical face cut above the road. A big NE dipping fault also runs roughly along the road and has formed a big fault scarp which dips valley side (Fig. 10-11). The fault coupled with jointing causes problems of rock sliding.

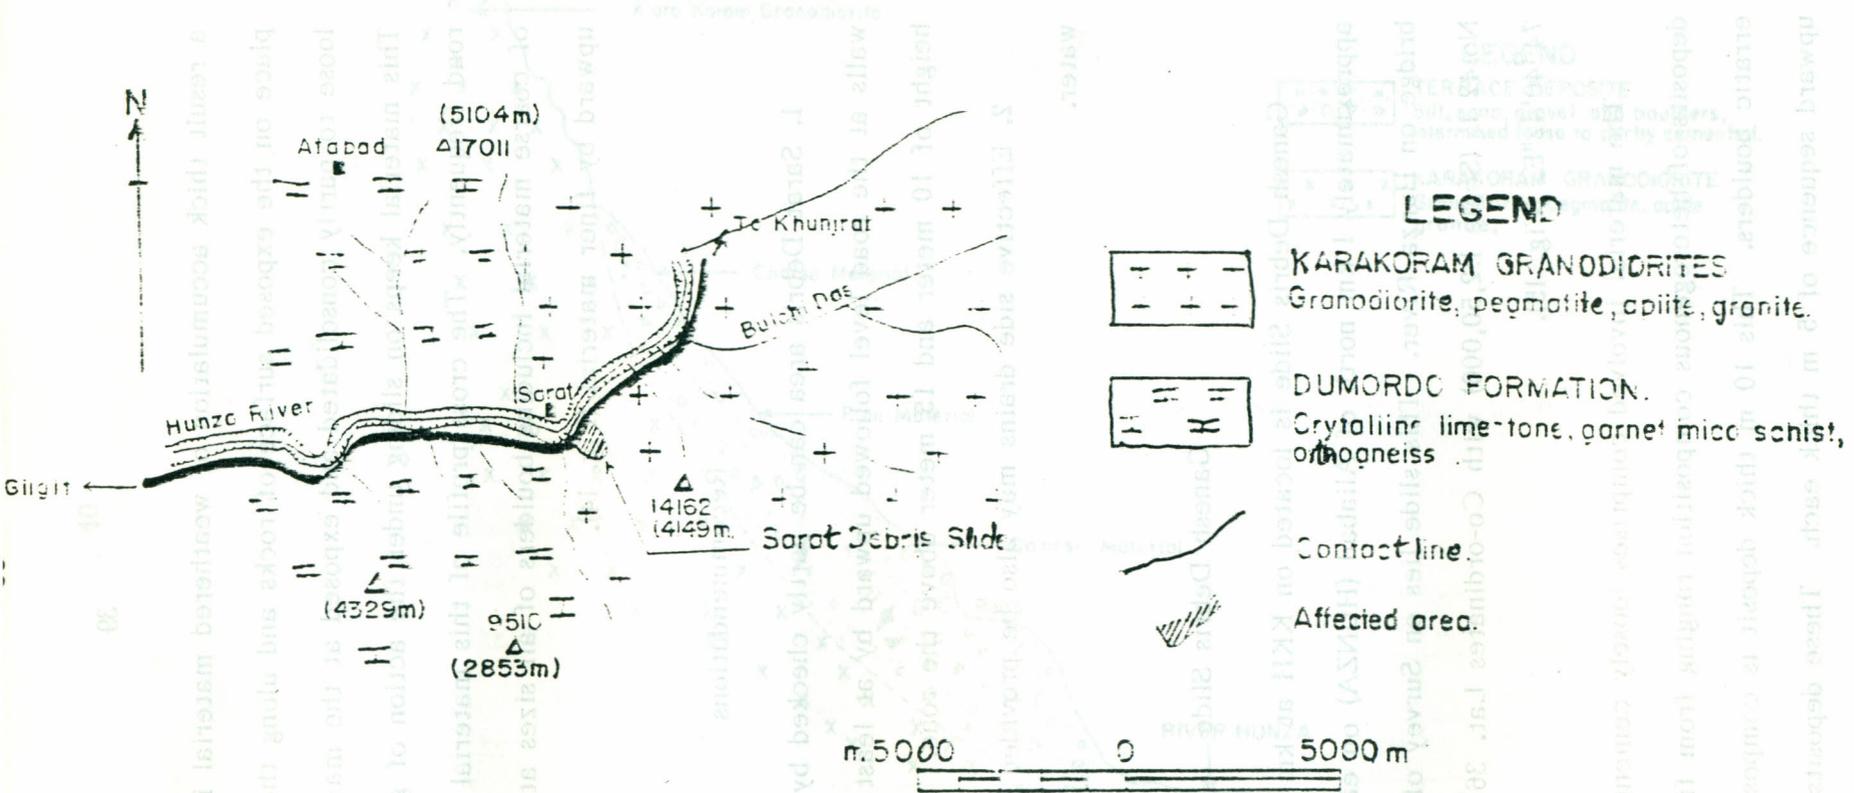
Figure 13— Generalised geological map showing location of Sarat Debris Slide area at Km 466 on the KKH.

Sarat Debris slide is located on KKH at km 466.32 from Thakot, opposite the village Sarat at Hunza River. This slide lies on Survey of Pakistan toposheet No. 42 L (1:2,50,000) with Coordinates Lat. $36^{\circ}18'13''N$ and Long. $74^{\circ}51'E$. (Fig. 13).

a result thick accumulation of weathered material in the form of scree to place on the exposed surface of rocks and along the valley slopes. Scree is loose to partly consolidated and exposed at the maximum angle of repose. This material keeps on sliding under the action of gravity and blocks the road frequently. The cross profile of this material shows greater percentage of coarse material including boulders of all sizes at the road level followed upward by finer material (Fig. 14).

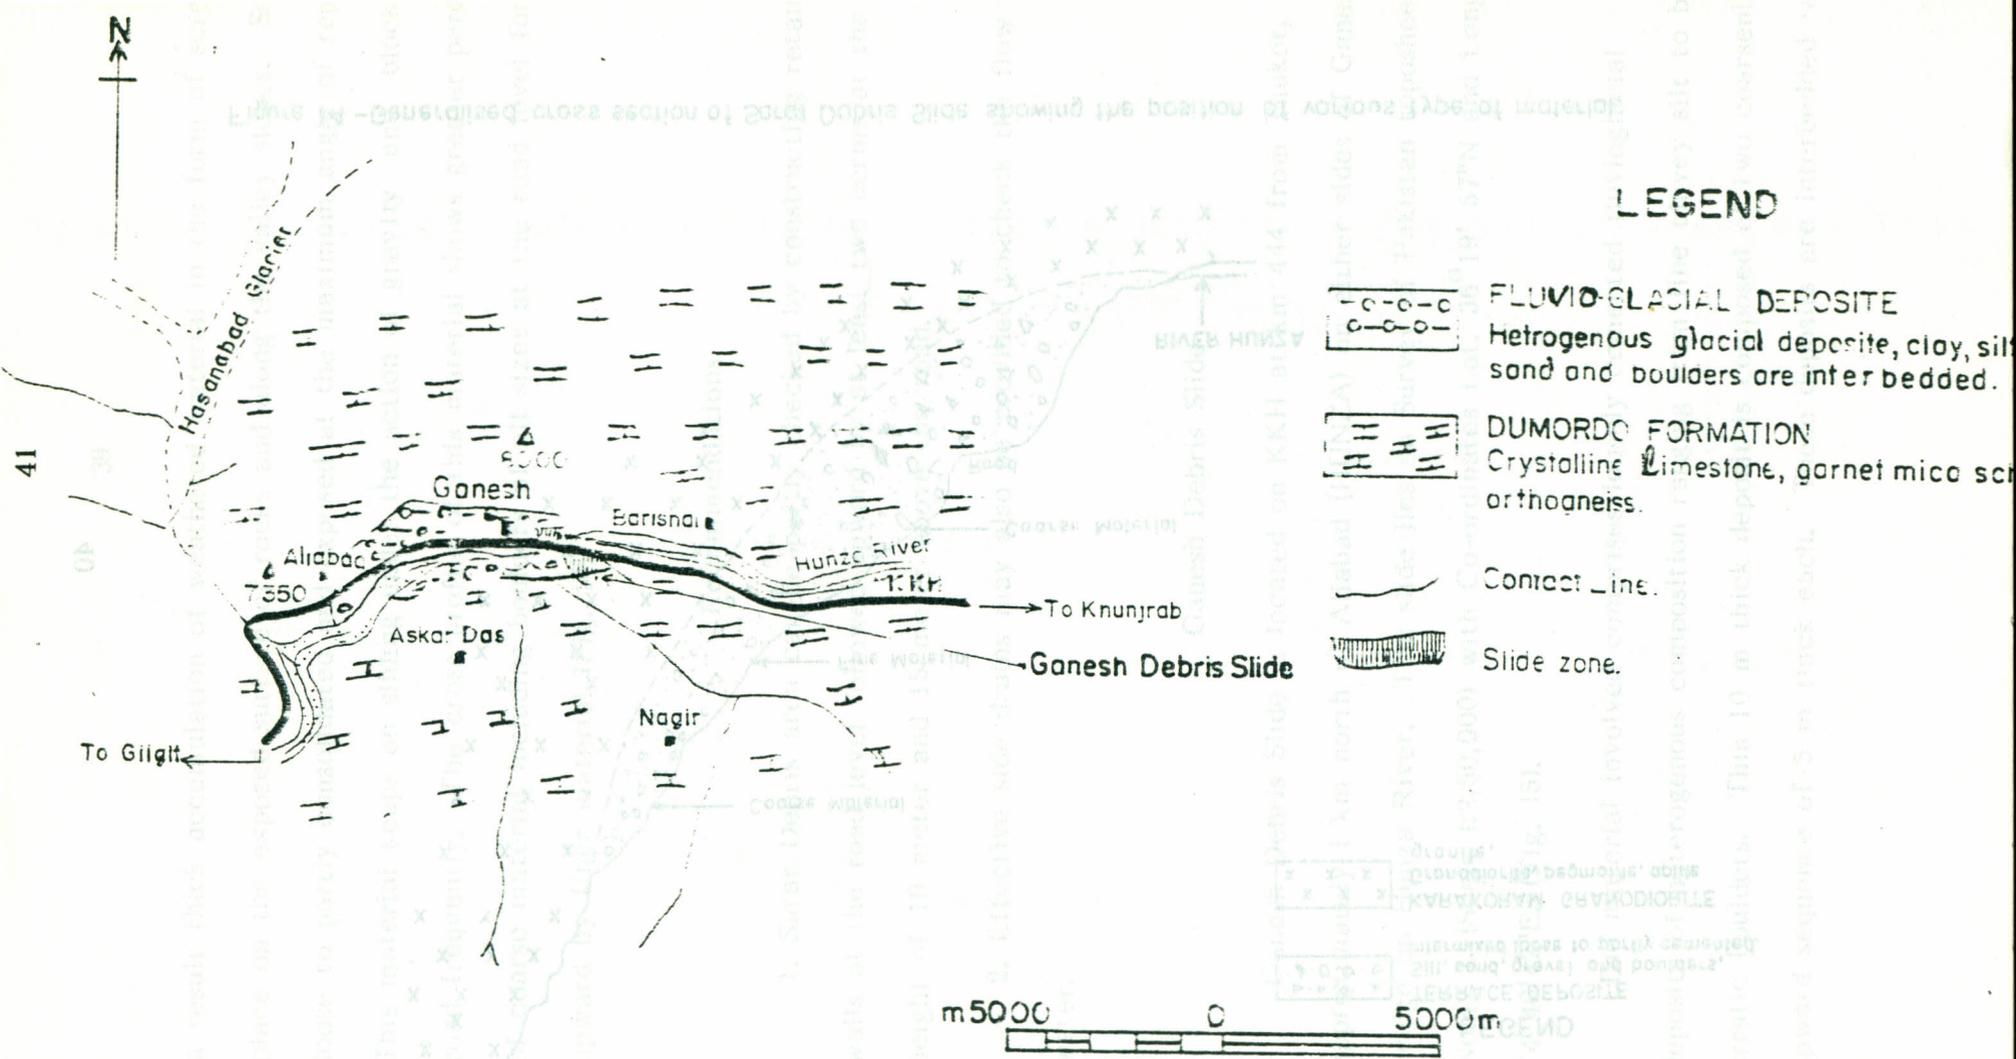
Figure 15- Generalised geological map showing location of Ganesh Debris Slide at Km 450 on the KKH.

Ganesh Debris Slide is located on KKH at km 444 from Thakot, approximately 1 km north of Aliabad (HUNZA) on either sides of Ganesh bridge on Hunza River. This slide lies on Survey of Pakistan toposheet No.42 L (Scale 1:2,50,000) with Co-ordinates Lat. $36^{\circ}19'57''N$ and Long. $74^{\circ}40'42''E$. (Fig. 15).

reworked and well stratified stream bed deposits. The stream bed deposits are well sorted and show graded bedding ranging in grain size from fine sand to big boulders and are exposed at vertical slope angle. Unlike that of fluvio-glacial deposits stream deposits form fining upward sequences and are repeated 2-3 times in one slope.

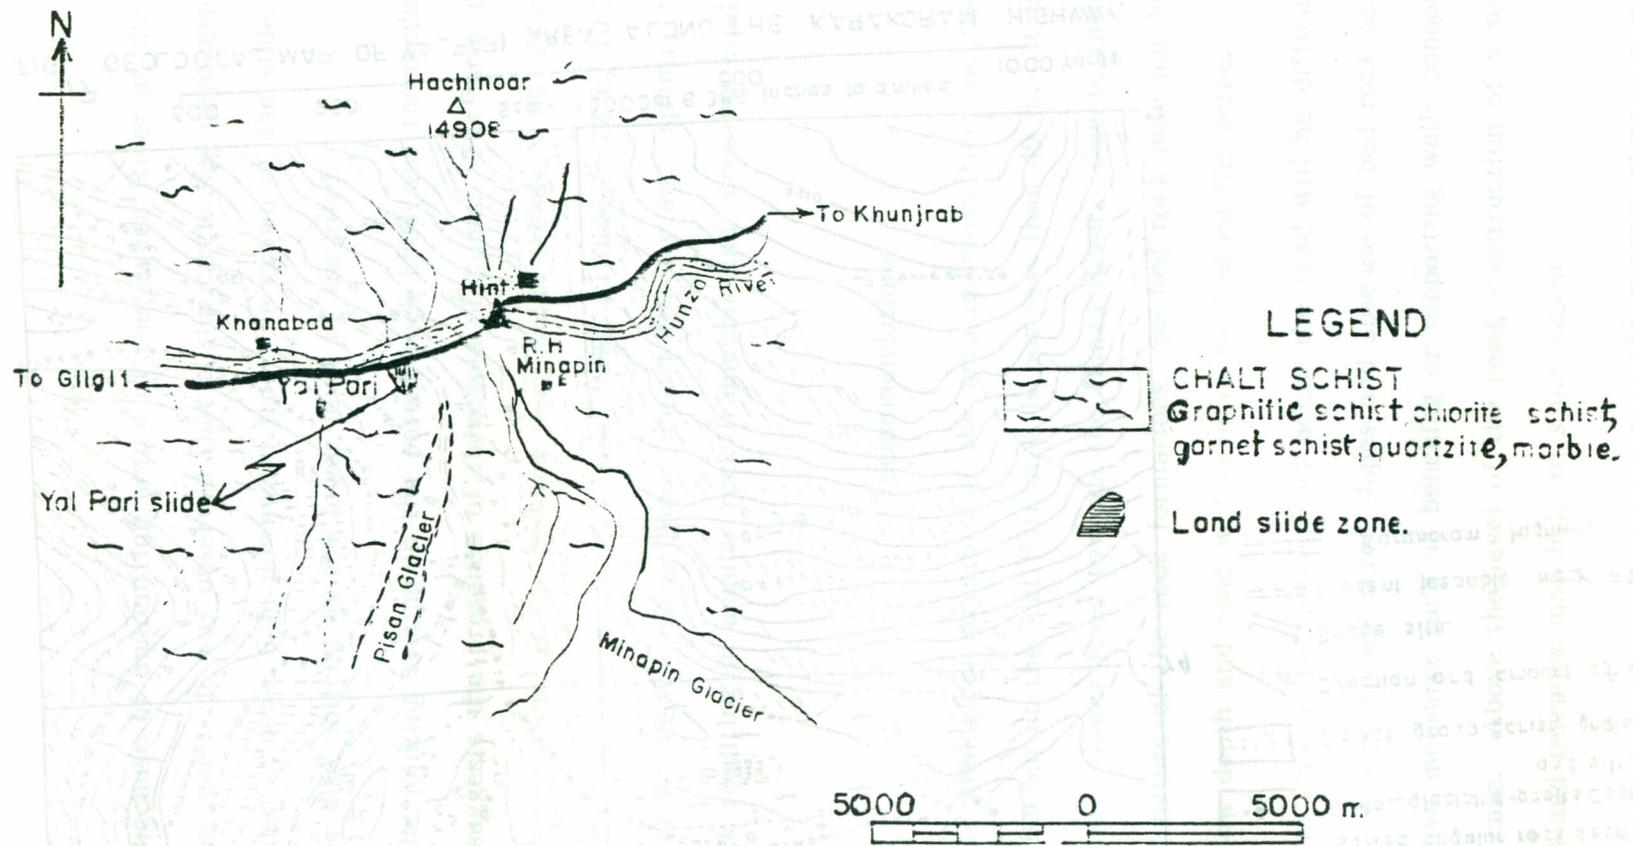
Figure 16- Generalised geological map showing location of Yal Pari Slide at Km 415 on the KKH.

bends forming an "S" shaped curve and cuts deeply through the metasedimentary rocks.(Fig.16).

The Yal Pari scree slope is very unstable because its angle of repose ranges between 45° - 48° degrees below & above the level of the present KKH. The slide is preceded by a flow or steady falling of rock fragments and it generally continuous throughout the day. The condition is further deteriorated by the undercutting action of the Hunza River. Another factor which has a detrimental effect on the movement of schistose rocks, is the presence of carbonaceous and slightly graphitic material in the main rock body. This material under wet condition acts as a lubricating agent and activates the movement of rock blocks.

Due to the absence of any bedrock at shallow depth the scree has no firm base to get consolidated, and is poised for sliding at the slightest disturbance. During the high flood period, the conditions become even

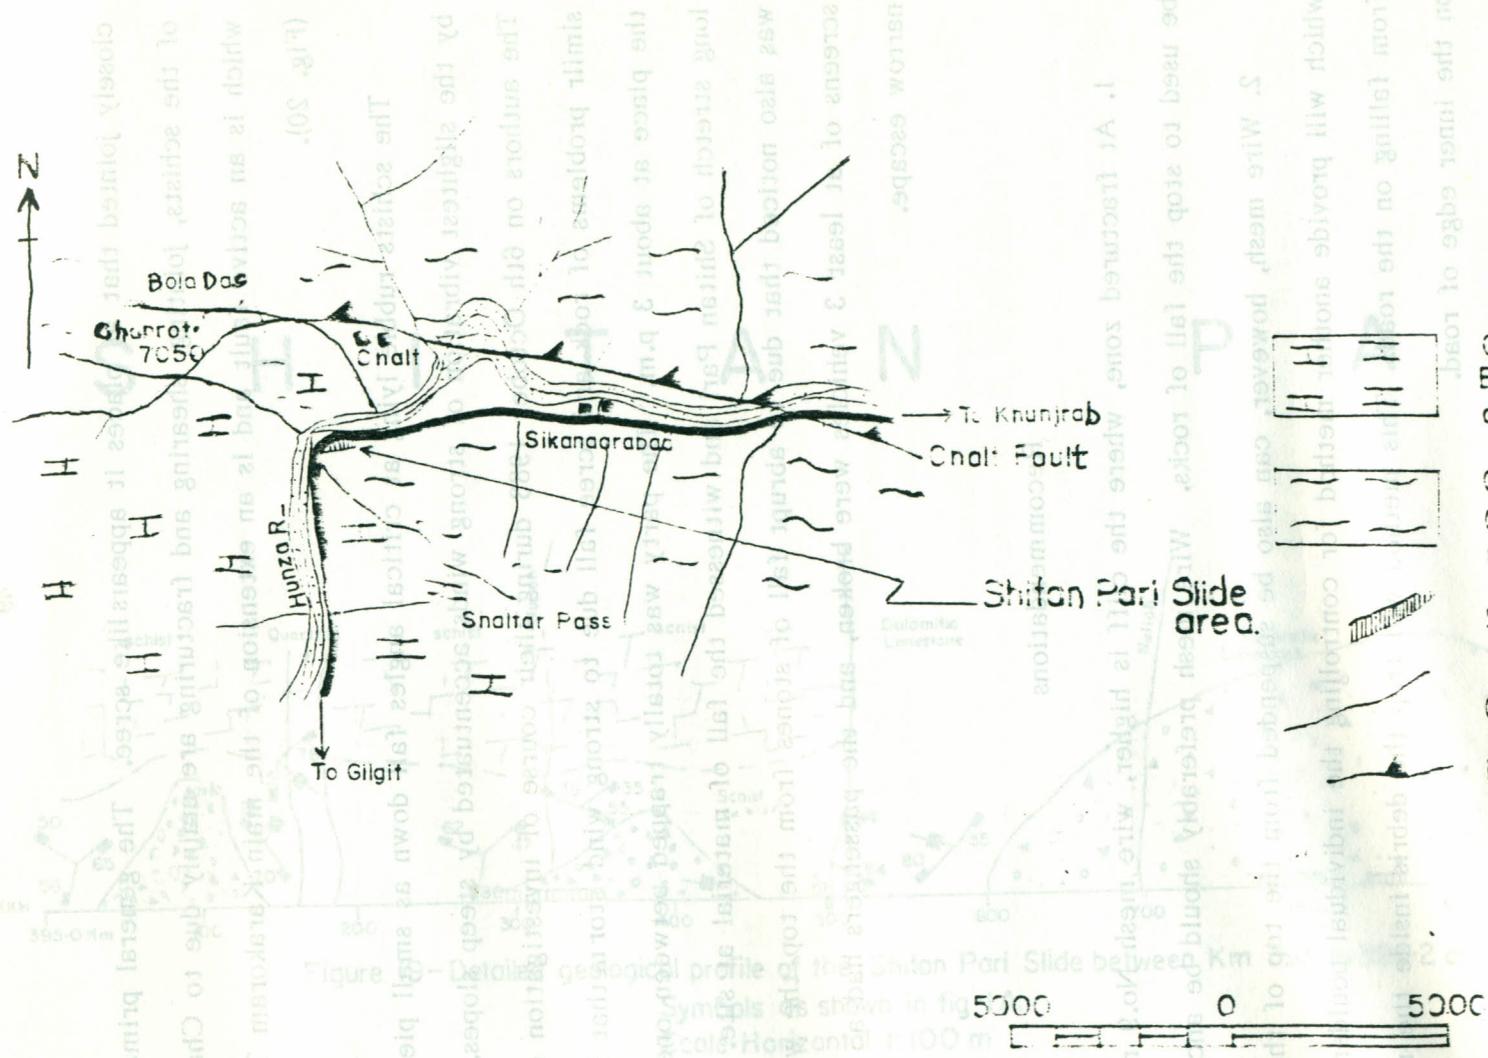
Figure 19- Generalised geological map showing location of Shitan Pari Slide area at Km 395 on the K K H.

Generalized geological map of the area shows that two formations are exposed at this site, Greenstone complex and Chalt Schist. The Chalt fault crosses near the affected site (Fig. 19). At Shitan Pari, Chalt schists are exposed which includes mica schist, calcareous schist, and chlorite schist. A thick outcrop of dolomitic limestone is also exposed within the Chalt schist.

Schists are of platy structure, thinly bedded and loosely jointed. At places schists are well foliated with steep vertical faces when followed upward give rise to highly fractured schist blocks. Away from the road these blocks vary from 30x15x10 cm to 100x60x10 cm. Schists are so
